5.2 SIHP # 50-80-09-2268 Waiahole Ditch System/ post-Contact Irrigation Ditch

SIHP # 50-80-09-2268 consists of the entire Waiahole Ditch System, a post-Contact irrigation ditch dating from 1916. The historic property spans approximately 22 miles (Figure 79) transporting water from the windward side of the Ko'olau Range through the Ko'olau Range by a system of tunnels, across central O'ahu and on to the 'Ewa Plain (Condé and Best 1973). Approximately 380 linear m of the Waiahole Ditch was identified in the northern and western portions of the project area. The ditch extends along the northern boundary, crossing the central project area as it extends southwest down the natural sloping landscape, exiting the southern boundary and continuing to extend southwest away from the project area (Figure 80).

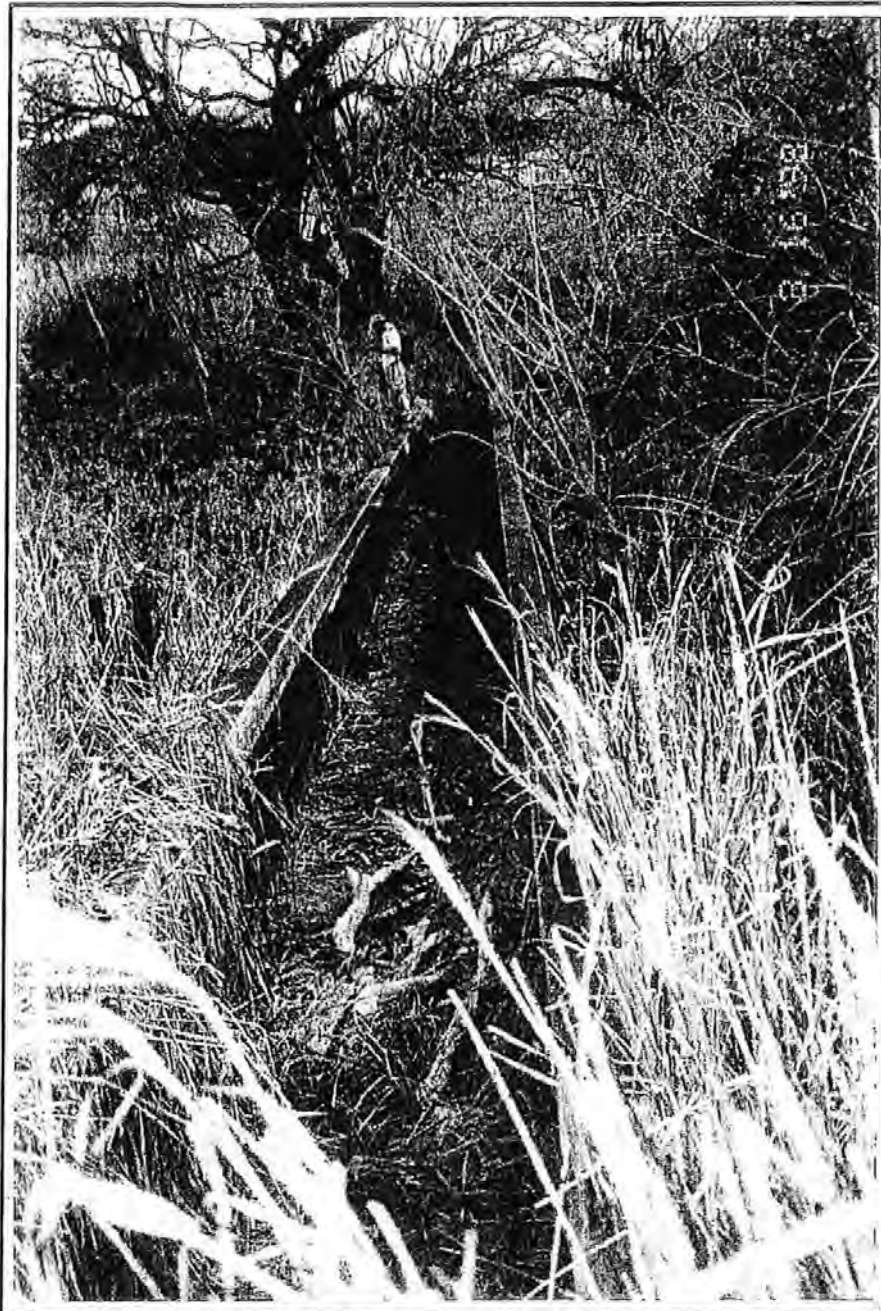
Figure 7: Site 2268, a Section of Water Flume. View to Northeast.

Figure 81. Portion of SIHP # 50-80-09-2268 documented by Dega et al. (1998:18)

The ditch was encountered on the western slope of the westernmost gulch which trends north-south through the eastern portion of the property. The major flume crosses the bottom of the gulch through a concrete flume and enters a c. 1000 m long tunnel. A branch within this tunnel is also connected to the Waiahole Ditch System via a more northerly route. This ditch exits the tunnel, crosses the bottom of another smaller gulch through a shorter concrete flume and then enters another tunnel. The ditch follows along the 400 to 440 foot contours in this manner along the eastern and southern slopes of Pu'u Kapua'i and exits the property to the west near Kaloi Gulch. There are, altogether, seven tunnels of various lengths along the ditch within the project area.

The flume itself is 60 cm deep and about 1 m across [...] The sides of the ditches have been shored with stone masonry. The tunnels are 90 cm wide and about 140 cm high. Cement was used to support the sides and roofs of the tunnels only near the entrances. At greater depth within the tunnels cement was used only to shore up the walls. The tunnel roofs in these areas consist of bare rock.

Figure 81 shows the section of the flume feature documented by Dega et al. (1998).

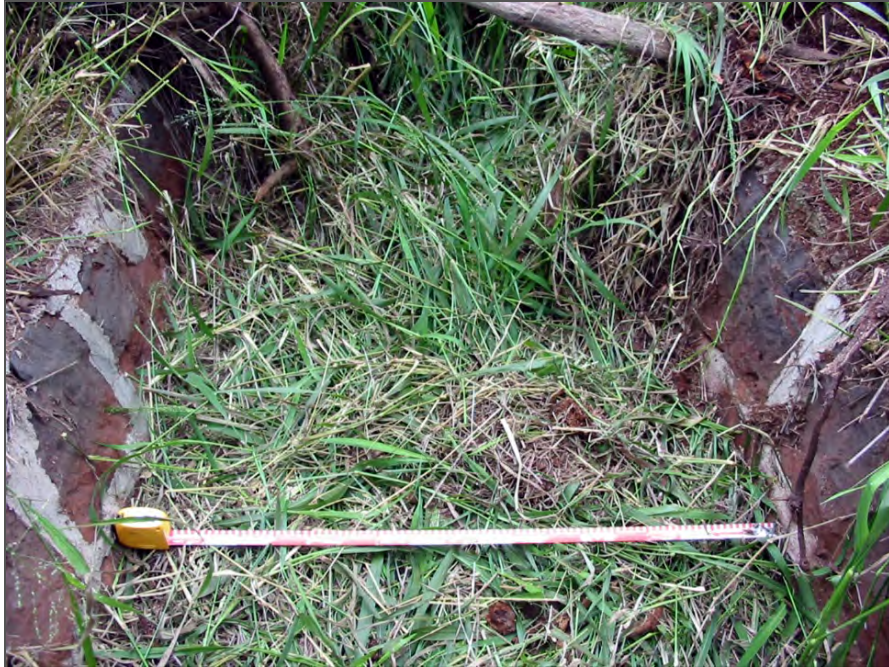
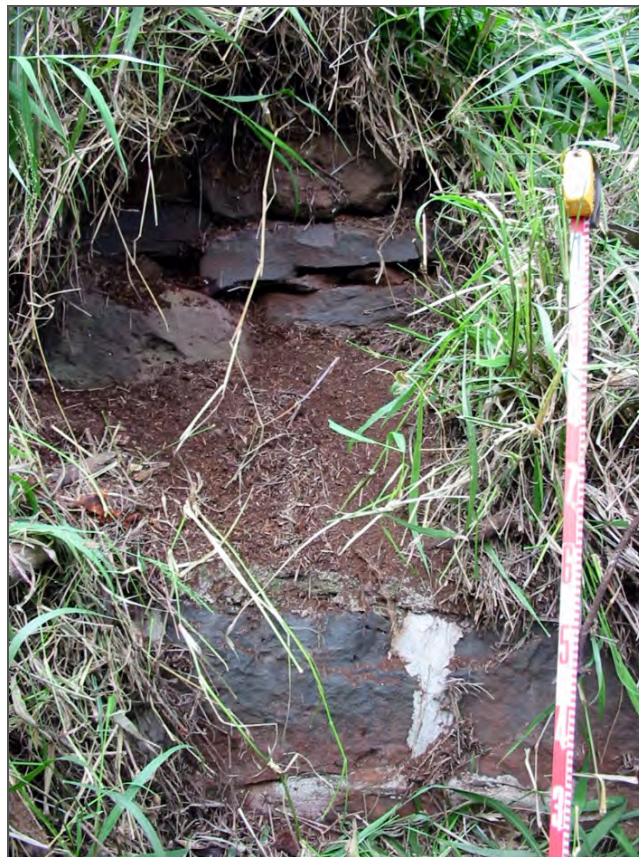
Figure 82. SIHP # 50-80-09-2268 showing the dressed basalt boulder and mortar Waiahole Ditch (top), and stacked basalt boulder and cobble retaining wall (below) (Tulchin and Hammatt 2004:53)

The improved ditch appeared to be constructed in a U-shaped configuration, with a flat bottom and nearly vertical sidewalls. However, heavy sedimentation within the interior of the ditch did not allow for direct observation of the base of the ditch. The main constructed portion of the ditch measured 90 cm [centimeter] wide and 1 m [meter] in height. The sidewalls were of cut basalt stone and mortar construction [present Figure 82]. In areas where the ditch was cut deeply into the slope, loosely stacked basalt boulder and cobble retaining walls were constructed along the top edges of the ditch as necessary. The stones composing the retaining wall appeared to be flaked, likely during the fashioning of cut basalt blocks. [Tulchin and Hammatt 2004:52]

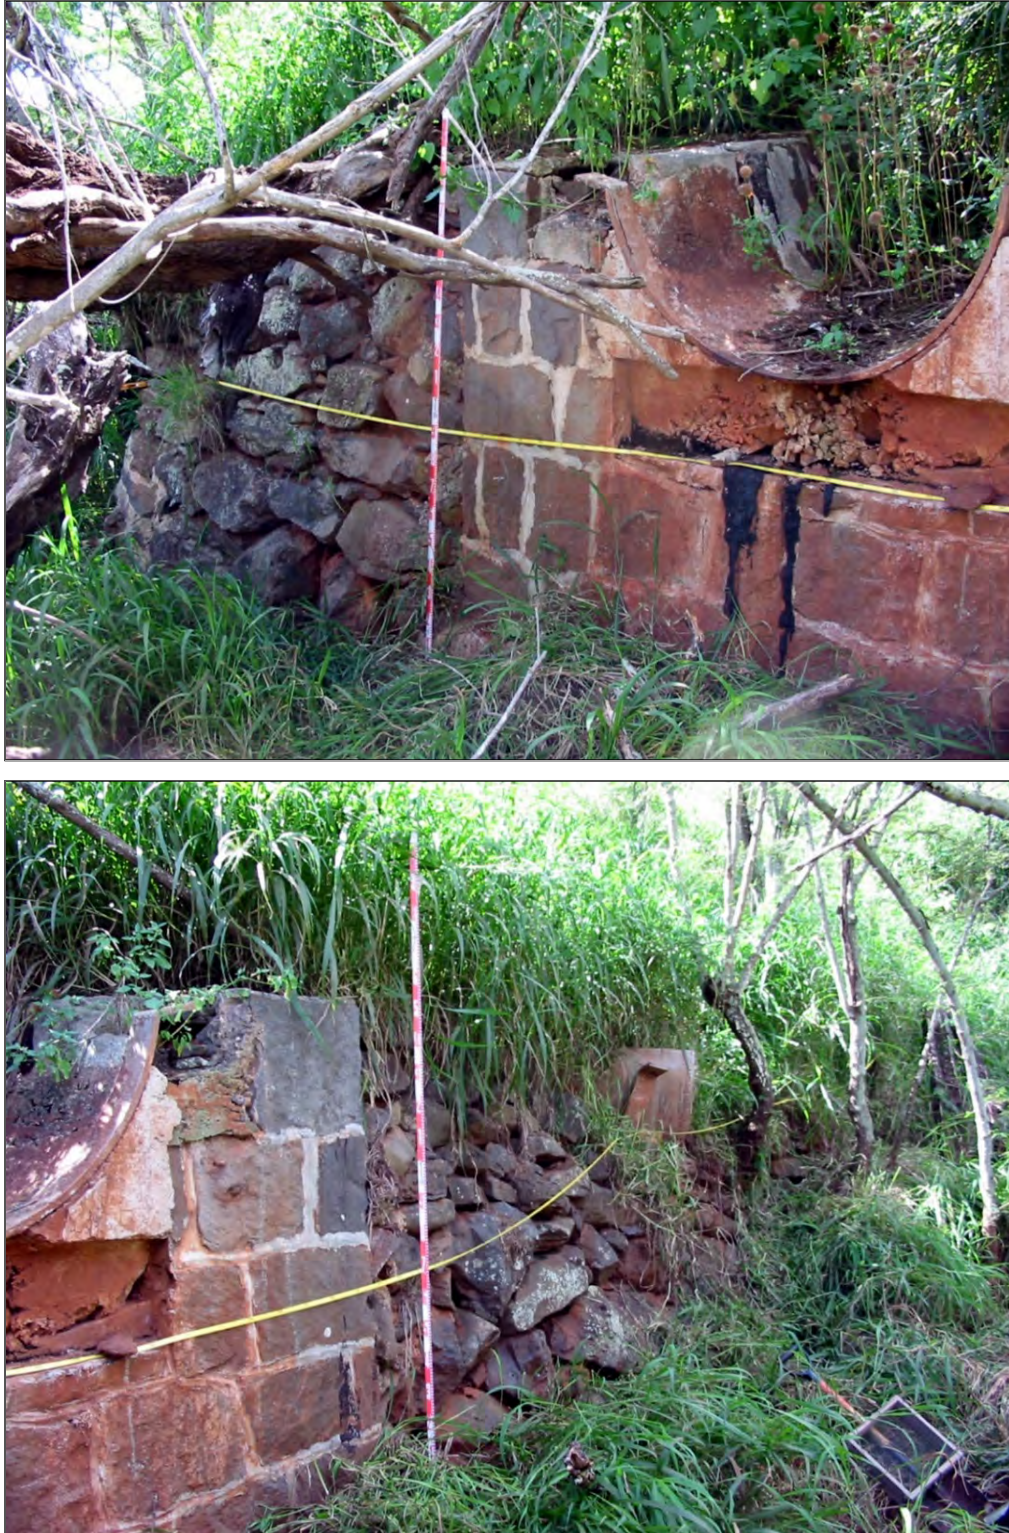
Figure 83. Showing the eastern (top, view to east) and western (bottom, view to south) ends of the southern portion of SIHP # 50-80-09-2268 Feature A: flume bridge (Tulchin and Hammatt 2004:55)

Near the easternmost point of the project area, the ditch crosses an unnamed drainage gully which empties into Kalo'i Gulch. In order to cross the gully, foundations were constructed at each edge of the gully to support a metal flume section spanning the approximately 4.8 m gap. At the time of the inventory survey, the metal flume was not intact, though remnants were observed in the brush in the immediate vicinity of the structure. Each foundation consisted of a central portion constructed of cut basalt boulders and mortar, measuring 2.8 m wide and a maximum height of 1.8 m [Figure 84 and Figure 83]. In addition to the central stone and mortar constructed portion, additional stacked basalt boulder and cobble retaining walls were constructed along the edges of the gully both up and down slope of the main ditch foundation. The retaining walls extended approximately 7.2 m upslope and 3.4 m down slope of the main ditch foundation. The stones were stacked a maximum of 7-8 courses high, with a maximum height of 2.2 m. The retaining walls were generally constructed of loosely stacked stones, though mortar was observed at the interface between the retaining wall and the ditch foundation, as well as at the down slope terminus of the retaining wall. Wooden fence posts with attached barbed wire were observed to run along the top of the retaining walls and over the ditch foundations. [Tulchin and Hammatt 2004:52]

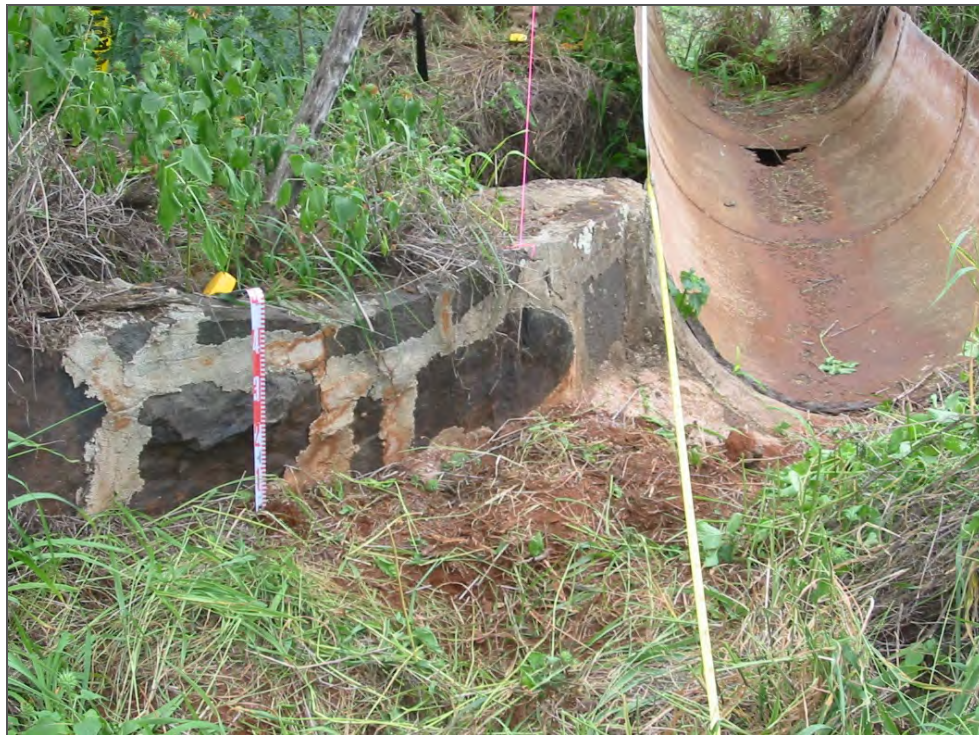
Figure 85. SIHP # 50-80-09-2268 Feature B, showing stone and mortar flume support foundation, view to north (Hunkin and Hammatt 2009:50)

Feature B is an improved drainage channel and short flume section. Feature B is located in the central portion of the project area, where the Waiāhole Ditch crosses a small drainage channel along the Kalo'i Gulch slope. The drainage channel appears to have been improved by excavation of loose soil and stones to improve water flow. Feature B consists of a metal half-pipe flume section constructed over the Waiāhole Ditch [Figure 87 and Figure 88]. The metal flume is constructed of three (3) riveted sections of U-shaped sheets of iron. The flume is oriented perpendicular to the ditch, with the upslope end of the flume located in the center of the drainage channel. The flume is supported on the upslope end by a stone and mortar foundation and retaining walls that direct the water flow from the drainage channel into the flume [Figure 85]. The central portion of the flume is supported by wooden support beams and crossed with wooden cross beams. The down slope portion of the flume rests on the soil berm down slope of the ditch, with a stacked-stone retaining wall constructed along the berm in the vicinity of the flume. Down slope of the end of the metal flume section are remnants of a wooden flume that likely connected to the end of the metal flume [Figure 86]. Feature B functions as a drainage improvement associated with the Waiāhole Ditch. The flume collects storm water from an improved drainage channel and transports the water over the ditch and down the gulch slope, thereby reducing damage to and sedimentation of the ditch during periods of heavy rainfall. [Hunkin and Hammatt 2009:47]

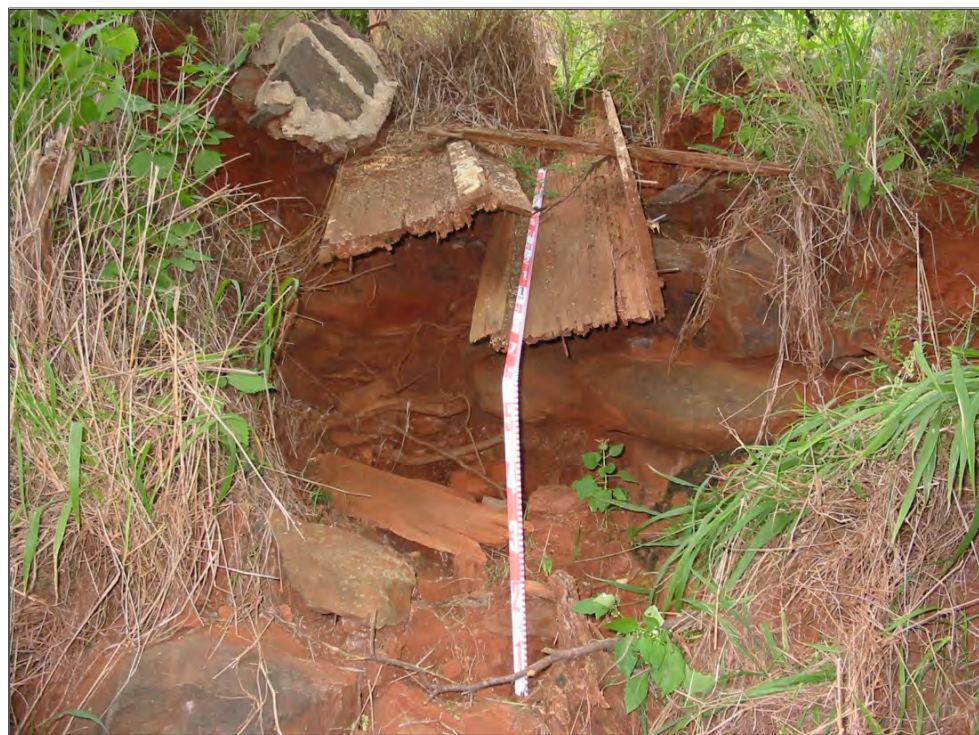
Figure 86. SIHP # 50-80-09-2268 Feature B flume, showing wooden flume extension (Hunkin and Hammatt 2009:50), view to southeast

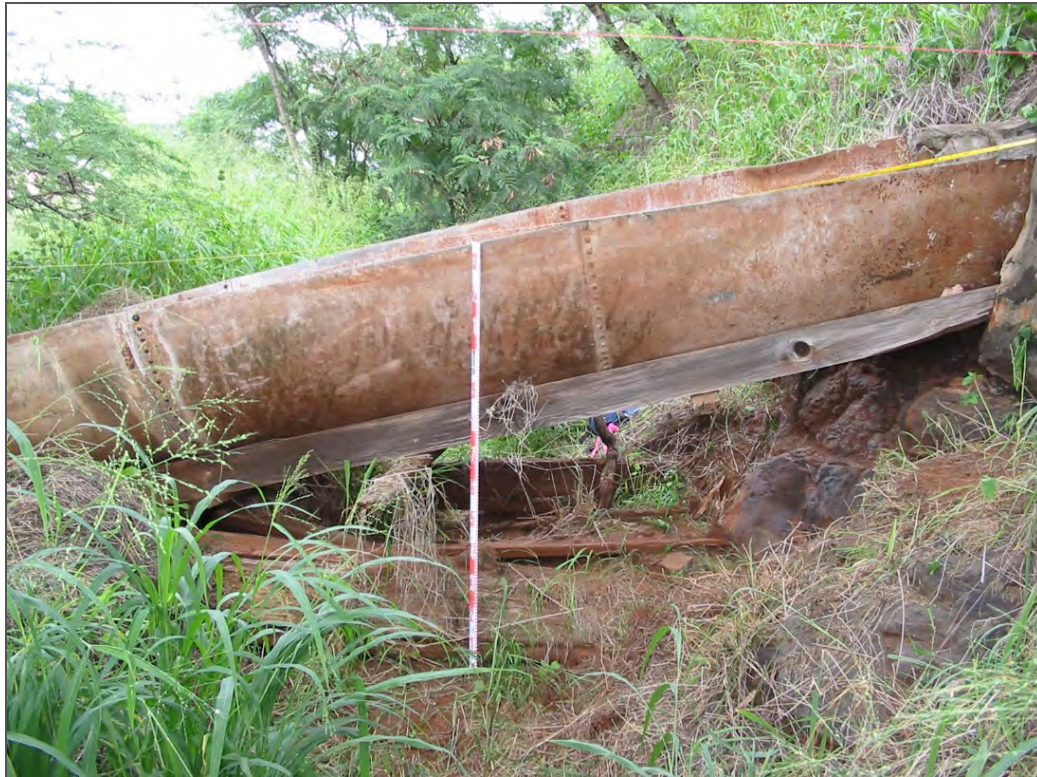
Figure 88. Photograph (top, view to east) and cross-section map (bottom) of SIHP # 50-80-09-2268 Feature B flume (Hunkin and Hammatt 2009:49)

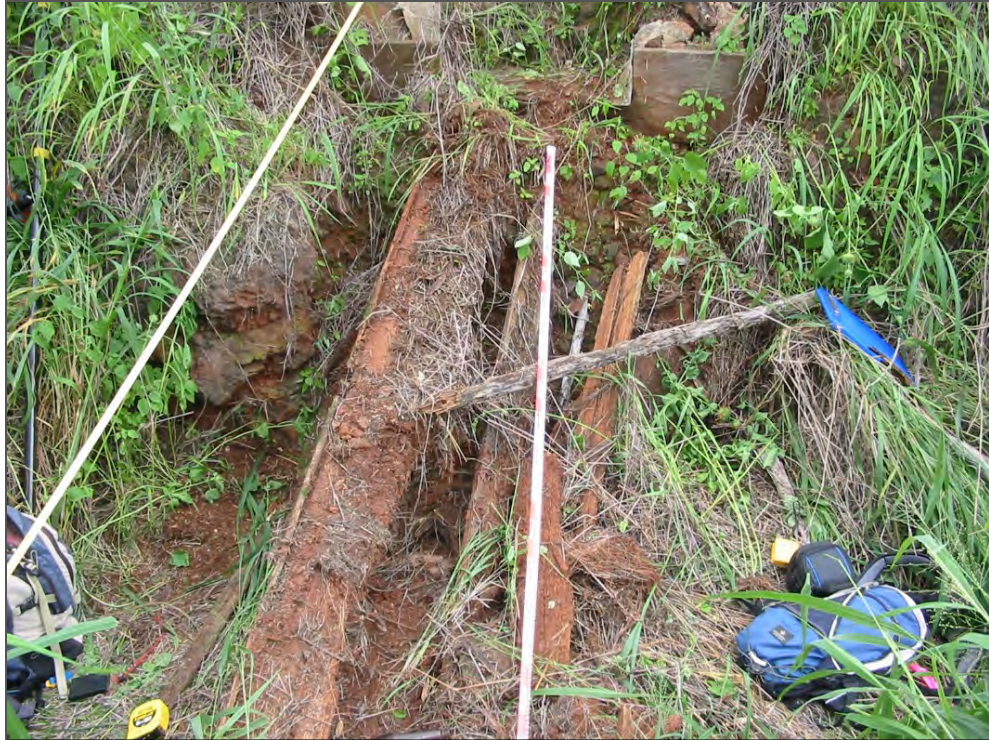
Figure 89. SIHP # 50-80-09-2268 Feature C, view to south (Hunkin and Hammatt 2009:52)

Feature C is an improved drainage channel and short flume section, similar to Feature B. Feature C is located where the Waiahole Ditch crosses a small drainage channel, approximately 100 m east of Feature B. The drainage channel appears to have been improved by excavation of loose soil and stones to improve water flow. Feature C consists of a wooden U-shaped flume section constructed over the Waiahole Ditch (Figure 91 through Figure 90). The flume is oriented perpendicular to the ditch, with the upslope end of the flume located in the center of the drainage channel. The flume is supported on the upslope end by a stone and mortar foundation and retaining walls that direct the water flow from the drainage channel into the flume. The downslope portion of the flume rests on the soil berm downslope of the ditch. Feature C functions as a drainage improvement associated with the Waiahole Ditch. The flume collects storm water from an improved drainage channel and transports the water over the ditch and down the gulch slope, thereby reducing damage to and sedimentation of the ditch during periods of heavy rainfall. Due to its wooden construction, much of the Feature C flume has deteriorated. [Hunkin and Hammatt 2009:47]

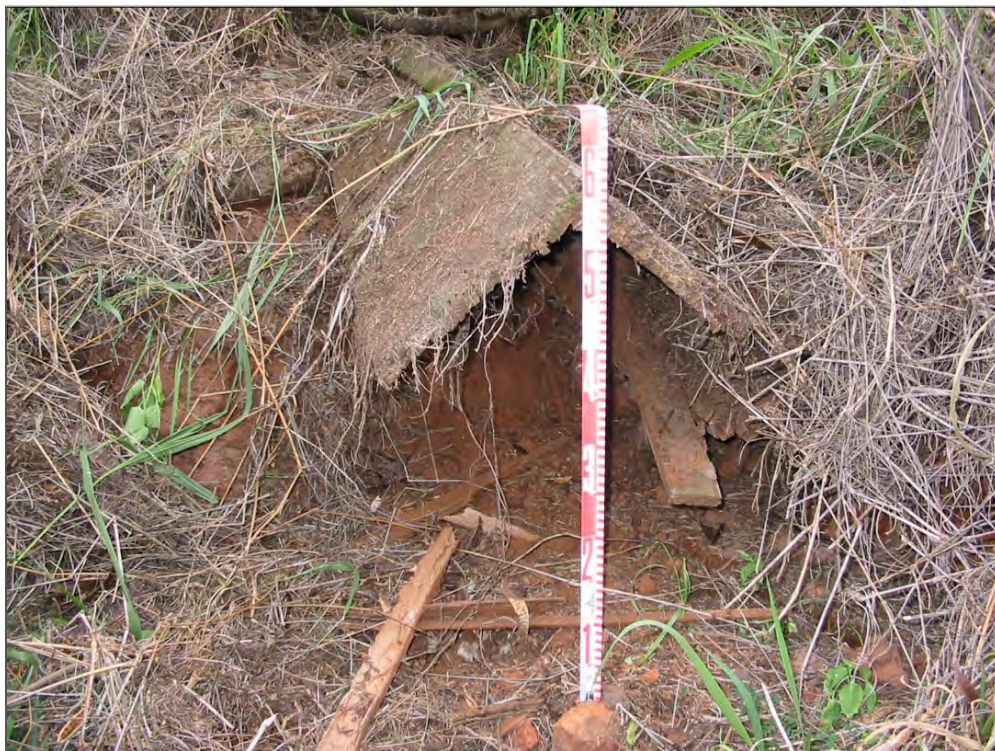
Figure 90. SIHP # 50-80-09-2268 Feature C, showing partially intact wooden flume section, view to south (Hunkin and Hammatt 2009:52)

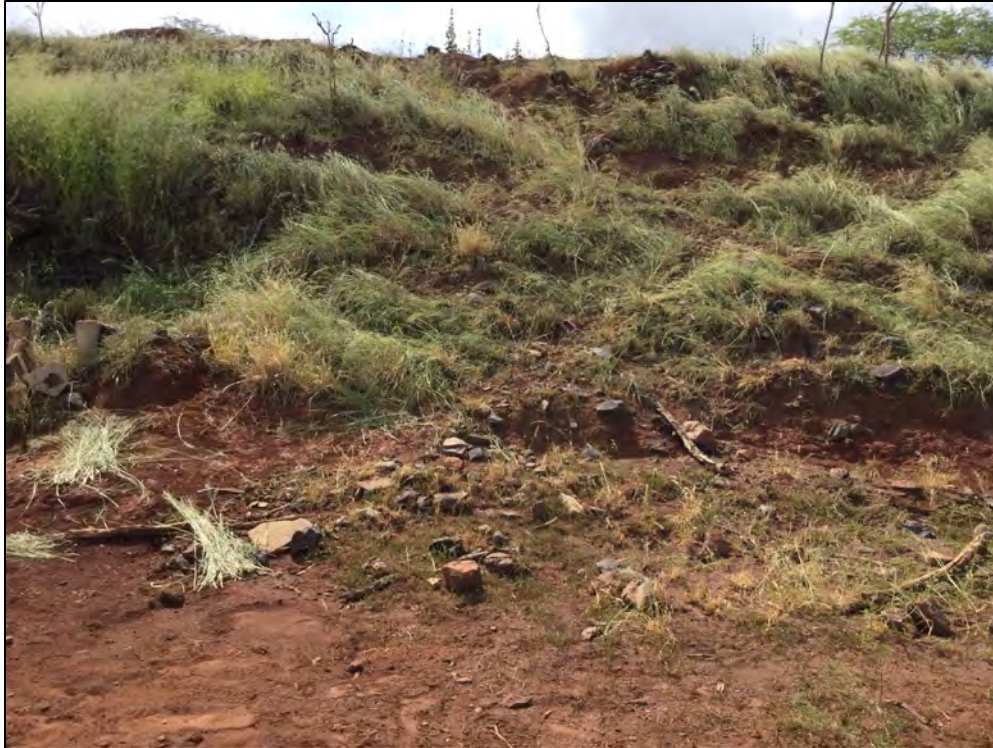
Figure 92. SIHP # 50-80-09-2268 Feature D, earthen mound, view to southwest (Zapor et al. 2018:79)

The newly identified Feature D is a large earthen mound and stacked stone wall [Figure 92 and Figure 93] located in the northeastern portion of the project area running adjacent to SIHP # 50-80-12-6951 and is likely the remnants of the reservoir that can be seen on historic maps at the terminus of the Waiahole Ditch System...Sometime after 1977, the reservoir was filled in with sediment resulting in the current state of Feature D. [draft Zapor et al. 2018:76]

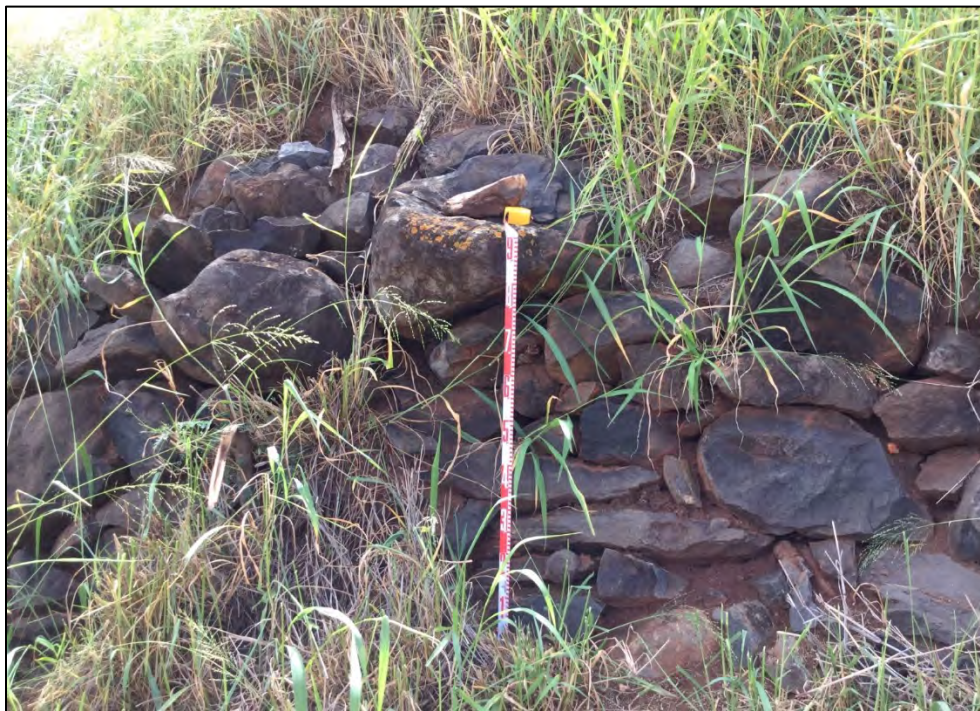
Figure 93. SIHP # 50-80-09-2268 Feature D, stacked stone wall, view to southwest (Zapor et al. 2018:79)

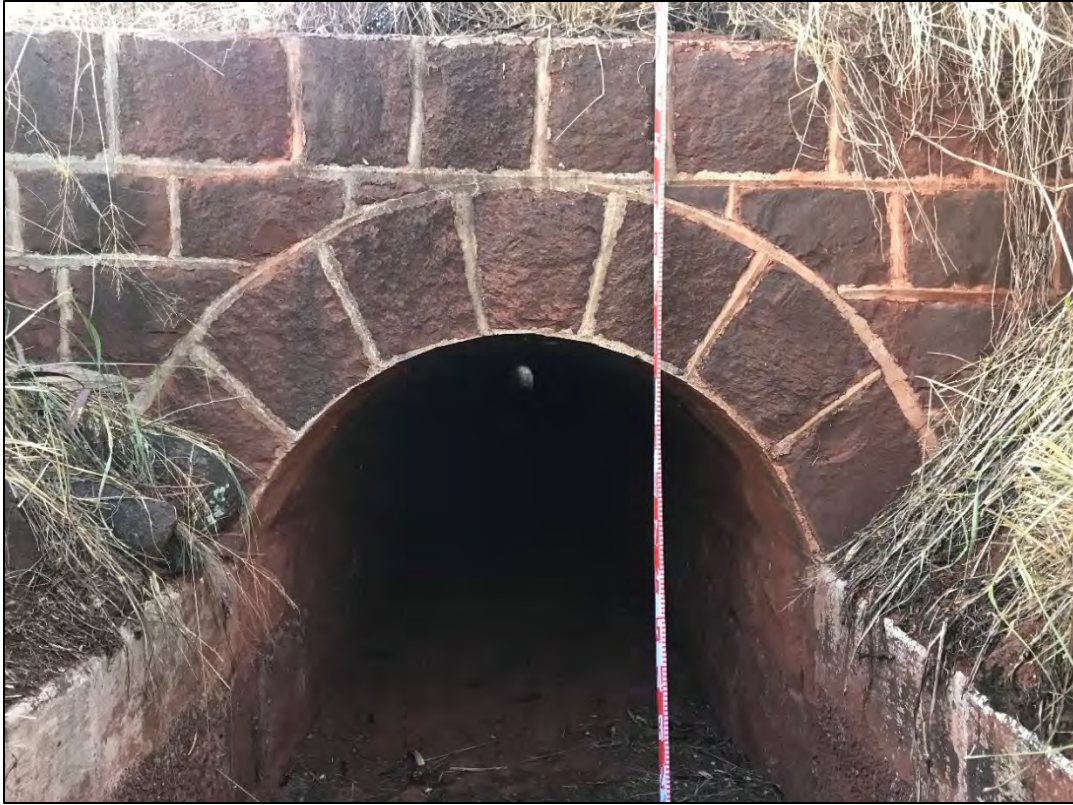
Figure 94. Culvert of SIHP # 50-80-09-2268, Waiahole Ditch, northwest of (outside) the project area, view to southwest

Several variations of the Waiahole Ditch were observed during the current study. Just outside the northern boundary of the project area, the ditch consists of a more formal construction, with mortared basalt sides and tunnels (Figure 94 through Figure 96). Concrete-lined portions were also observed just north of the project area boundary, as were several tunnel entrances and sluice gate features (Figure 97 and Figure 98). Much of the length of the Waiahole Ditch runs underground in concrete-lined tunnels. In the central portion of the project area, the ditch was observed as an informal earthen ditch, largely overgrown (Figure 99). In the southwest portion of the project area, dry-stacked basalt sides were observed (Figure 100 and Figure 101). As discussed above,

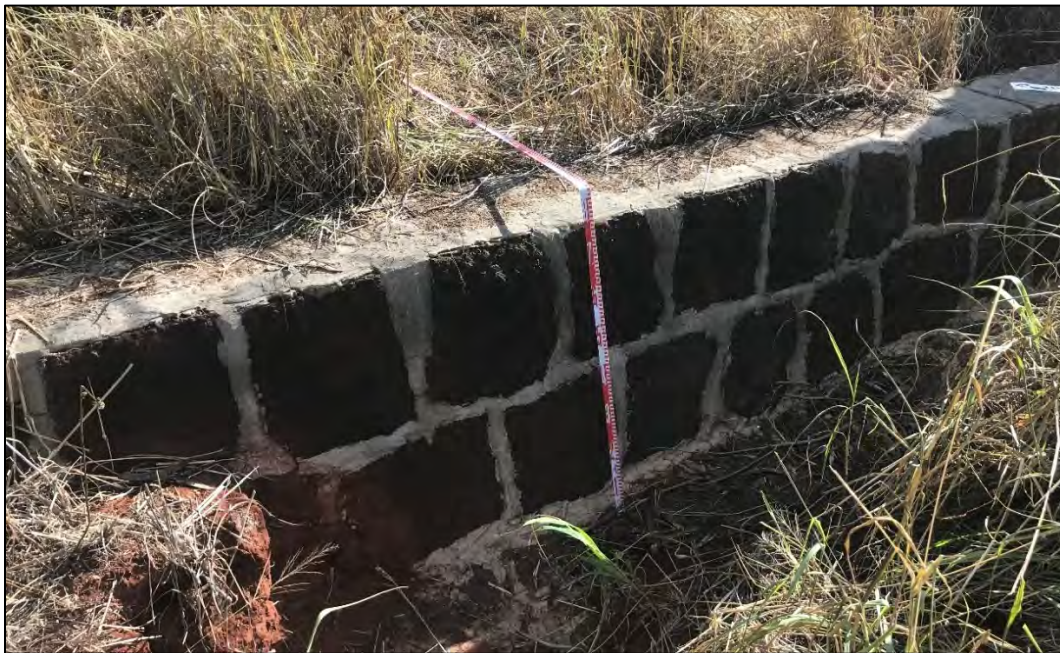
Figure 95. Representative photo of SIHP # 50-80-09-2268, Waiahole Ditch outside (northwest) of the project area, view to east

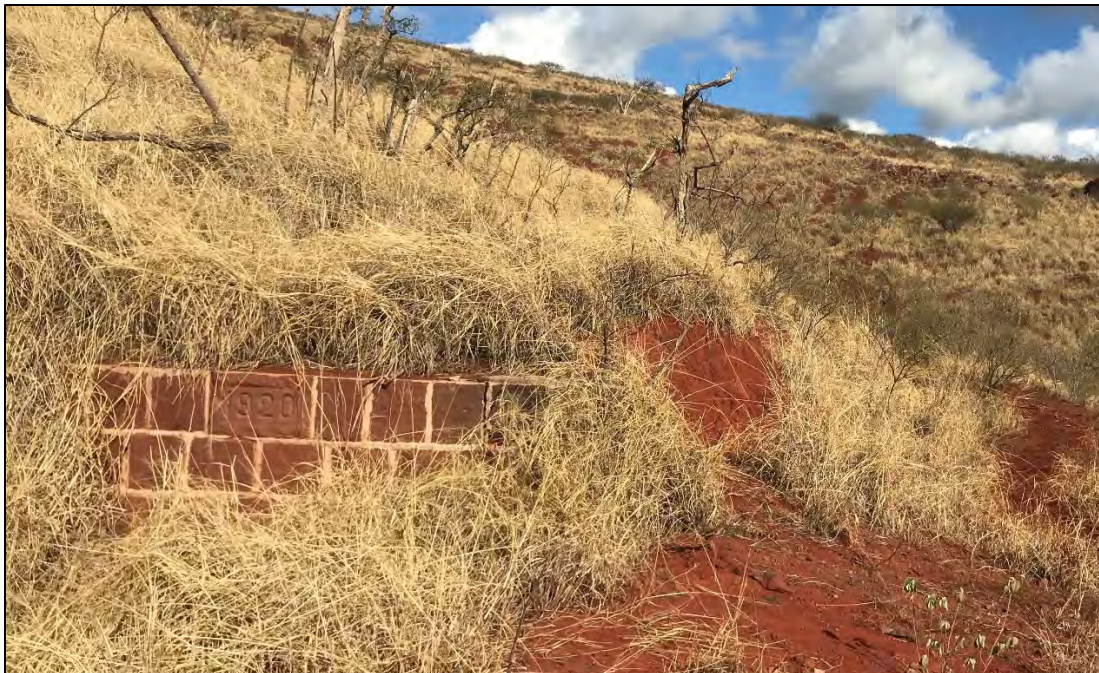
Figure 96. Portion of SIHP # 50-80-09-2268, Waiahole Ditch outside (north) of project area, with date “1920” inscribed on basalt and mortar culvert, view to northeast

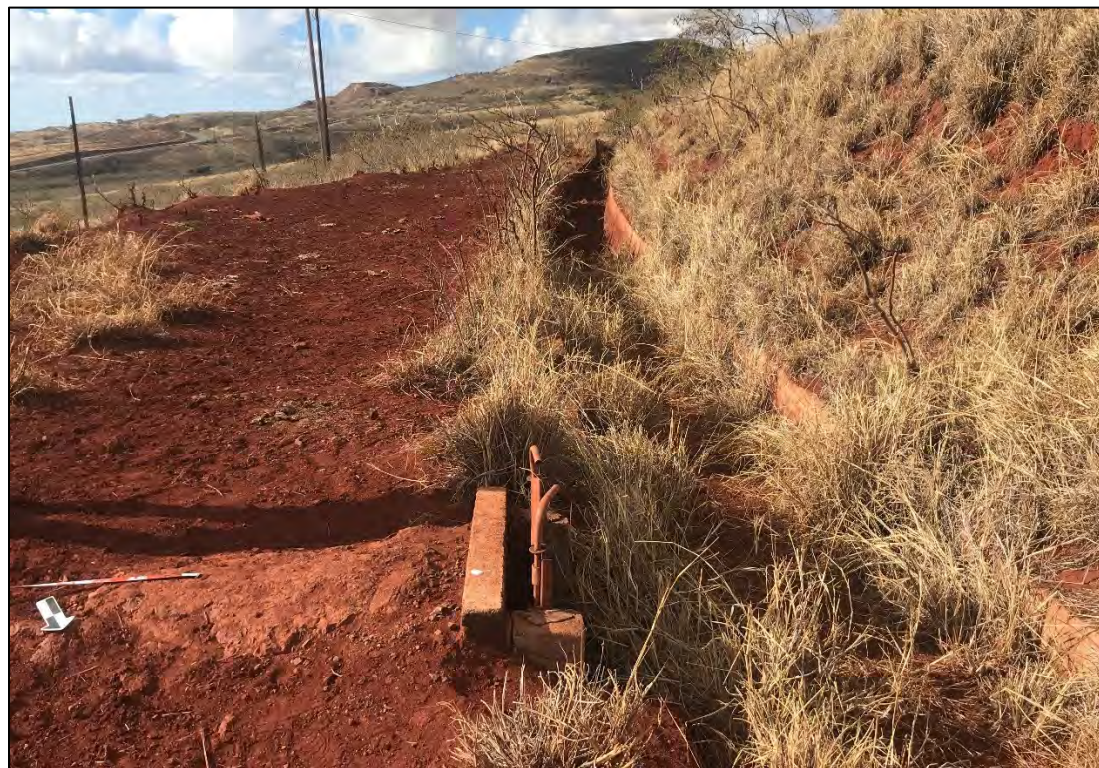
Figure 97. Portion of SIHP # 50-80-09-2268, Waiahole Ditch in northeastern project area, view to southwest

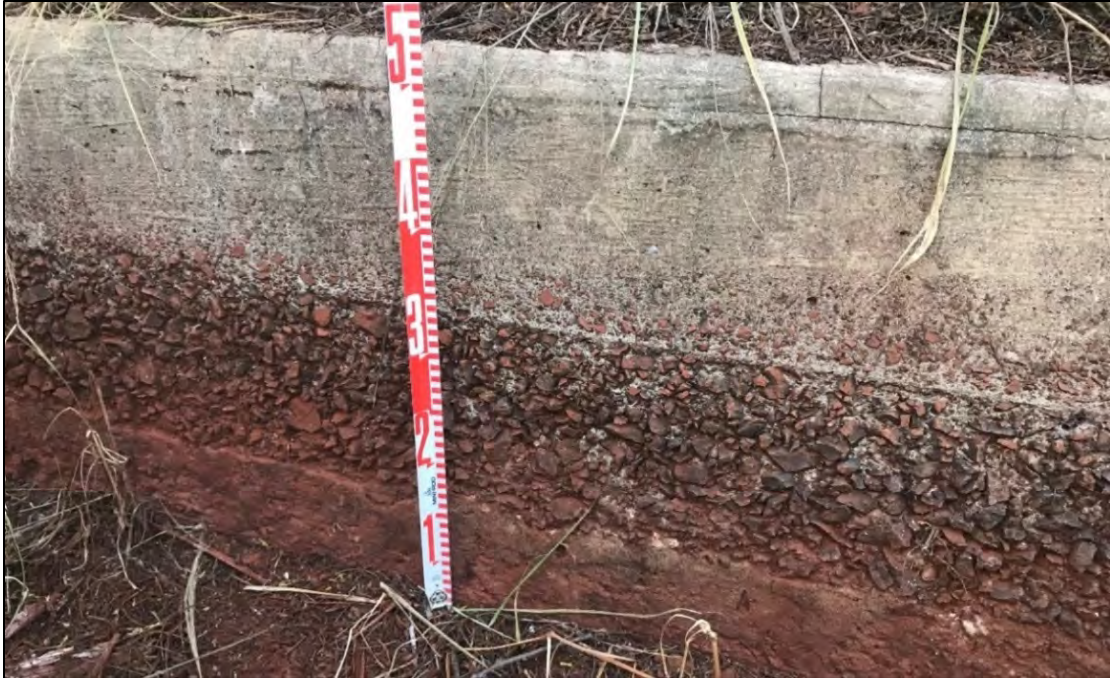
Figure 98. Representative photo of SIHP # 50-80-09-2268, Waiahole Ditch construction outside (northwest) of the project area, view to west

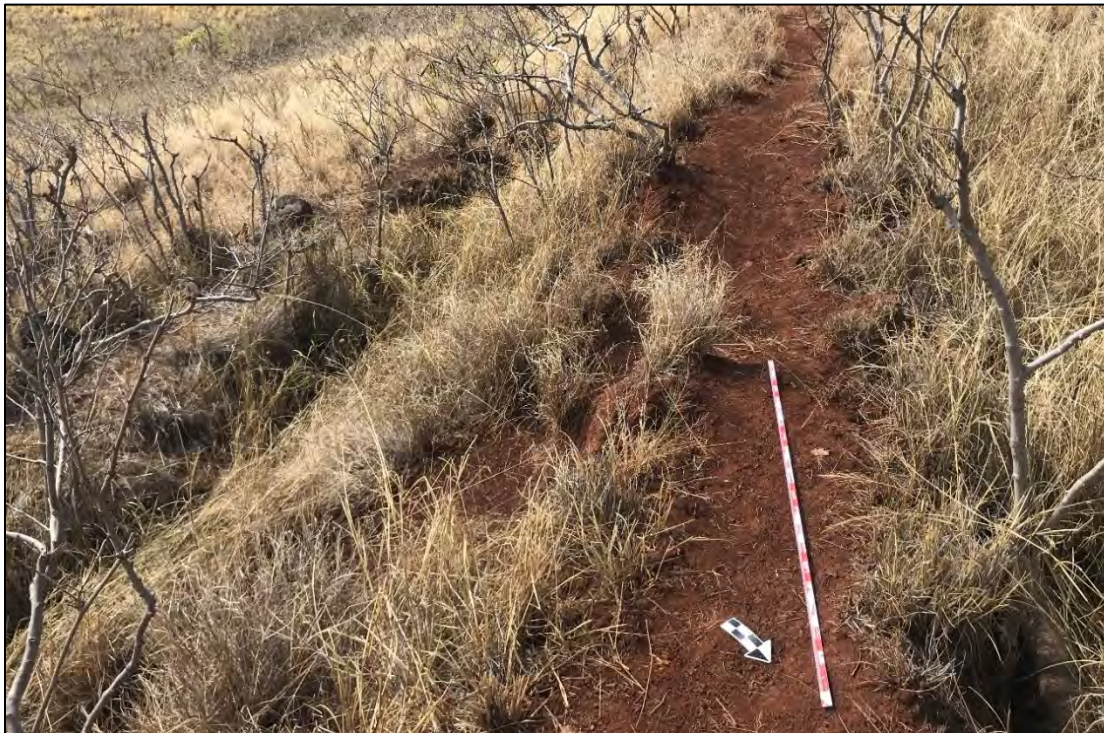
Figure 99. Representative photo of SIHP # 50-80-09-2268, Waiahole Ditch (left) in central project area, view to southwest

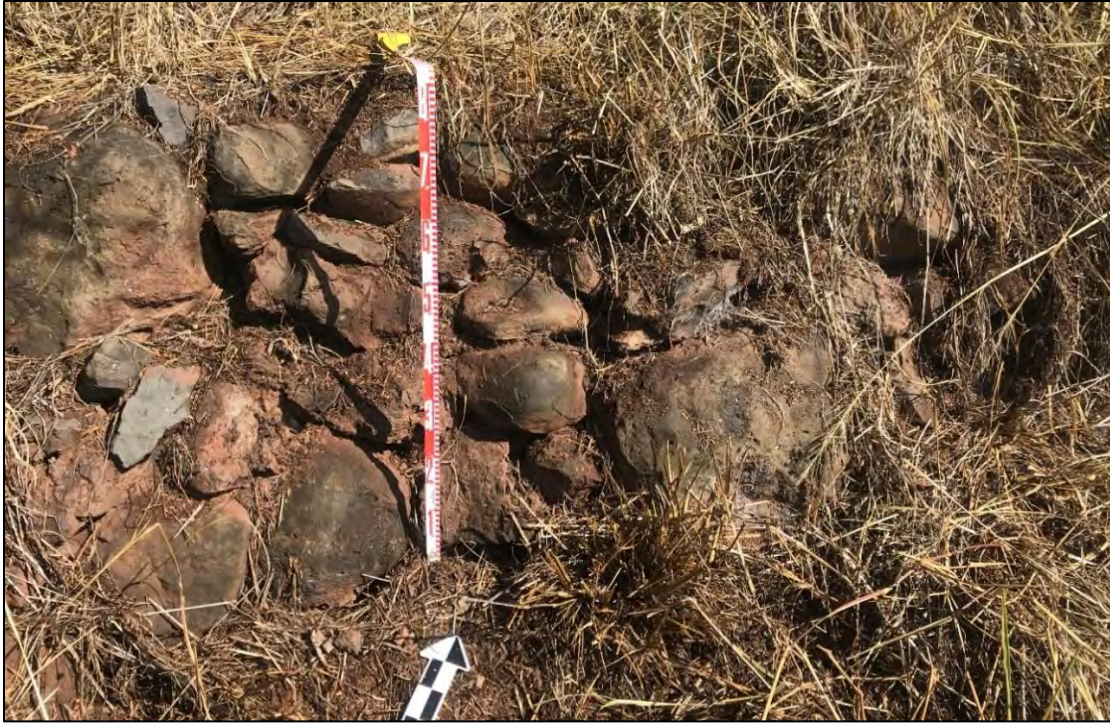
Figure 100. Representative photo of SIHP # 50-80-09-2268, Waiahole Ditch in southwest project area, dry-stacked basalt, view to north

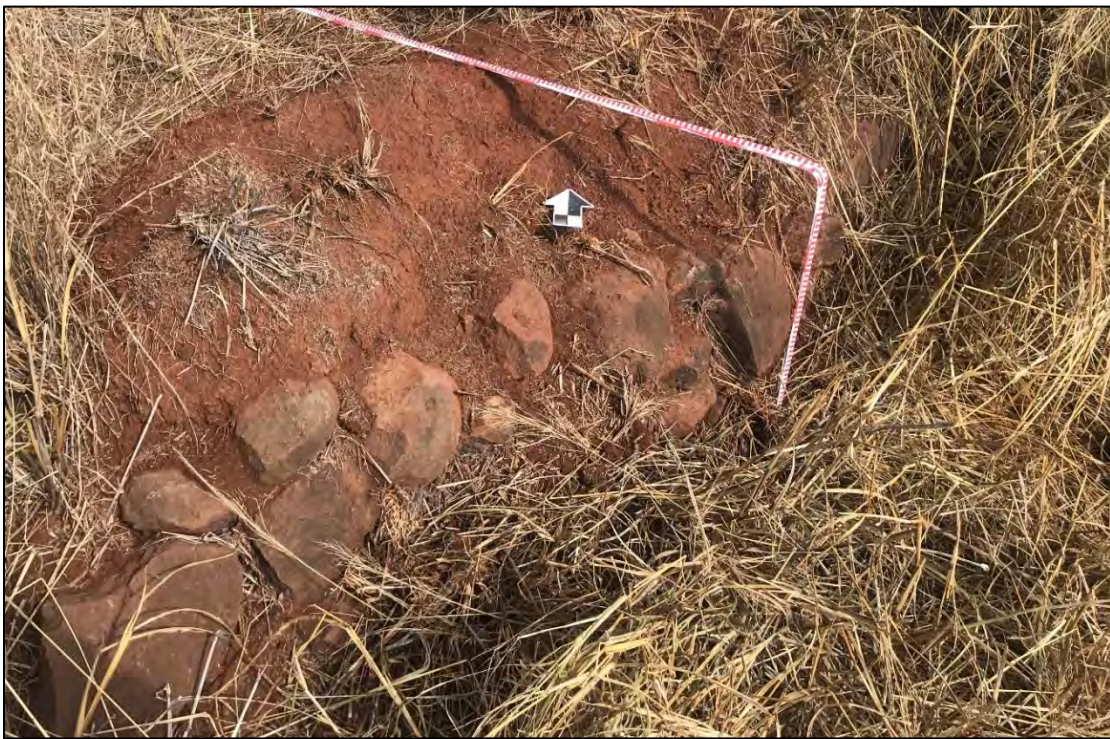
Figure 101. Representative photo of SIHP # 50-80-09-2268, Waiahole Ditch in southwest project area, view to north

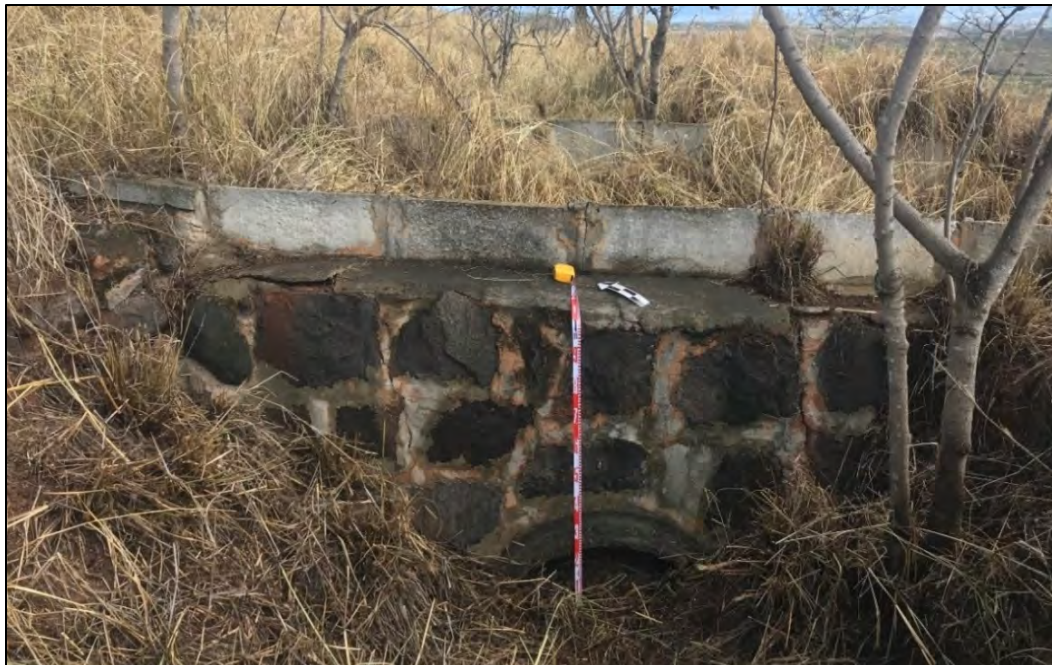
Figure 102. SIHP # 50-80-09-2268 Feature E, culvert and bridge components of the Waiahole Ditch in southern project area, view to northeast

Portions of the Waiahole Ditch within and surrounding the project area have additional components related to water control including culverts, metal pipes, sluice gates, and bridges. The first designated feature of the Waiahole Ditch for the current project, **SIHP # 50-80-09-2268 Feature E**, consists of a culvert associated with the ditch, documented in the southwest portion of the project area (Figure 102 through Figure 105). The culvert consists of mortared cut basalt blocks, two to three courses high, constructed around a largely buried concrete drain pipe (see Figure 102). Both sides of the tunnel are faced, and a concrete slab extends over top of the culvert. The concrete slab is approximately 6.5 m long and 1.5 m wide (Figure 103). The faces of the culvert are approximately 3.5 m wide, and the height of the exposed portion is 1.3 m. The observed portion of the mouth of the pipe is 50 cm in diameter. These components are in fair condition. The southeast portion of the concrete slab is damaged due to partial collapse.

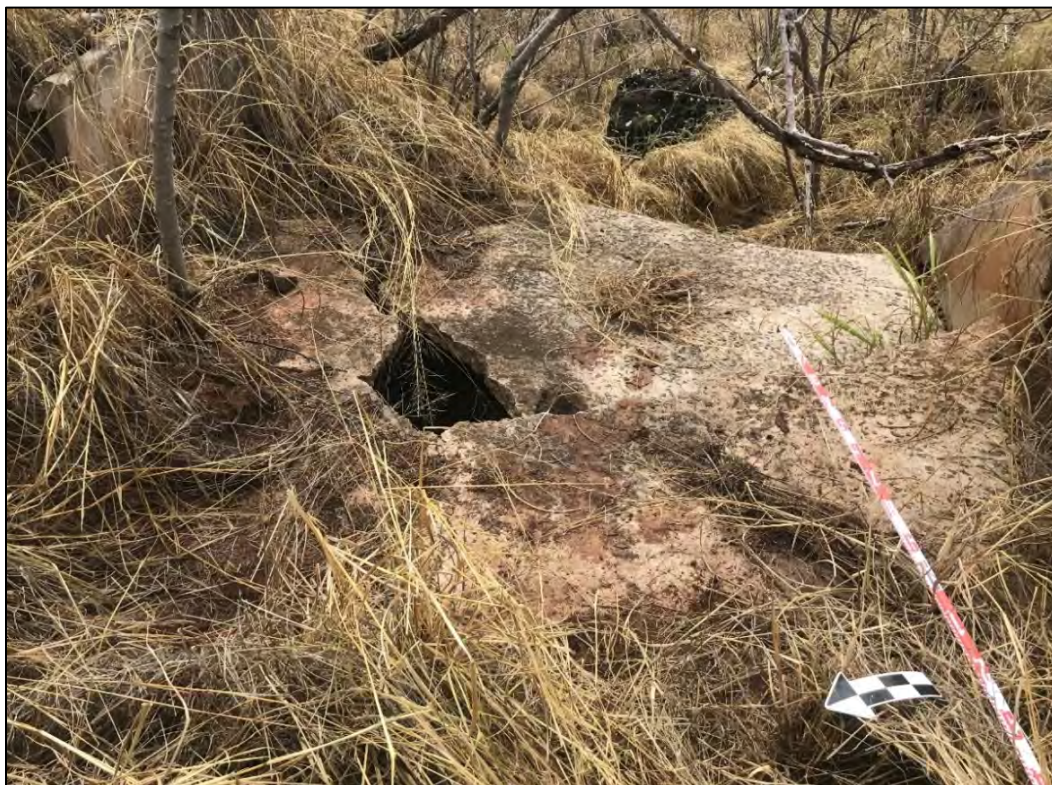
Figure 103. SIHP # 50-80-09-2268 Feature E bridge overlying culvert of Waiahole Ditch in southern project area, view to east
