SCS Project Number 1871-1

## ARCHAEOLOGICAL INVENTORY SURVEY REPORT FOR 5.0 ACRES LOCATED IN HŌLUALOA 1<sup>ST</sup> AHUPUA'A, NORTH KONA DISTRICT, HAWAI'I ISLAND, HAWAI'I [TMK: (3) 7-6-021:017 POR.]

## AUGUST 2016 DRAFT

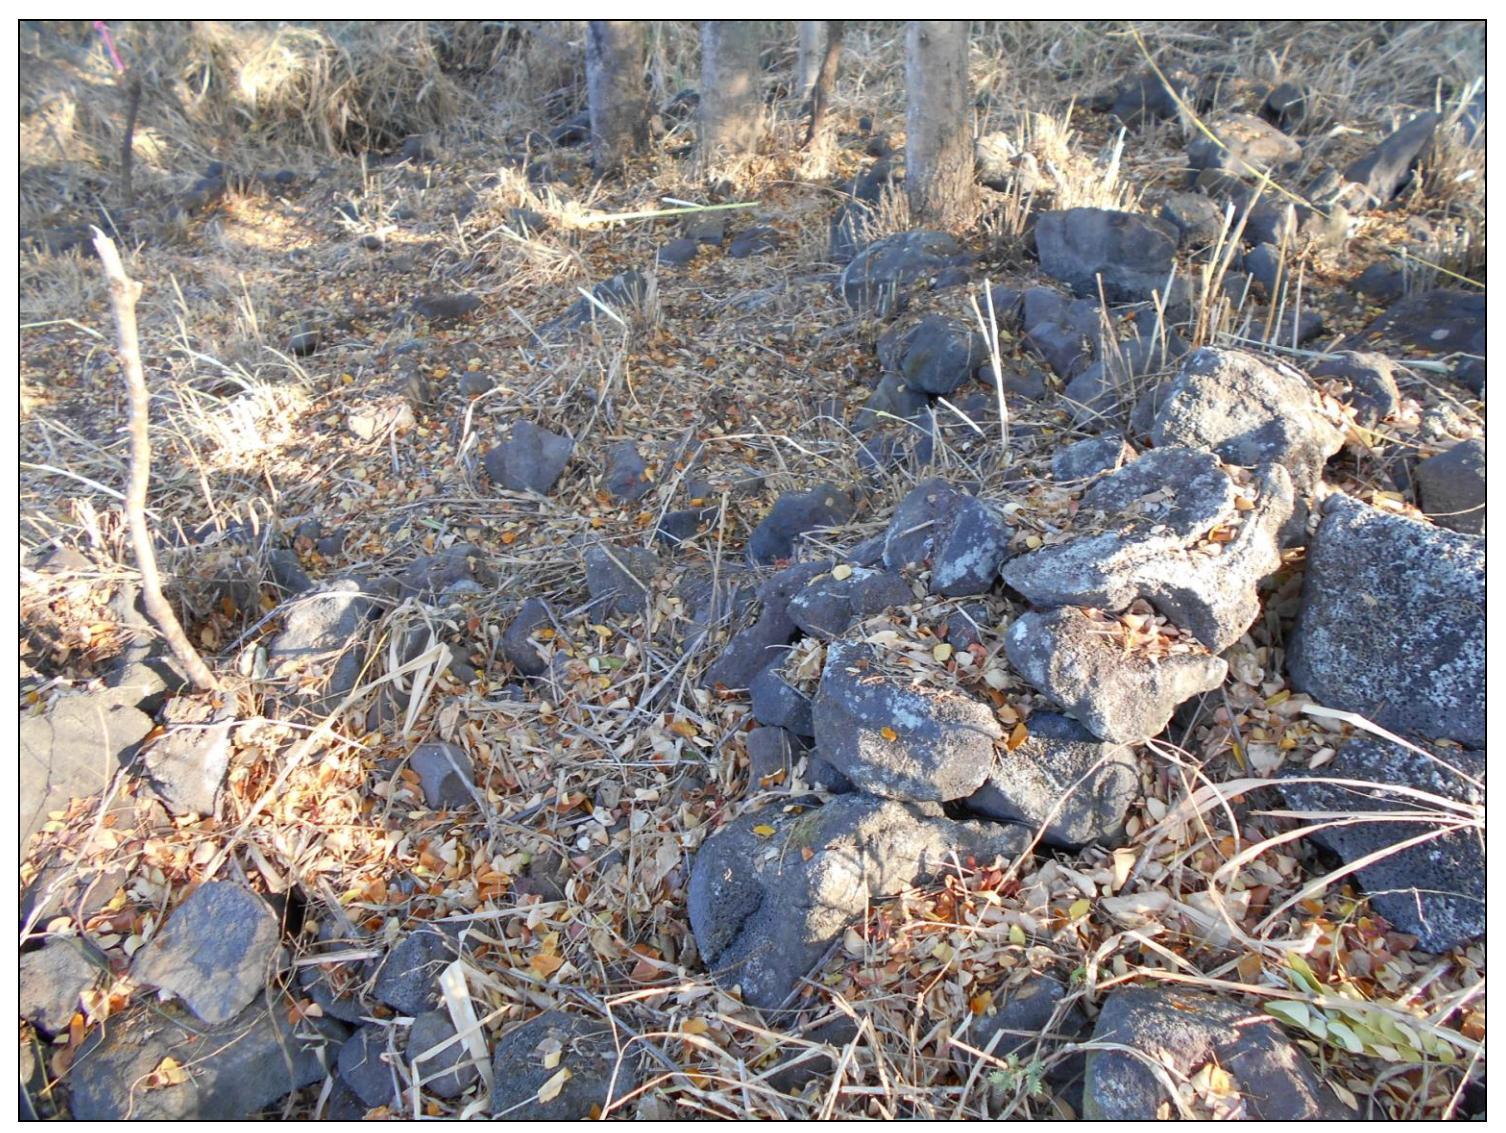
Figure 17: Photograph of Site 30591 Feature 6 Looking North.

Feature 6 is a roughly rectangular terrace located in the northeast corner of the site (Figure 17). The terrace is constructed along the northeast side of the central rock alignment. The terrace is approximately 6.1 m in length (N/S) by 3.2 m wide, with a

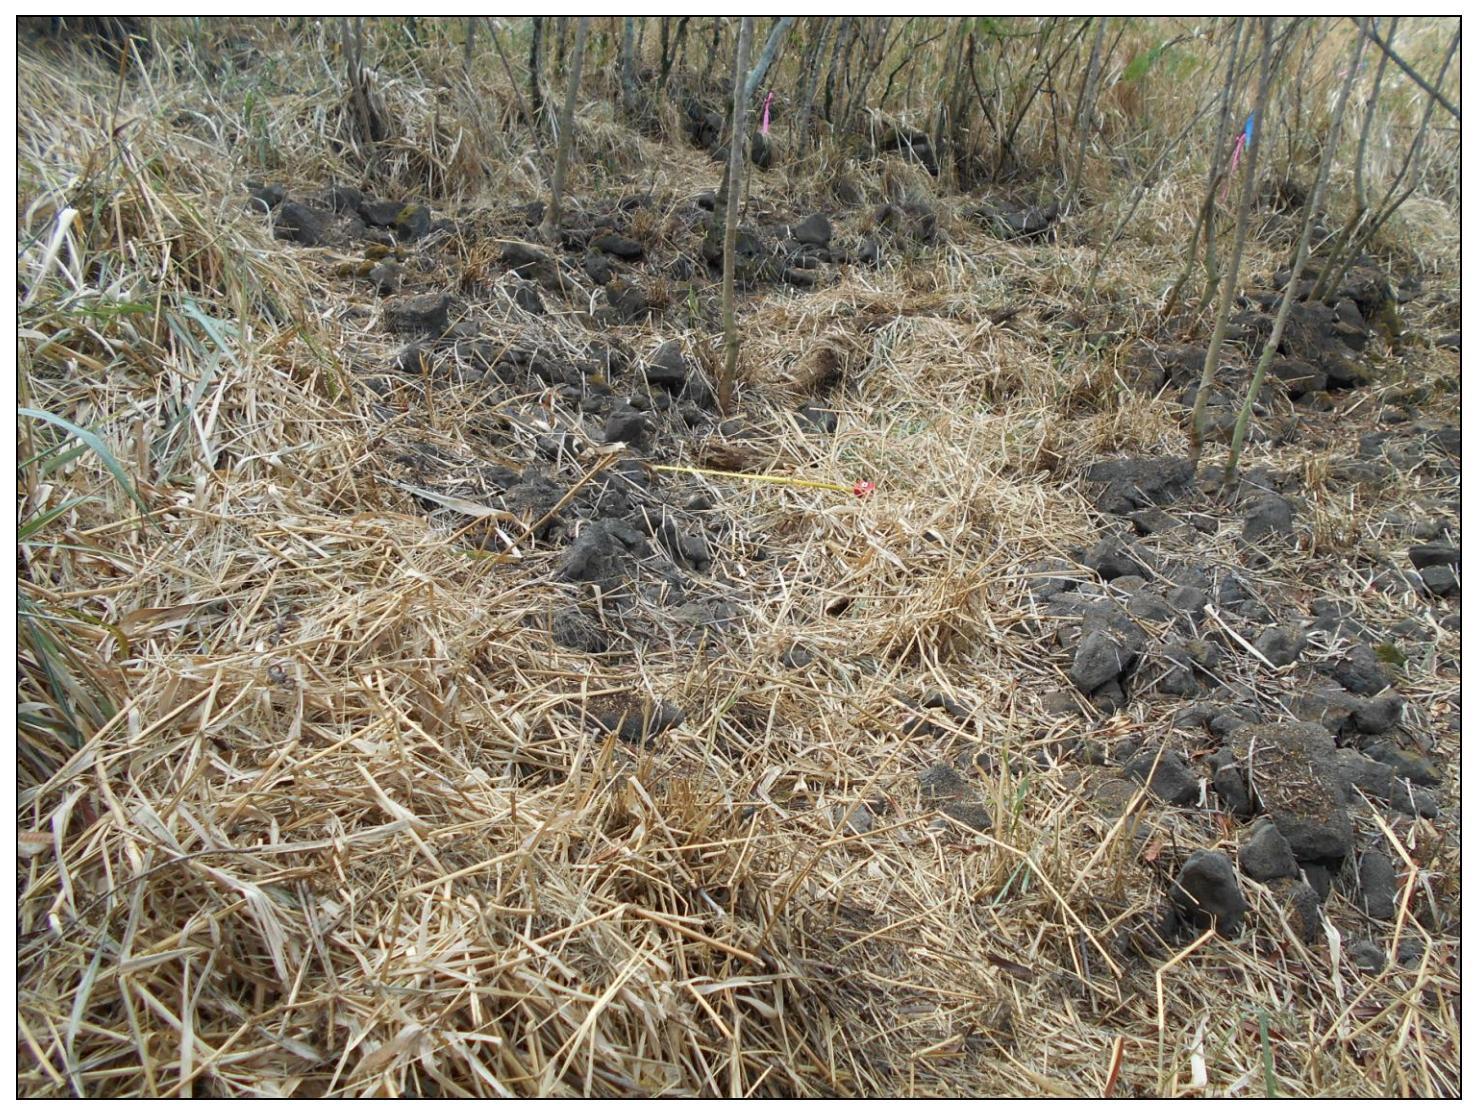
Figure 21: Photograph of Site 30594 Feature 1 Looking South.

Feature 1 is a roughly rectangular soil filled terrace on the east side of the site (Figure 21). It is approximately 10.0 m long by 1.8 m wide, with a maximum height of 0.81 m. There is a retaining wall constructed of piled and stacked angular and subangular small boulders and cobbles along the west side of the level soil terrace. There is no formal facing evident in the retaining wall construction.

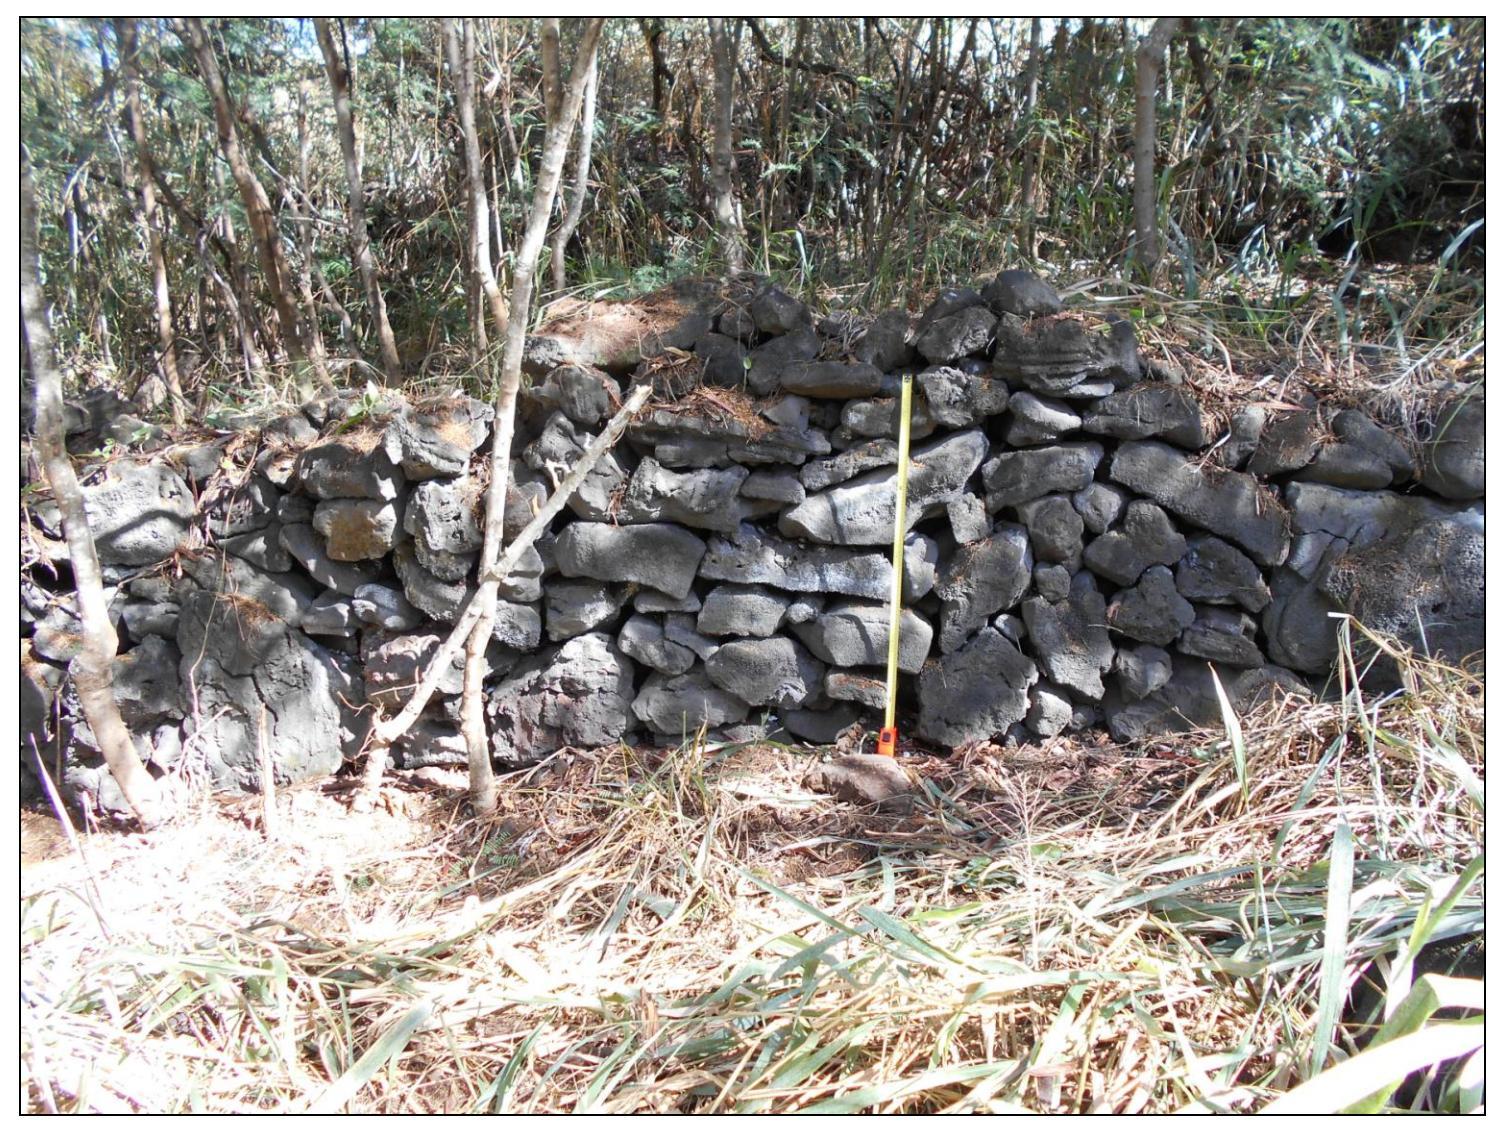
Figure 26: Photograph of Site 30595 Wall Looking North.

There was no cultural material on the ground surface at the site. Site 305951 is an Historic era wall that has been altered by bulldozing, is partially collapsed in places, and is in fair condition. No further work is recommended at Site 30595.

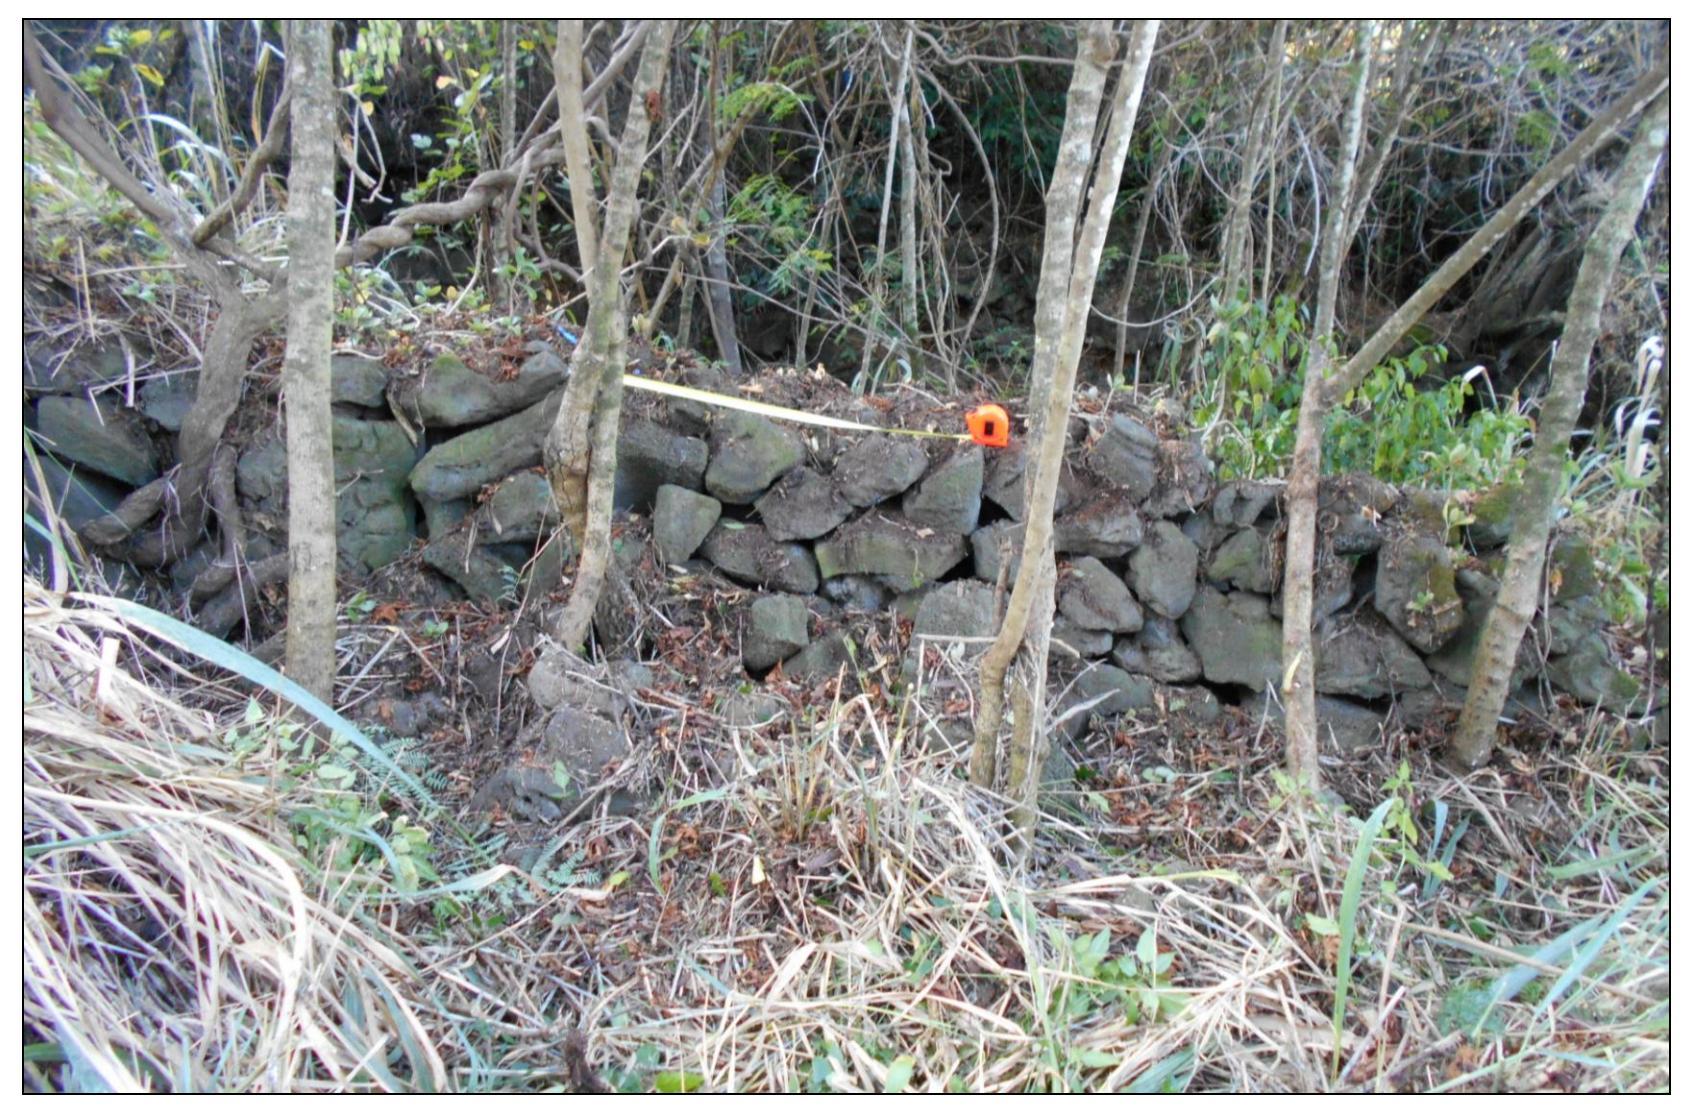
Figure 33: Photograph of Site 30597 Wall with Gulch in Background, Looking South.

The wall is constructed of stacked angular and subangular basalt cobbles and small boulders, incorporating small boulders as large as 0.50 m at the base (Figure 33). It is bifaced and cobble core filled. The rock wall is approximately 145.0 m long (E/W) where it crosses the project area by 0.90 m wide, with a maximum height of 1.30 m. The east terminus of the wall is at the east end of the project area. The wall continues downhill beyond the west property boundary. Portions of the wall are no longer present, and may have been removed by flood events. Site 30597 is an Historic era ranch wall, and although it has collapsed in some areas, it is generally in fair condition. There were no cultural remains encountered on the ground surface at the site. No further work is recommended at Site 30597.

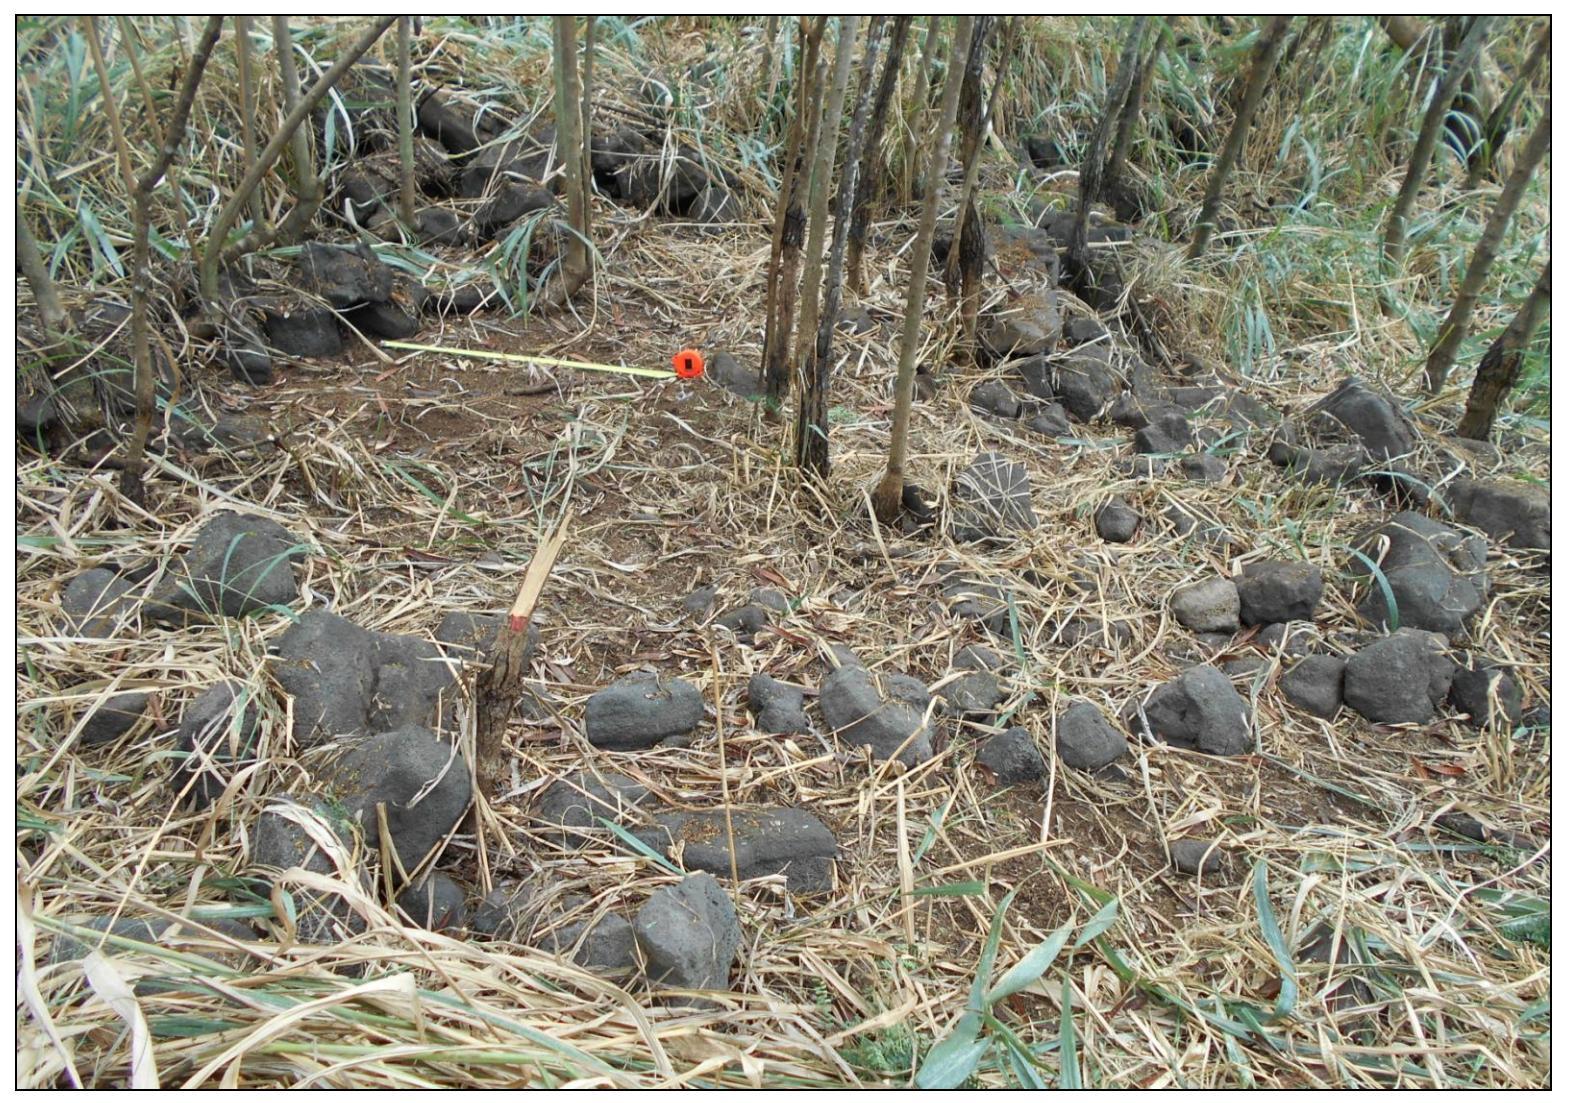
Figure 42: Photograph of Site 30600 Looking Southeast.

Based on the simple construction of the terrace, its size, and the proportionally large number of Historic era sites recorded on the project area, it is likely that Site 30600 is also an Historic era agricultural terrace, possibly associated with coffee growing. Site 30600 appears to be unaltered and is in good condition. No further work is recommended at Site 30600.

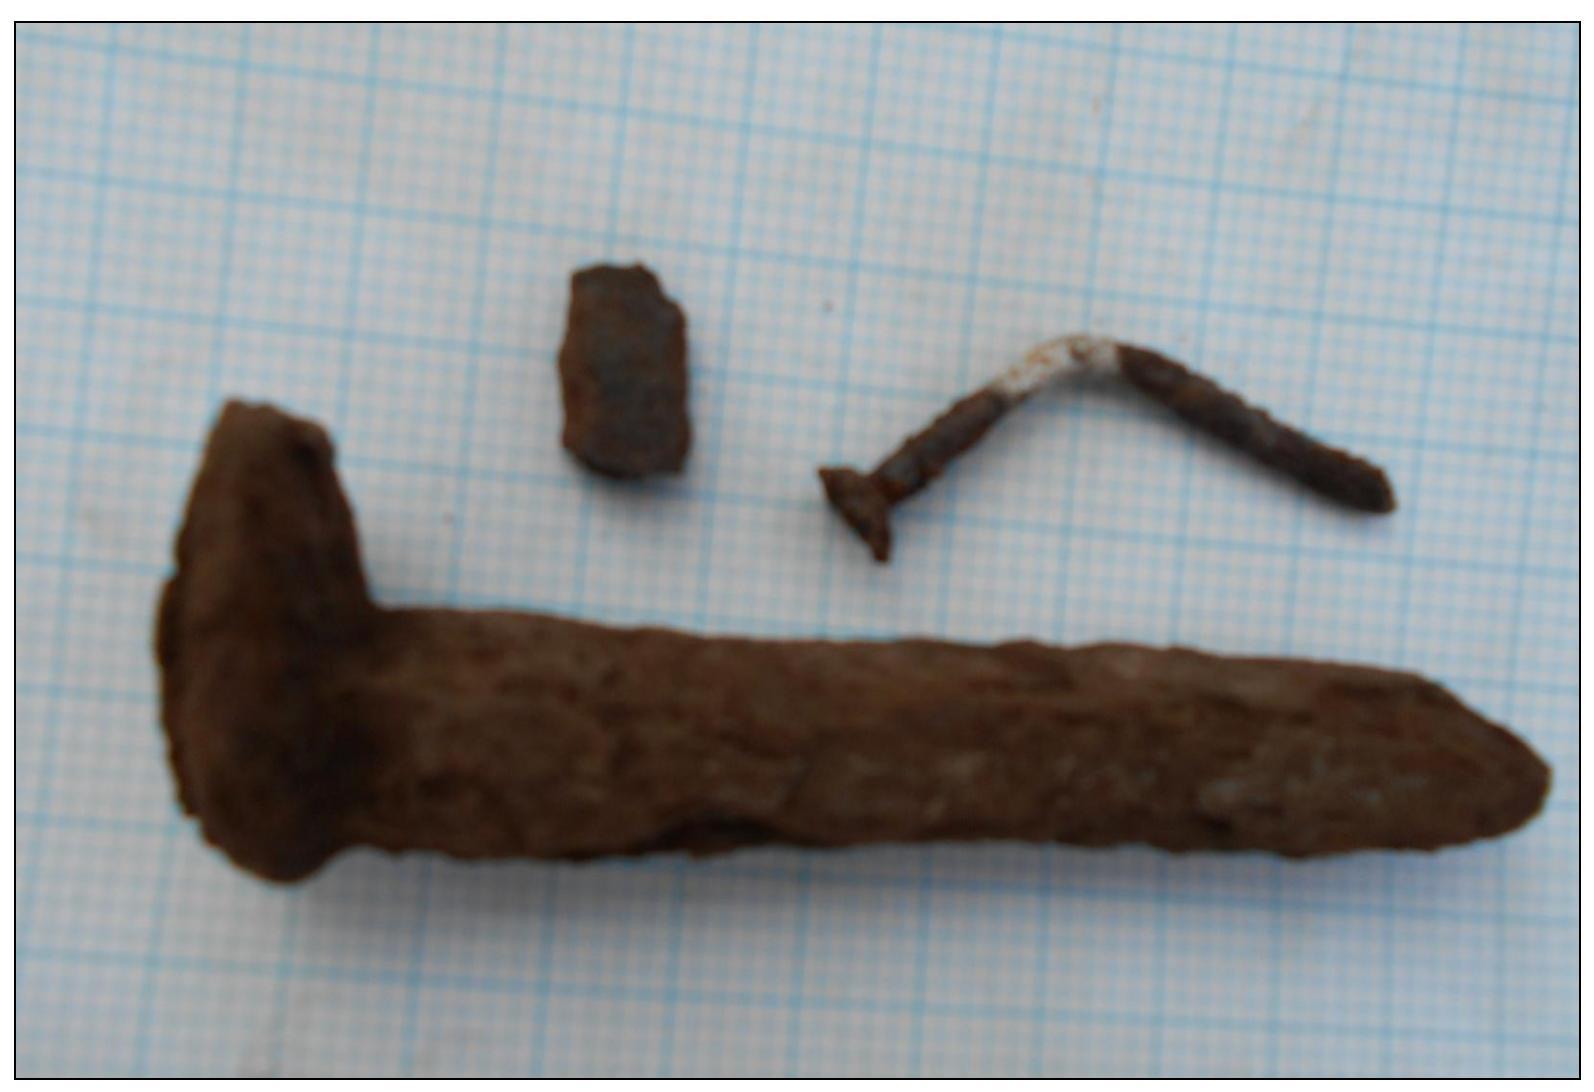
Figure 58: Photograph of Artifacts Recovered from Site 30604, Feature 3, SP-1.

A shovel probe (SP-1) was excavated within the level soil of the Feature 3 terrace to determine function and age. SP-1 was excavated to a depth of 50.0 cmbs and terminated on bedrock or a large basalt rock. A railroad spike, a wire nail, and a volcanic-glass flake were recovered from SP-1 (Figure 58).

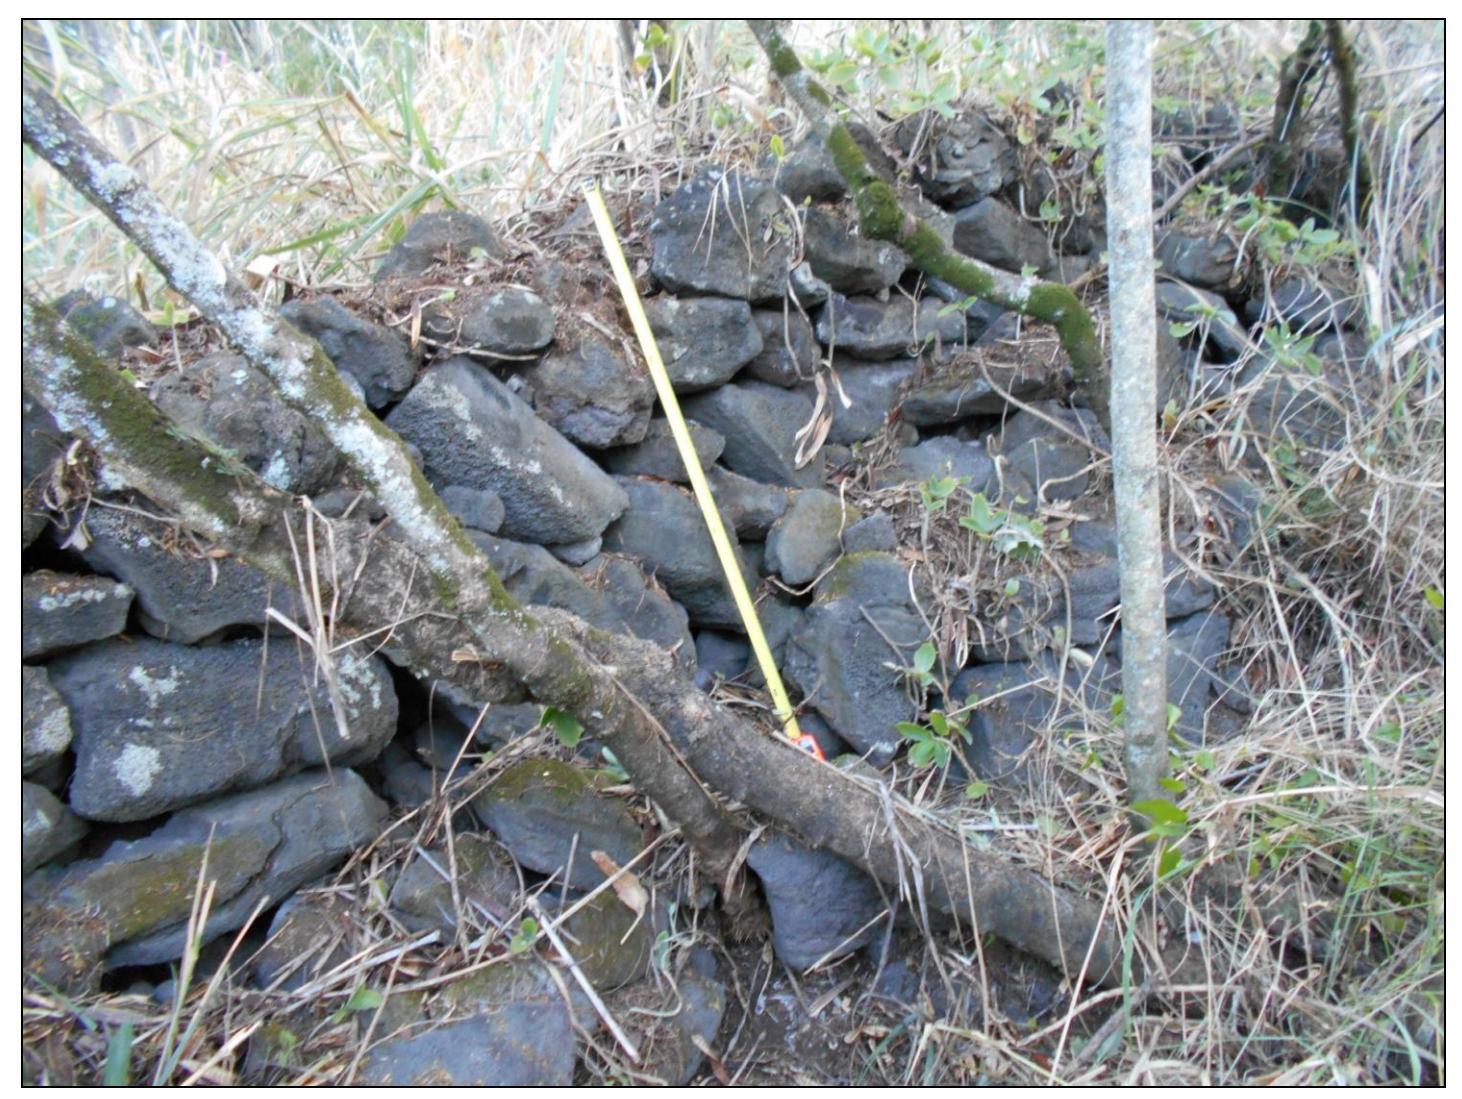
Figure 60: Photograph of Site 30605 Wall Looking Northeast.

The wall bisects the property east to west, terminating to the east near the Site 30592 railroad berm and continuing to the west beyond the project area boundary. The wall is constructed of angular and subangular basalt cobbles and small boulders, incorporating some as large as 0.50 m (Figure 60). The wall is approximately 90.0 m long (E/W) where it crosses the project area by 0.75 m wide, with a maximum height of 1.0 m. It is a bifaced cobble core filled wall and is stacked up to five courses in height. The condition of the wall diminishes near its western terminus where it has collapsed. There were no cultural remains encountered within the area of the site. Site 30605 has been impacted by modern land clearing activities, is partially collapsed in places, and is in good condition. No further work is recommended for Site 30605.

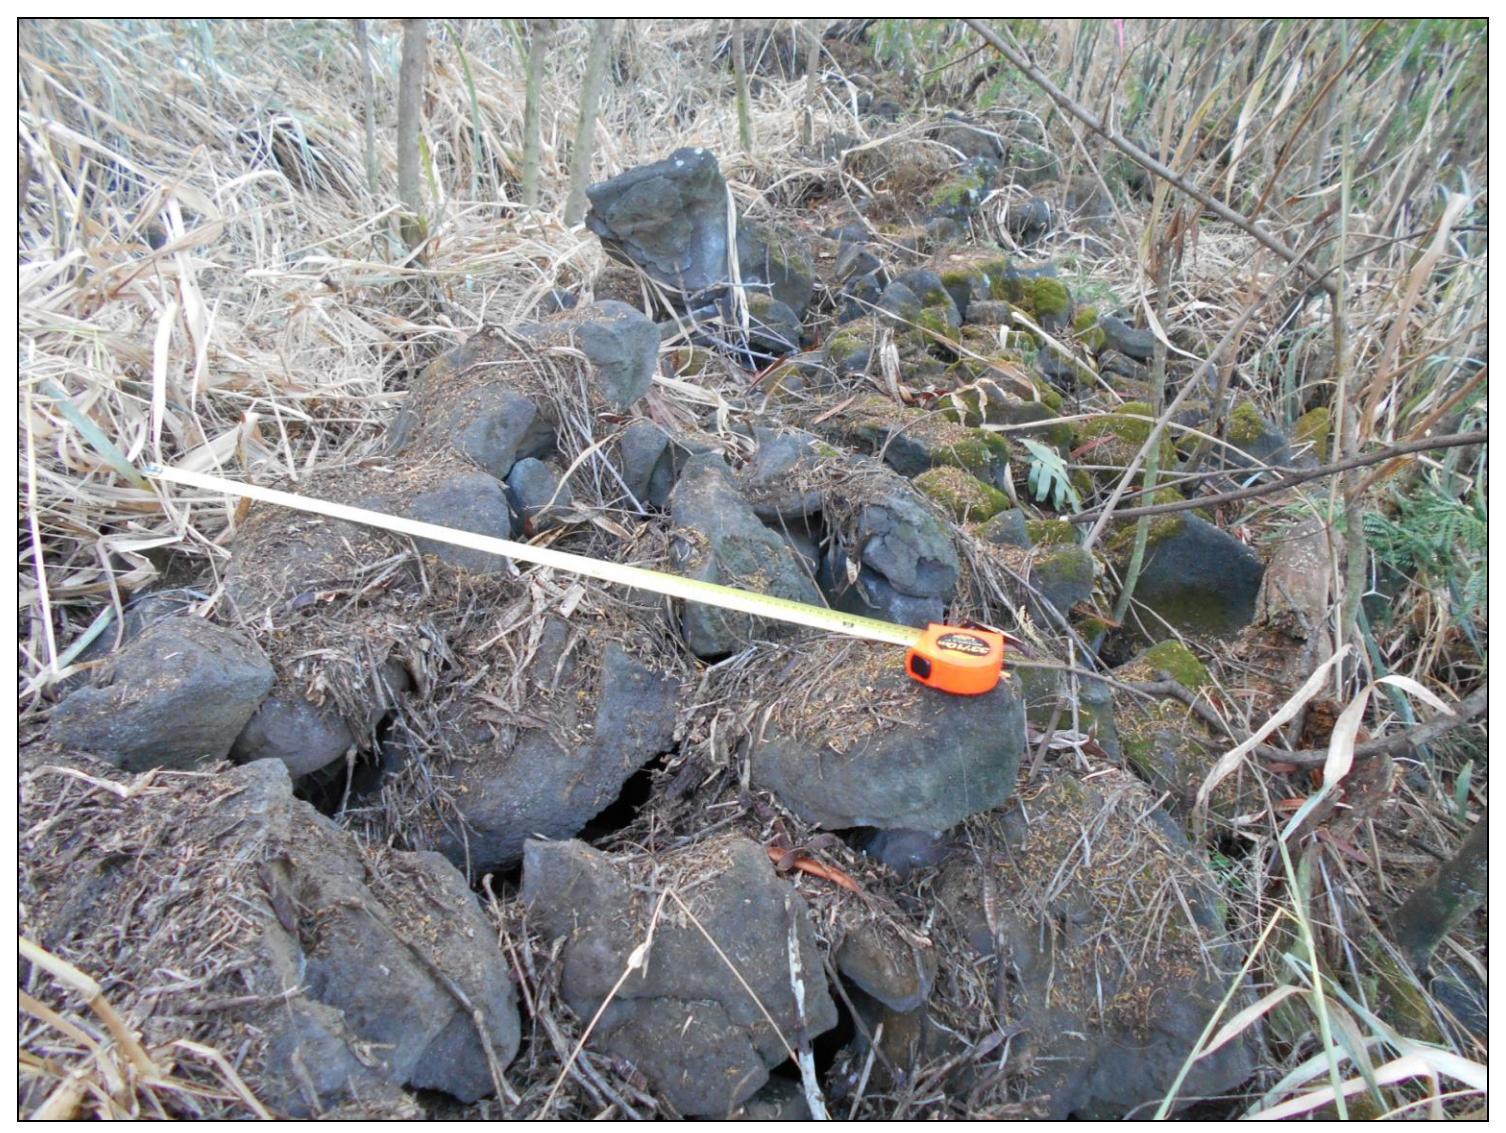
Figure 61: Photograph of Site 30606 Rock Wall Looking North.

The Site 30606 rock wall segment is located between the Site 30605 wall and the Site 30597 wall, and is less formally constructed than either of the two (Figure 61). The wall is approximately 37.0 m in length (NW/SE) and 1.90 m wide, with a maximum height of 1.30 m. Site 30606 is presently a rubble wall consisting of angular and sub angular basalt cobbles piled three to six courses high and three to four courses wide on the ground surface. There is no formal stacking or facing evident in the wall construction, though it might have been a stacked and faced wall that has been disturbed by modern land clearing activities. The majority of the western (downhill) portions of the wall have collapsed, with an increase in collapse in low lying areas. There were no cultural remains identified on the ground surface within at the site. Site 30606 is an Historic era rock wall associated with ranching. It has been altered by modern land clearing, is mostly collapsed, and is in poor condition.
