8.1.9 SIHP #50-80-10-8231 (Honua 4), Traditional Terraced 'Auwai

8.1.11 SIHP #50-80-10-8241 (Honua 14), Historic Guava Charcoal Kiln

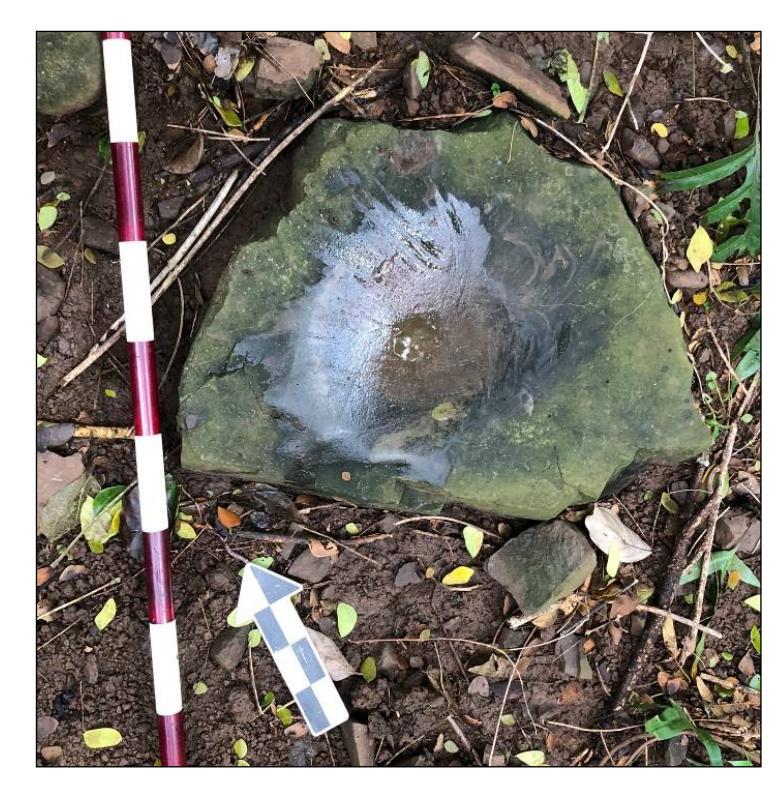
Figure 87. Photo of SIHP # -7079, Feature A (grinding stone)

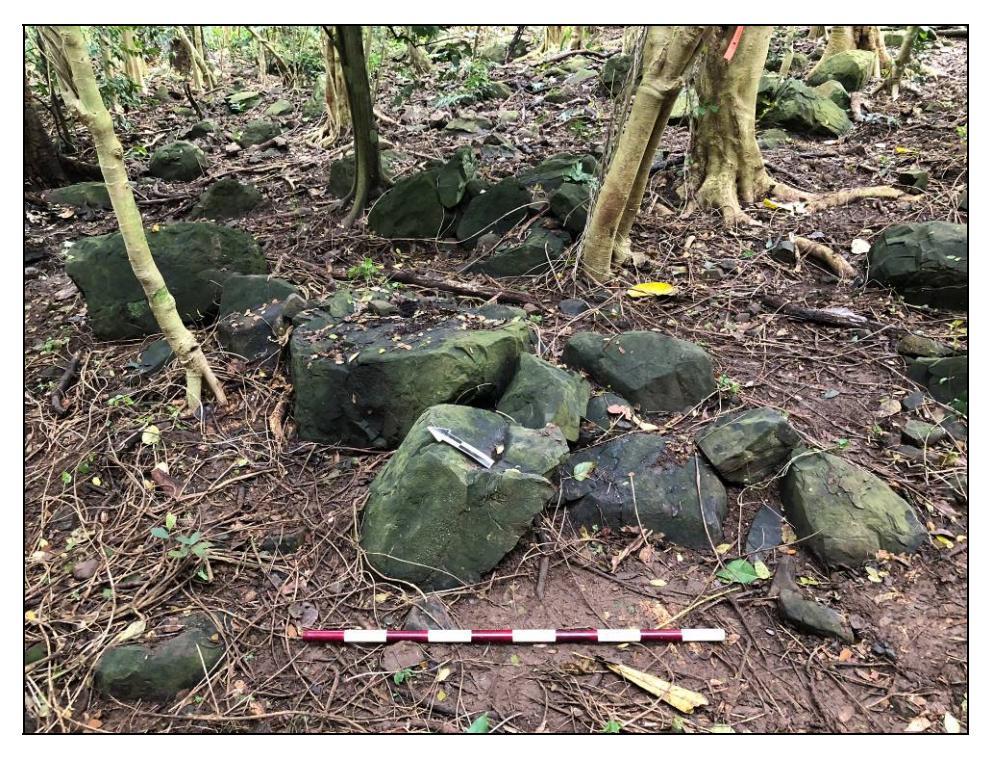
Figure 88. Photo of SIHP # -7079, Feature B (possible terrace remnant), view to northeast

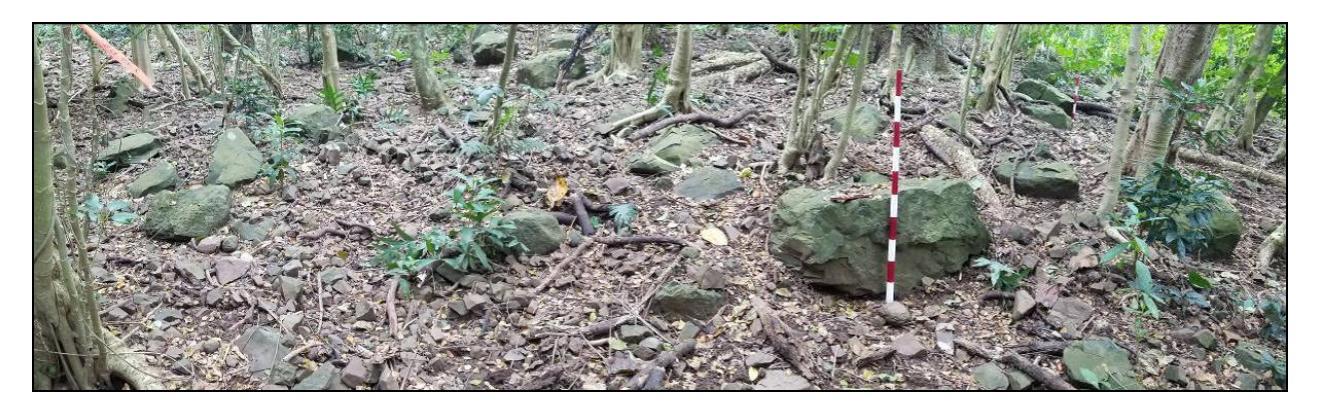
Figure 89. Photo showing SIHP #-7079, Feature C (terrace remnant), view to northeast

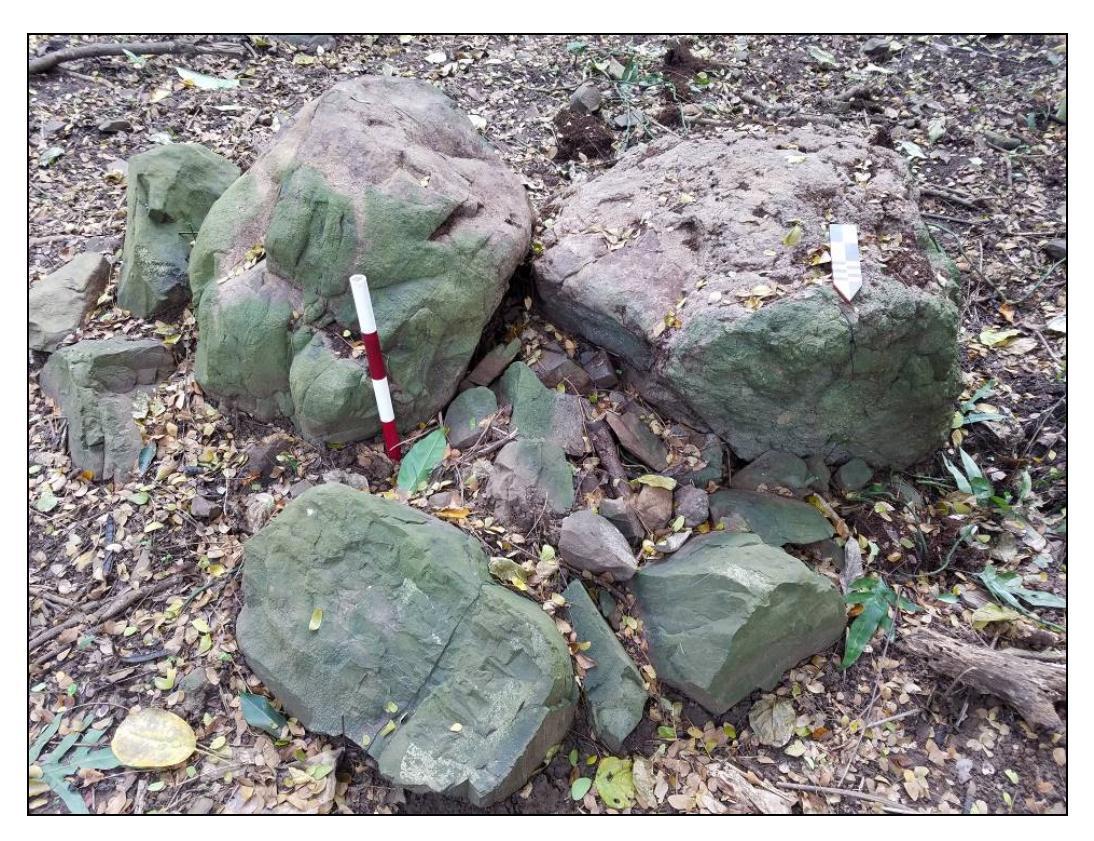
Figure 90. Photo showing SIHP # -7079, Feature D (mound), view to south

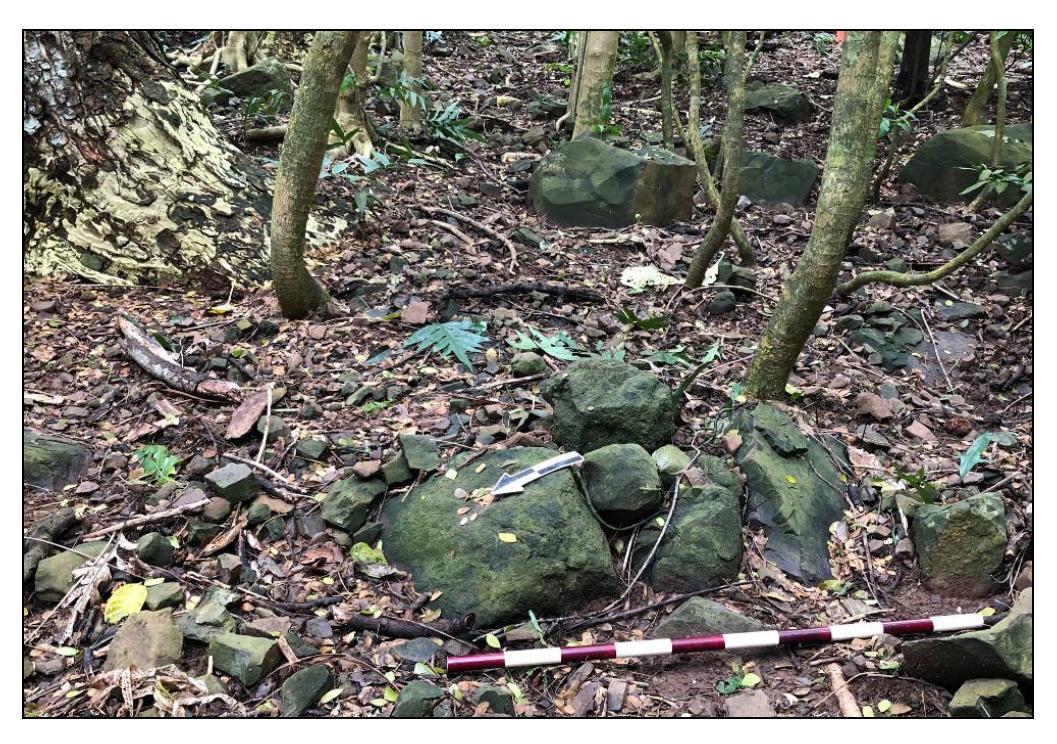
Figure 91. Photo showing SIHP # -7079, Feature E (terrace remnant), view to east

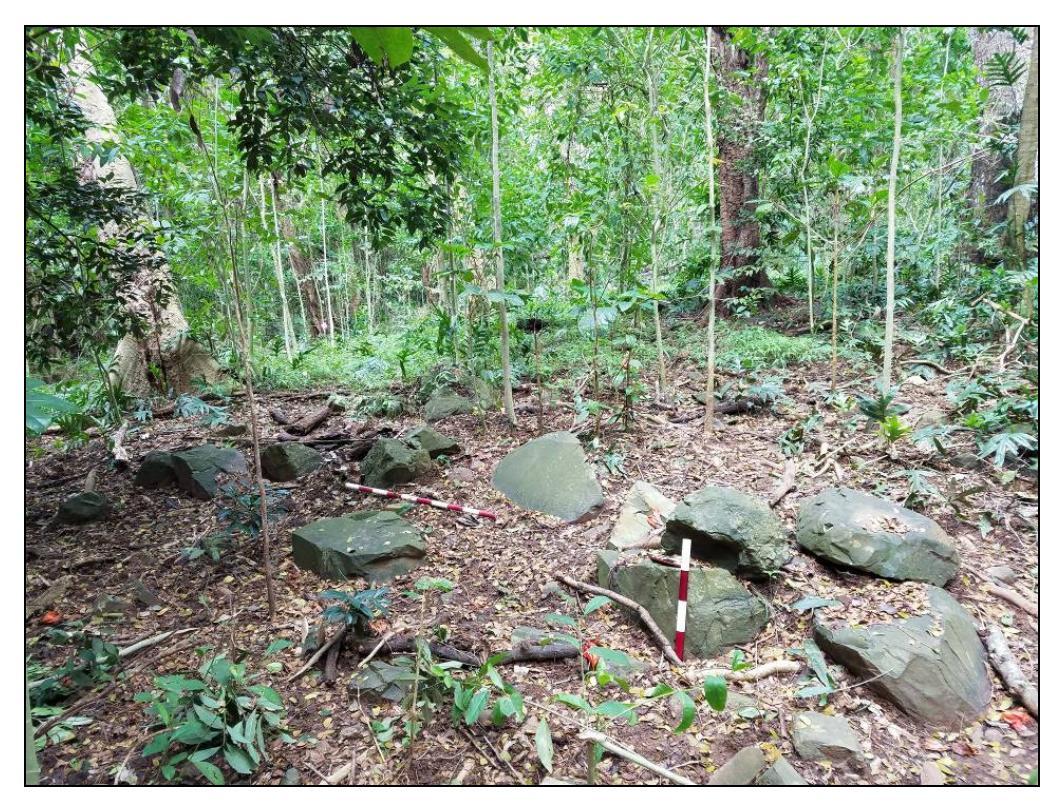
Figure 92. Photo showing SIHP # -7079, Feature F (possible terrace remnant), view to east

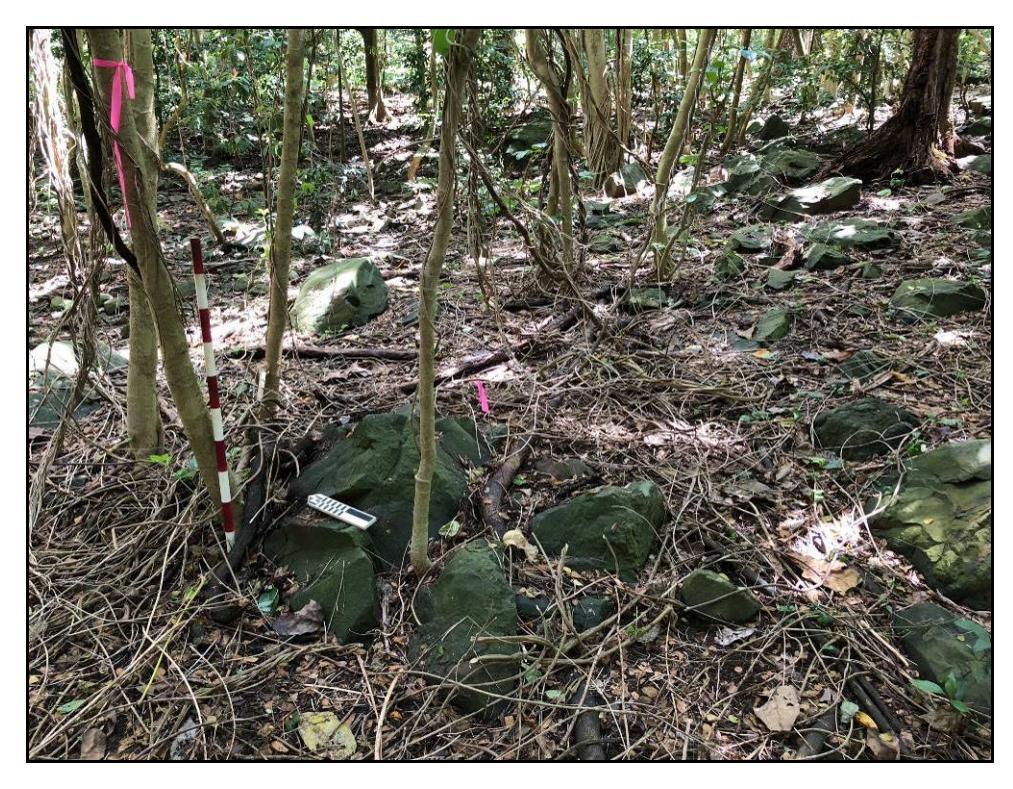
Figure 93. Photo showing SIHP # -7079, Feature G (possible terrace remnant), view to east

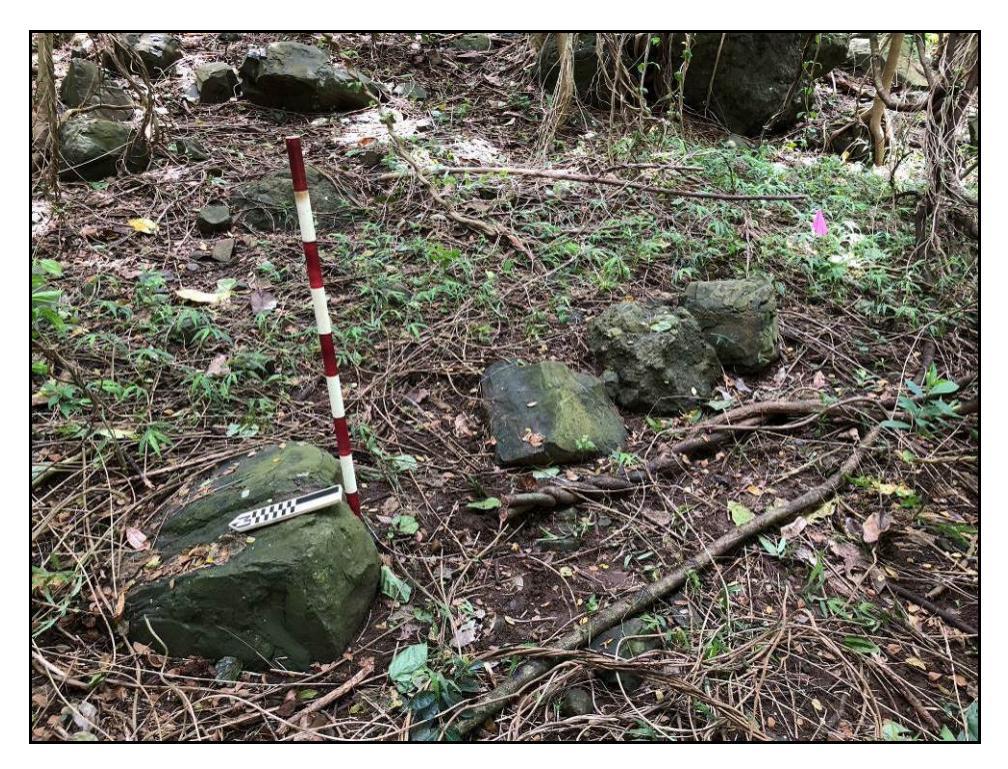
Figure 94. Photo showing SIHP # -7079, Feature H (stone alignment), view to east

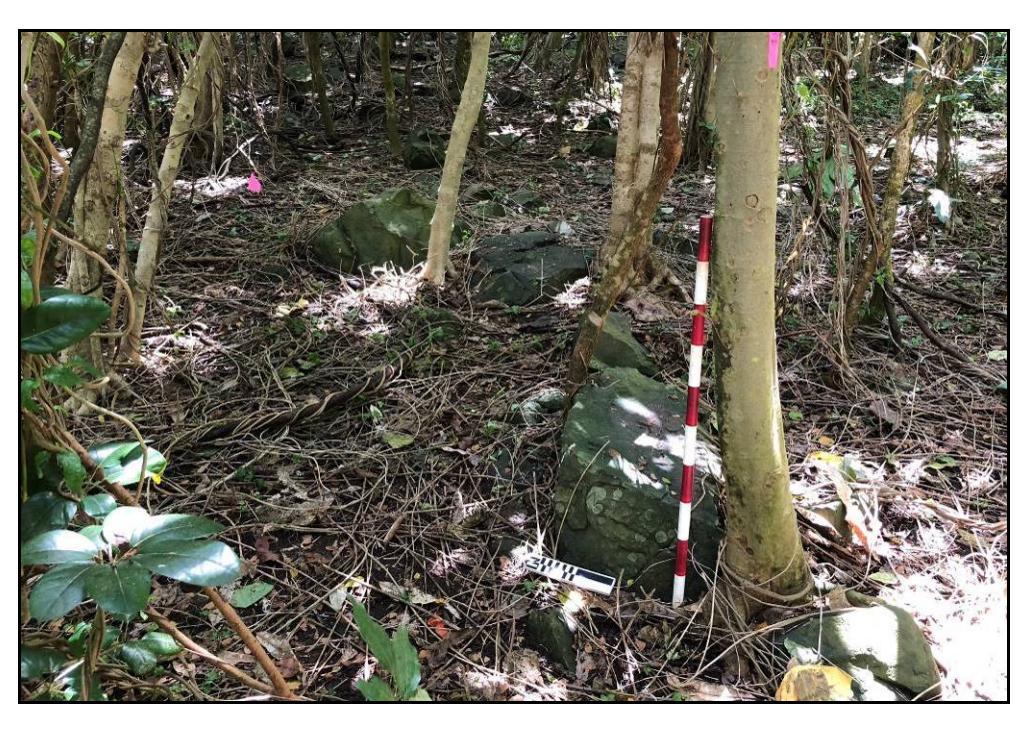
Figure 95. Photo showing SIHP # -7079, Feature I (stone alignment, north portion), view to east

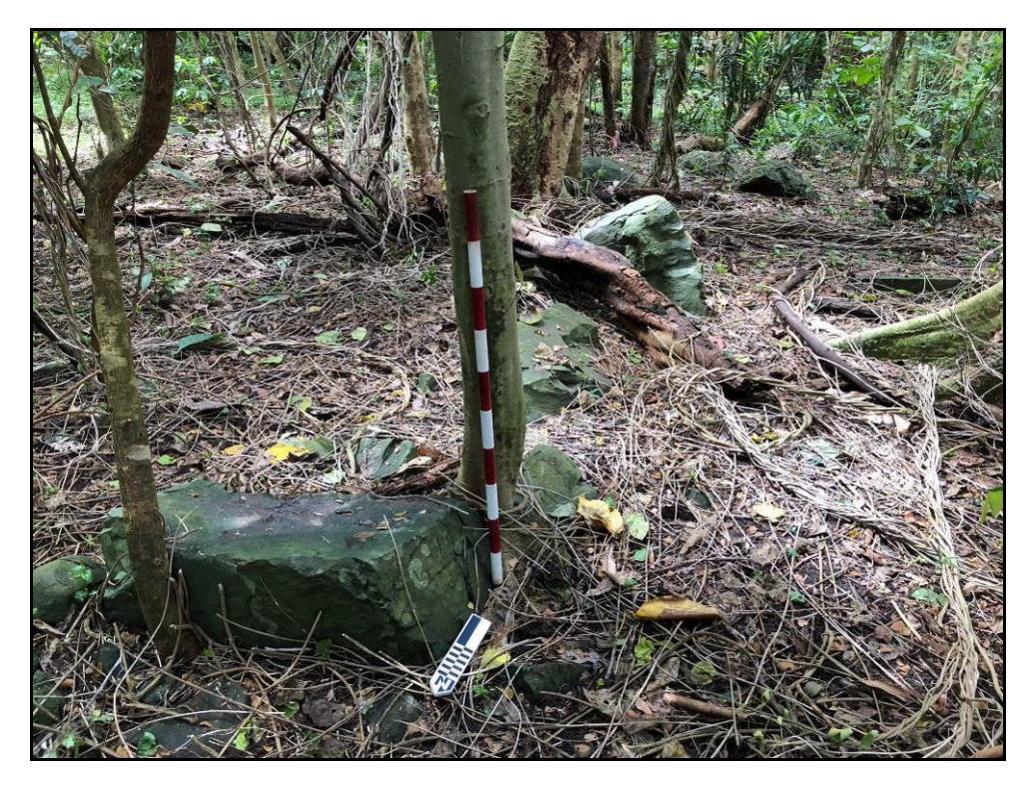
Figure 96. Photo showing SIHP # -7079, Feature I (stone alignment, south portion), view to southeast

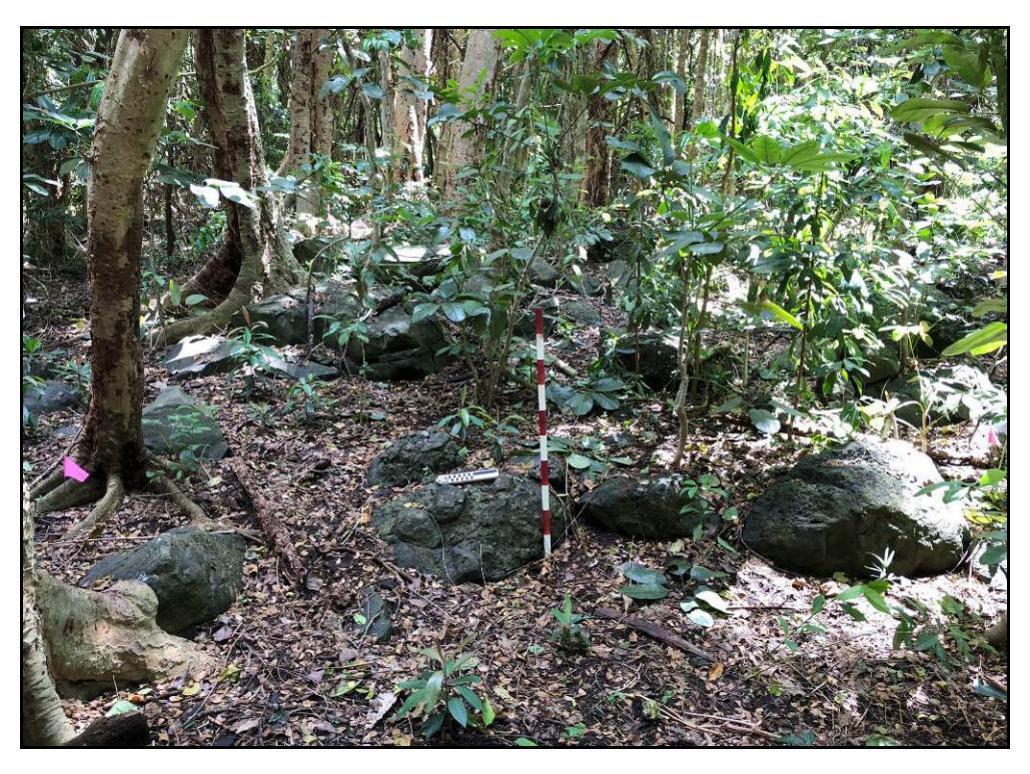
Figure 97. Photo showing SIHP # -7079, Feature J (stone alignment), view to east

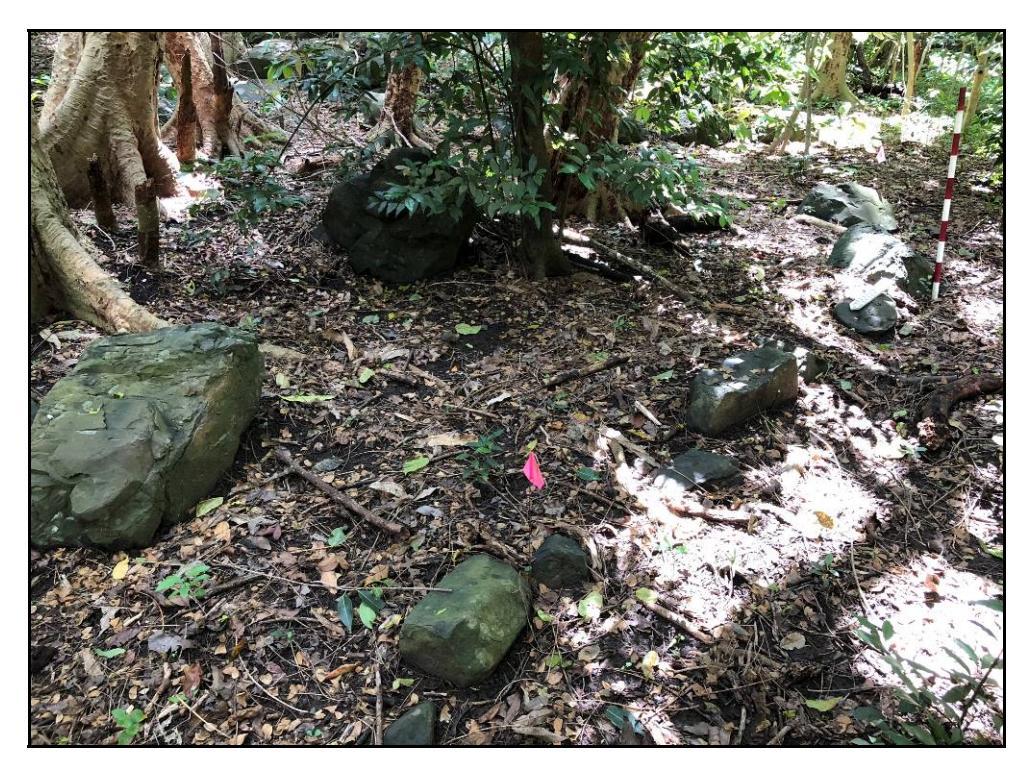
Figure 98. Photo showing SIHP # -7079, Feature K (stone alignment), view to southeast

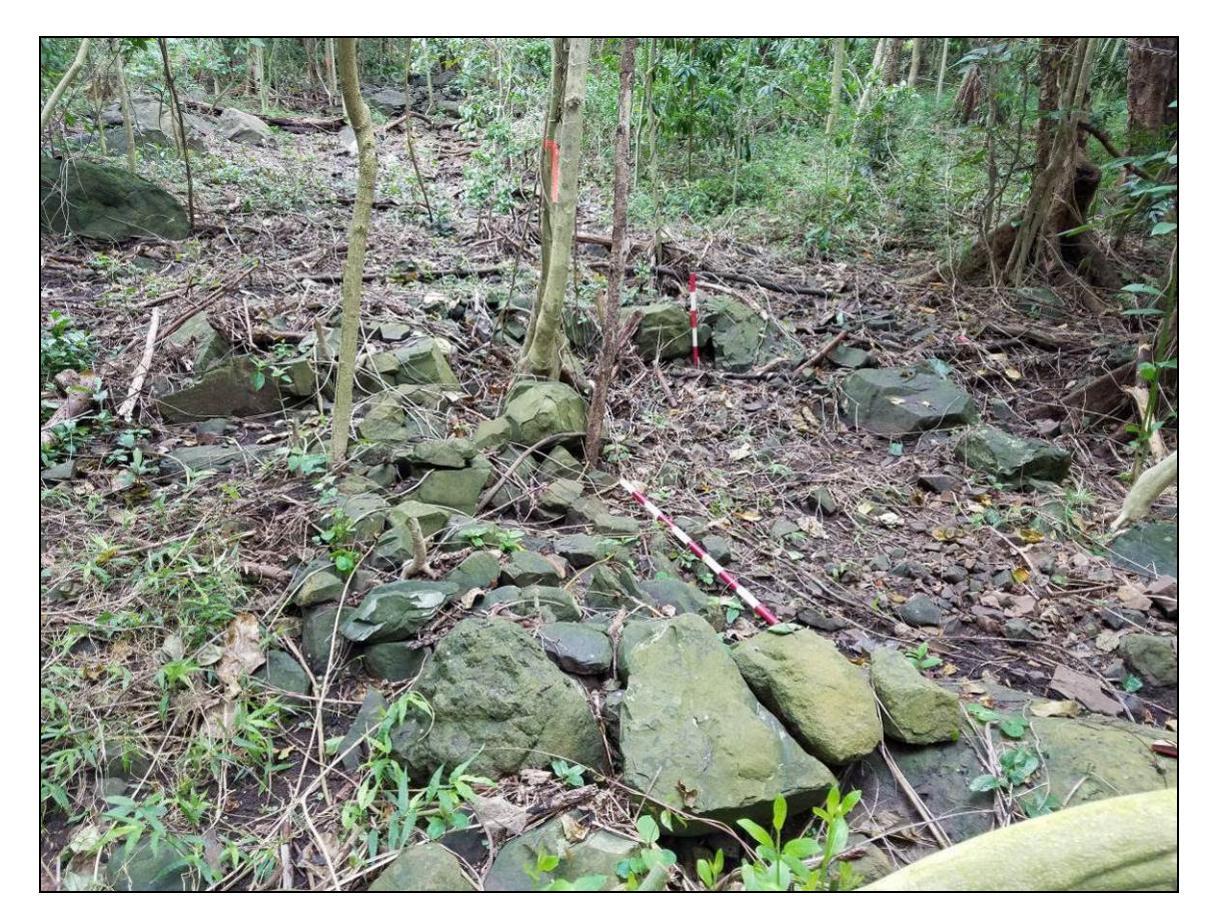
Honua 4 includes 7 features (A-G). Feature A is a large c-shaped terrace, approximately 3 m N/S by 6 m E/W and 40 cm tall, constructed on a level area using large natural basalt boulders and cobbles stacked 4 courses high (Figure 99). An 'auwai runs along the south side of the feature and continues westward. Due to the proximity of Feature A to the 'auwai, the feature is interpreted as agricultural rather than a habitation structure.

Figure 99. Photo showing Honua 4, Feature A (c-shaped terrace), view to west

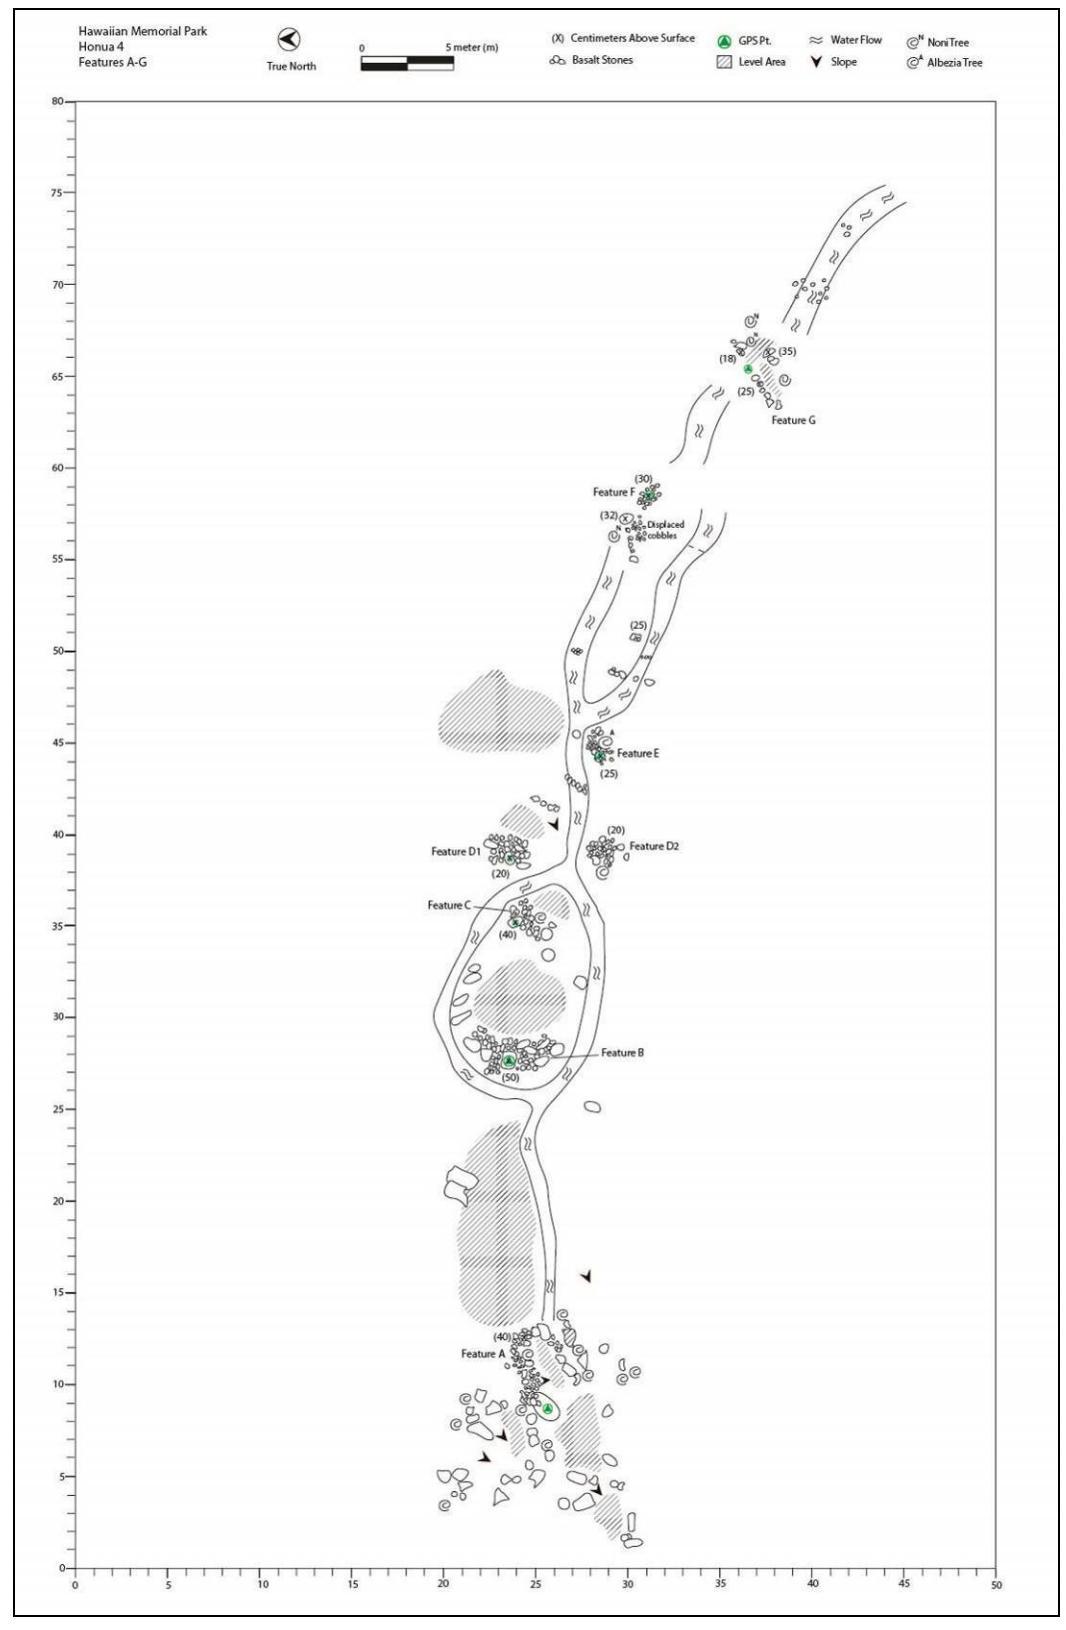
SIHP #50-80-10-8231 (Honua 4) is a terraced 'auwai system that consists of multiple stonestacked terraces and mounds used to divert water within a small 'auwai (Figure 100). The construction technique suggests the site is a traditional agricultural site. The site is located just south of the formerly proposed CP, and in coordination with the landowner it will likely be included within the boundary of the CP. The 'auwai appears to be a secondary stream tributary that drains into a larger primary tributary, which flows through an earthen ditch to a concrete drainage basin at the end of Lipalu Street (see northeast corner of SIHP # -4680 Plan Map, Figure 129).

Figure 100. Plan Map of SIHP #50-80-10-8231 (Honua 4, traditional terraced 'auwai)

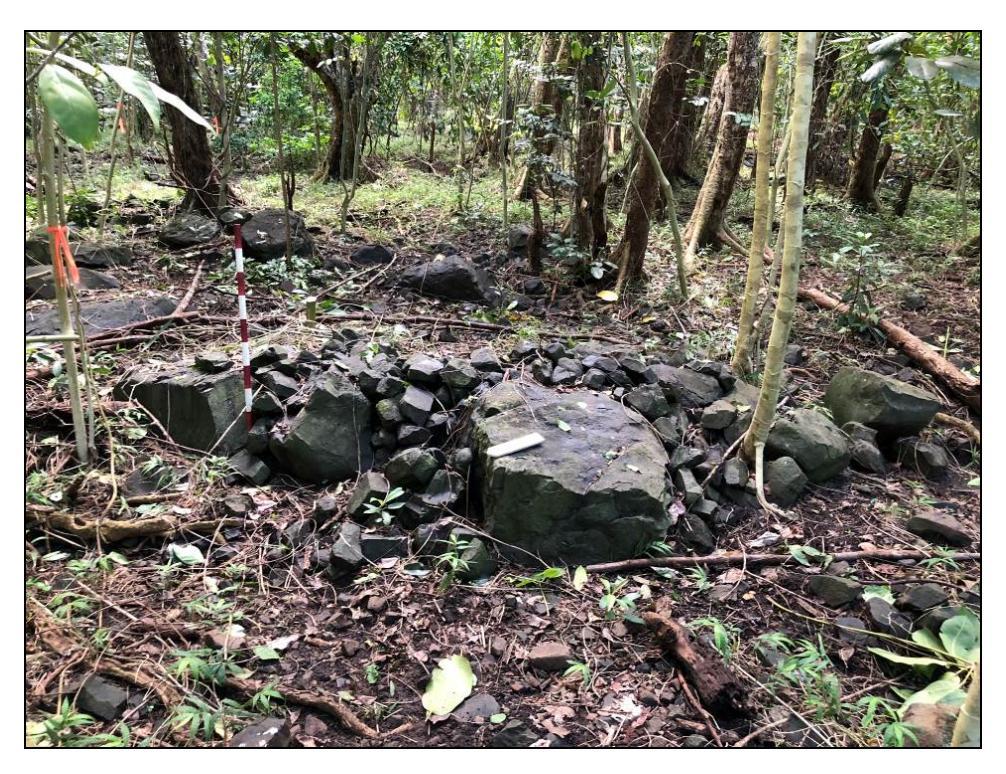
Feature B is a large terrace structure, approximately 6 m N/S by 1.5 m E/W and 50 cm tall, constructed on a relatively level area by using natural boulders and small cobbles stacked up to 7 courses high (Figure 101). The 'auwai runs on either side of Feature B and then joins into one water course just west of the feature. The function of Feature B appears to be for water diversion and likely agricultural planting on level areas above the stone facing.

Figure 101. Photo showing Honua 4, Feature B (terrace), view to southwest

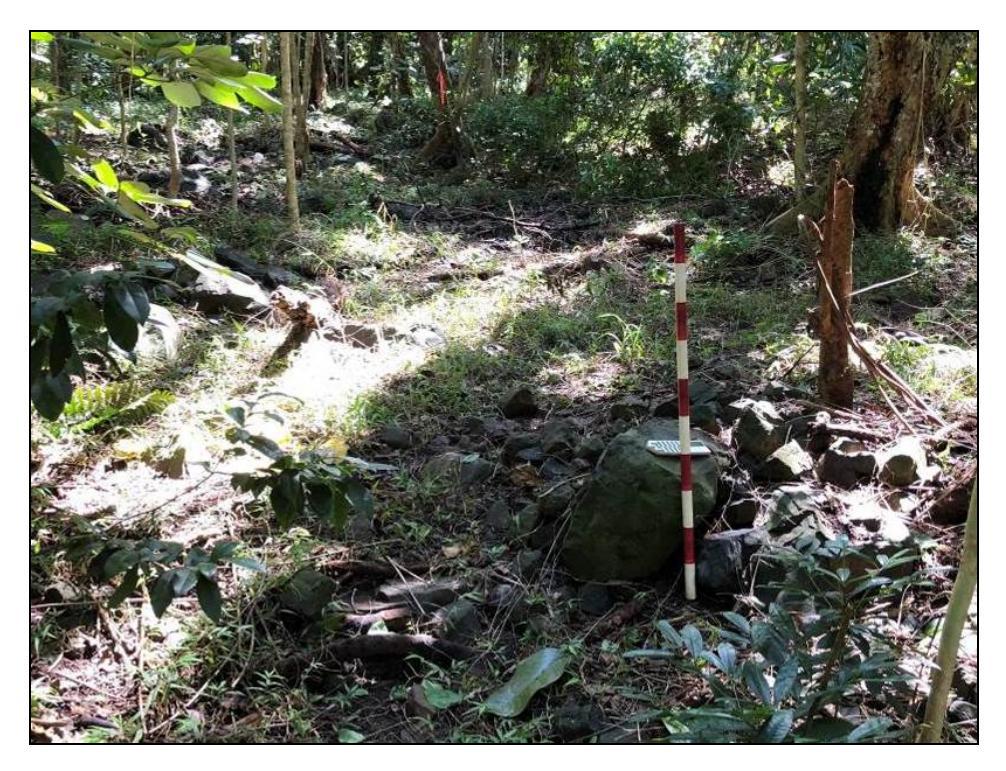
Feature C is a small terrace, 2.5 m E/W x 2.5 m N/S by 40 cm in height, that is constructed using a natural large boulder with small boulders and cobbles piled adjacent to it (Figure 102). Feature C is located within the center of the 'auwai path and appears to divide it so that the water flows on either side. The terrace was likely also used to capture soil and for agricultural planting.

Figure 102. Photo showing Honua 4, Feature C (mound, on right) and a section of the 'auwai (on left), view to southwest

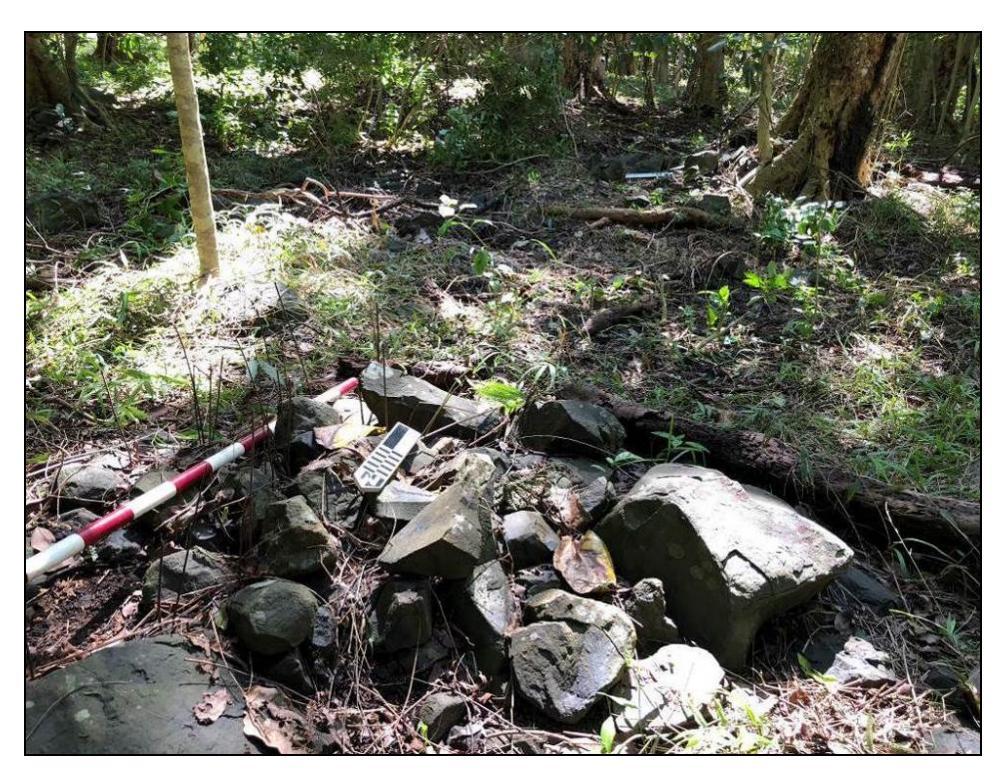
Feature D consists of two small rock piles (D1-D2) on either side of the 'auwai (Figure 103). The stones are stacked 2-3 cobbles high. Feature D1 is on the north side of the 'auwai and measures approximately 2 m N/S x 1.5 m E/W and 20 cm high. Feature D2 is on the south side

of the 'auwai and measures approximately 2 m N/S by 1.5 m E/W and 20 cm high. The function of the mounds was likely for agricultural use.

Figure 103. Photo showing Honua 4, Feature D1 (mound, in foreground) and Feature D2 (mound, in background next to tree), view to south

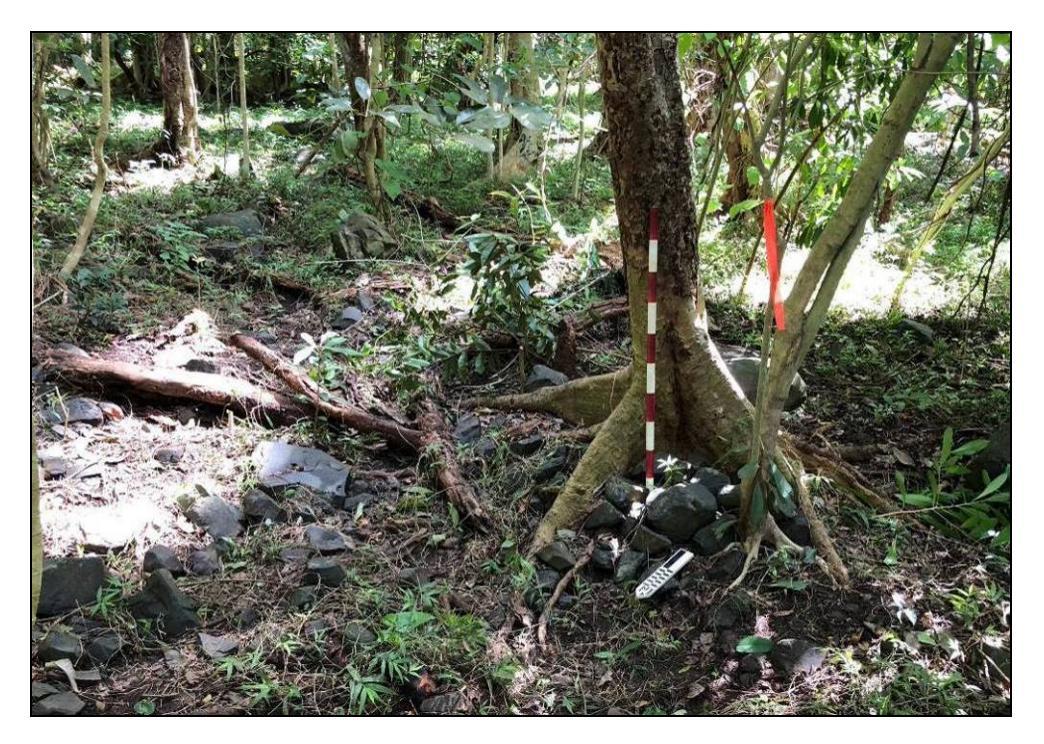
Feature E is a small rock pile, measuring approximately 0.7 m N/W by 1.5 m E/W and 25 cm tall, situated on the south side of the 'auwai (Figure 104). A tree is growing from Feature E. The mound was likely for agricultural use.

Figure 104. Photo showing Honua 4, Feature E (mound, under tree), view to south

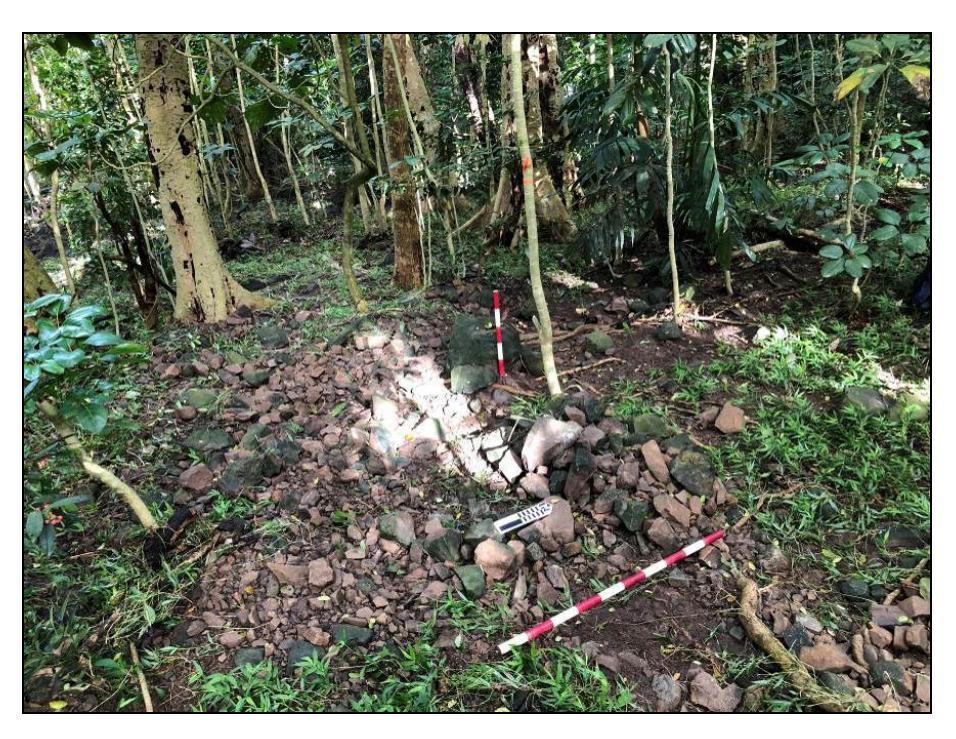
Feature F is a small rock pile, measuring approximately 1 m N/S by 1.5 m E/W and 30 cm tall, located on the north side of the 'auwai (Figure 105). The feature is adjacent to a concentration of angular basalt cobbles of red coloration, extending approximately 4 m to the west. The red coloration of the stones is indicative of recent rock displacement, likely due to heavy water flow. A large noni tree is growing near Feature F. Feature F may be a planting mound and/or a remnant of a water diversion terrace.

Figure 105. Photo showing Honua 4, Feature F (mound, in right foreground), view to northwest

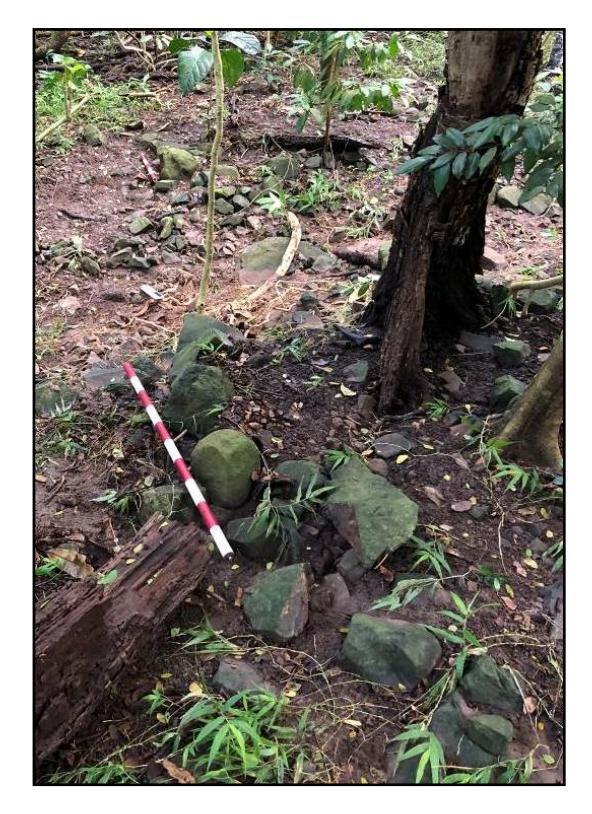
Feature G is a terrace, measuring approximately 4.25 m long E/W and 18-25 cm high, which crosses the 'auwai (Figure 106). Several large noni trees are growing adjacent to Feature G. Feature G is the highest documented feature in elevation of the Honua 4 complex.

Figure 106. Photo showing Honua 4, Feature G (terrace), view to northeast (notice the terrace exists on both sides of the 'auwai, lined by photo scales)

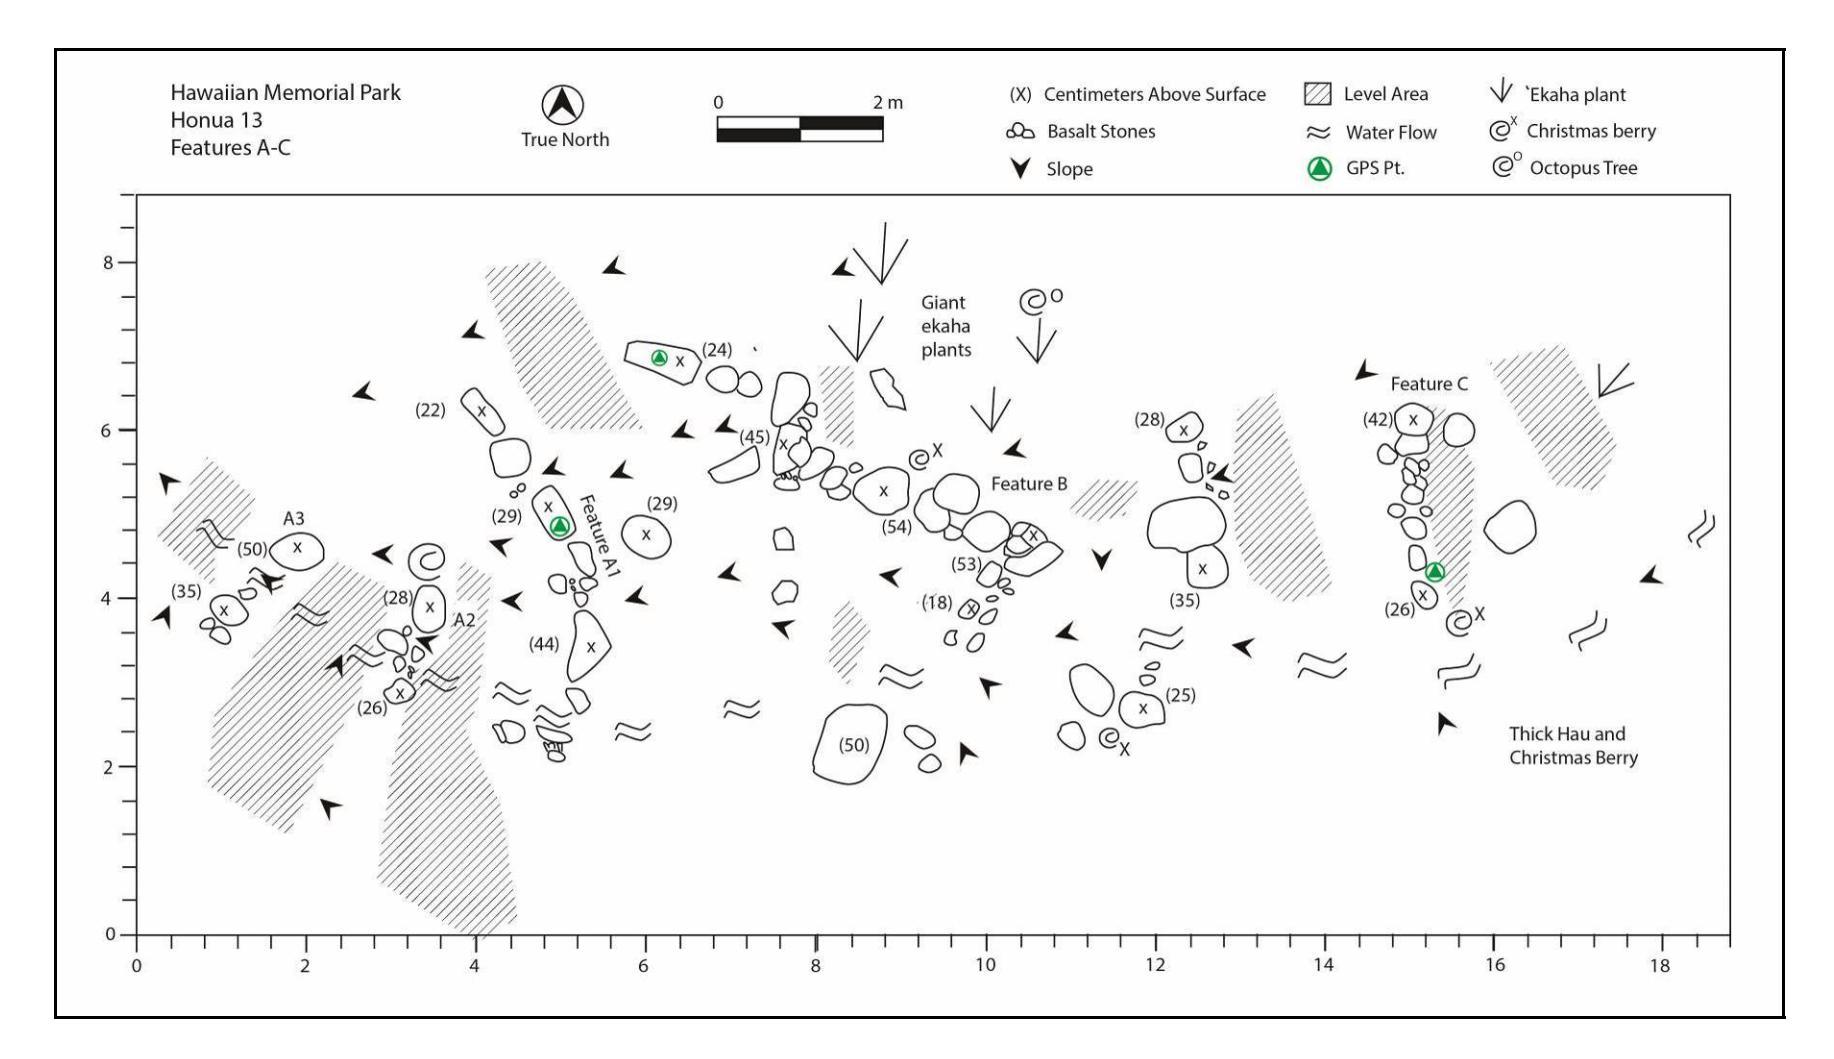
SIHP #50-80-10-8240 (Honua 13) is a traditional terraced 'auwai system where large 'ekaha plants (*Asplenium nidus*) are growing (Figure 107). The site includes several terraces (Features A-C) in fair condition. The terraces are built across and adjacent to a small 'auwai with intermittent water flow from natural hillside runoff. The hillside tends to the west and has a moderate slope with level areas adjacent to constructed terraces. Vegetation in the area includes 'ekaha, laua'e fern, mountain grass, hau, Christmas berry, kukui, and thick vines.

Figure 107. Plan Map of SIHP #50-80-10-8240 (Honua 13, terraced 'auwai)

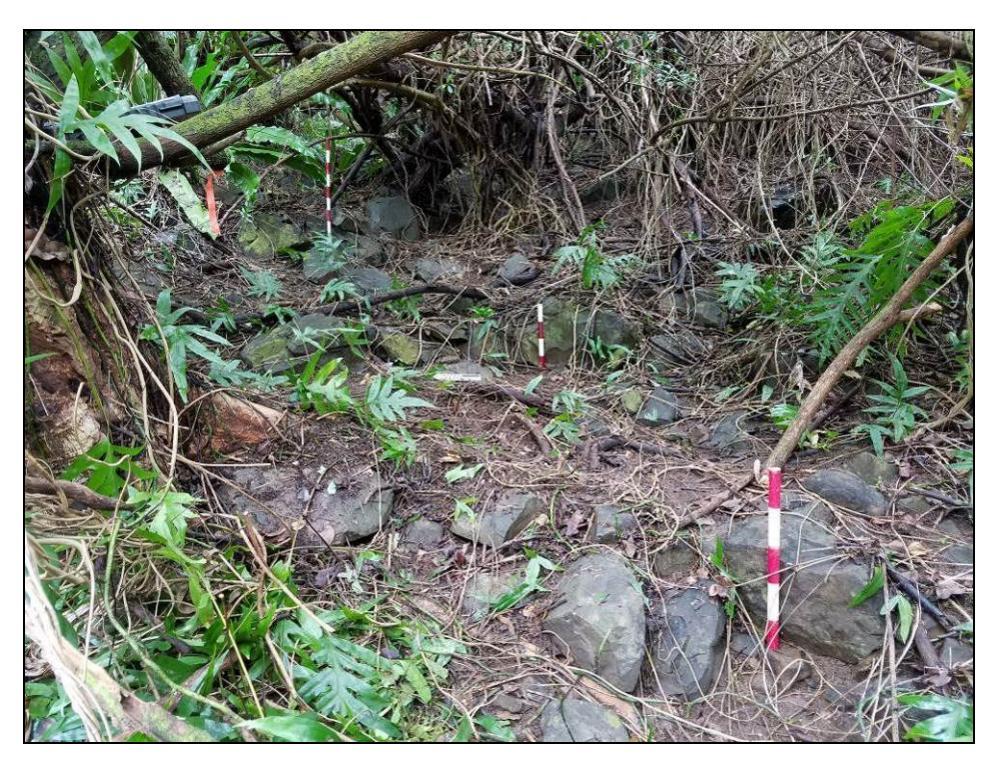
Feature A includes three terraces (A1-A3) constructed within and adjacent to an 'auwai. Feature A1 is a slightly curved terrace, approximately 3.7 m N/S by 1 m E/W and 22-44 cm tall, constructed of basalt boulders and cobbles (Figure 108). The 'auwai runs through the south end of Feature A1. Just downslope of Feature A1 are two small, approximately 1 m N/S by 50 cm E/W, terrace remnants (Features A2 and A3) which the 'auwai flows over. Upslope of Feature A1 are two well-constructed terraces (Feature B and C).

Figure 108. Photo showing Honua 13, Feature A2 (terrace, in foreground), Feature A1 (terrace, center), and Feature B (terrace, in background), view to northeast

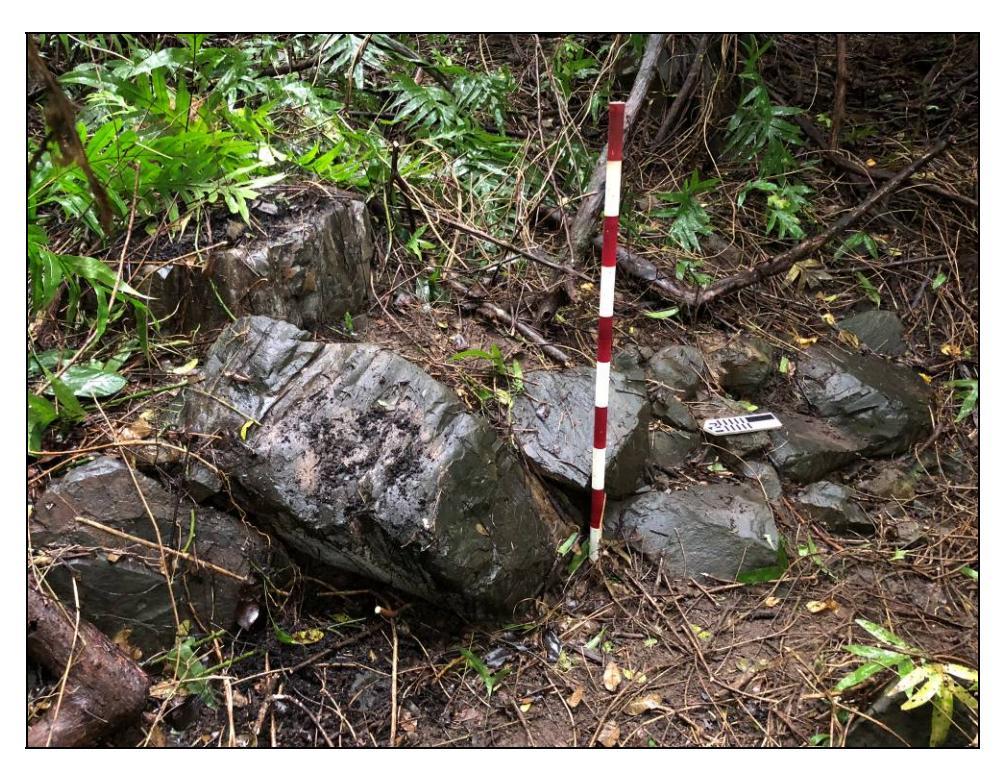
Feature C is a well-built, 2 course basalt cobbles and boulder terrace, approximately 2.5 m N/S by 0.5 cm E/W and ranging 26-42 cm tall (Figure 109). Feature C is covered in dense hau. A large 'ekaha plant was observed upslope of the feature.

Figure 109. Photo showing Honua 13, Feature C (terrace), view to north
