8.1.9 SIHP #50-80-10-8231 (Honua 4), Traditional Terraced 'Auwai

8.1.11 SIHP #50-80-10-8241 (Honua 14), Historic Guava Charcoal Kiln

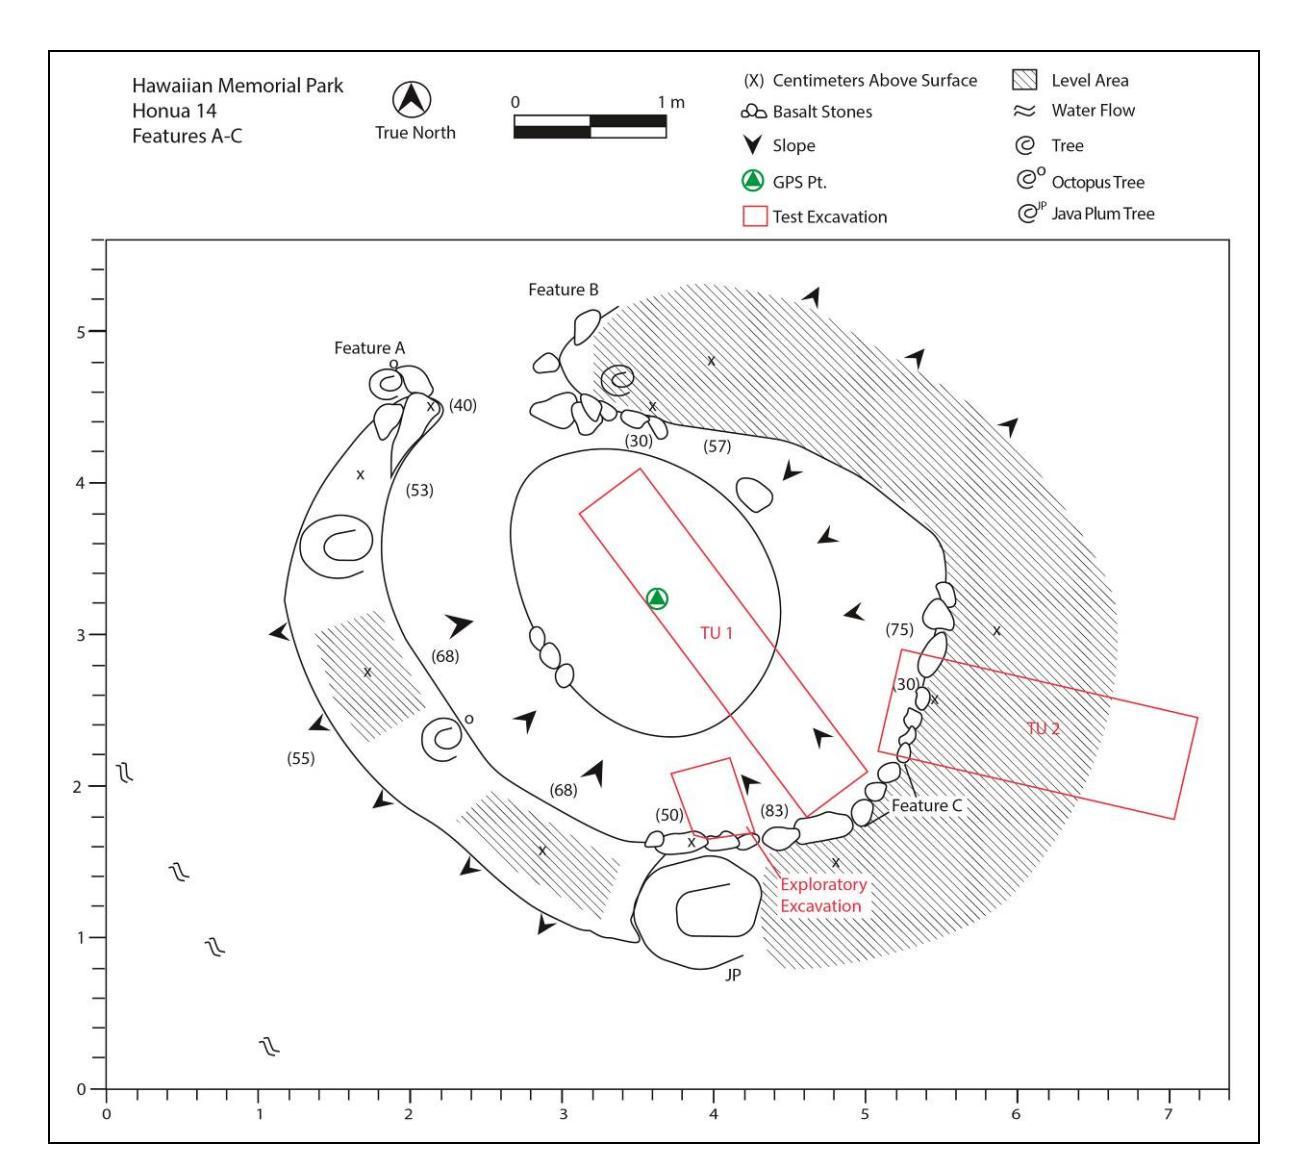
SIHP #50-80-10-8241 (Honua 14) is a large earthen pit with roughly stacked stone walls at the entrance (Features A and B) and a nicely constructed wall along the southern interior (Feature C) (Figure 110 through Figure 112). The interior floor of the pit measures approximately 2.65 m N/S by 2.3 m E/W, while the site itself measures approximately 4.5 m N/S by 5.5 m E/W and ranges from 53-83 cm tall from the interior surface to the surrounding site surface. The entrance to the pit faces northwest and contains stone walls, Features A and B, on either side, constructed of basalt cobbles roughly stacked up to three courses in height and ranging from 30-40 cm tall. The stone wall lining the southern section of the pit, Feature C, is constructed of basalt cobbles and boulders stacked 6-8 courses high, with approximately 3-4 courses or 30-50 cm of the wall below the ground surface. The site is cut into the surrounding hillside, with the abutting ground surface being level with the top of the site. The west side of the earthen pit is created by an earthen berm which borders a small drainage. The site is covered in dense laua'e fern, octopus trees, and Java Plum.

Initially the site function and associated time period were undetermined. The stone walls are constructed using a traditional Hawaiian dry-stone stacking technique. On the surface, the soil within the interior of the pit does not show evidence of burning, which is dissimilar to other large earthen pit features documented within the project area that are interpreted as historic charcoal kilns. In order to determine the site type, function, and associated time period two test units (TU 1 and 2) and a small exploratory trench were excavated adjacent to the Feature C stone wall (see Figure 110). Descriptions of excavations are detailed below.

Figure 110. Plan Map of SIHP #50-80-10-8241 (Honua 14, historic guava charcoal kiln)

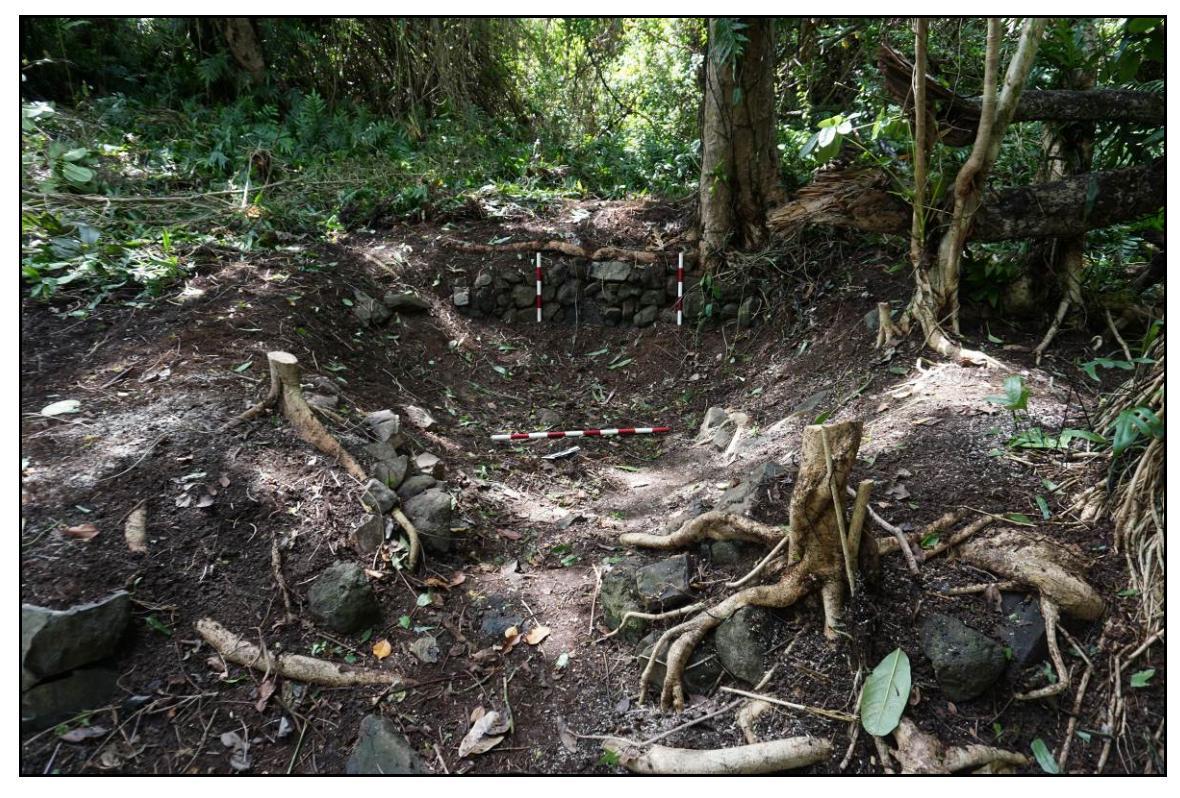
Figure 111. Photo of Honua 14 (walled pit), showing Feature A (right foreground), Feature B (left foreground), and Feature C (background), view to southeast; after clearing

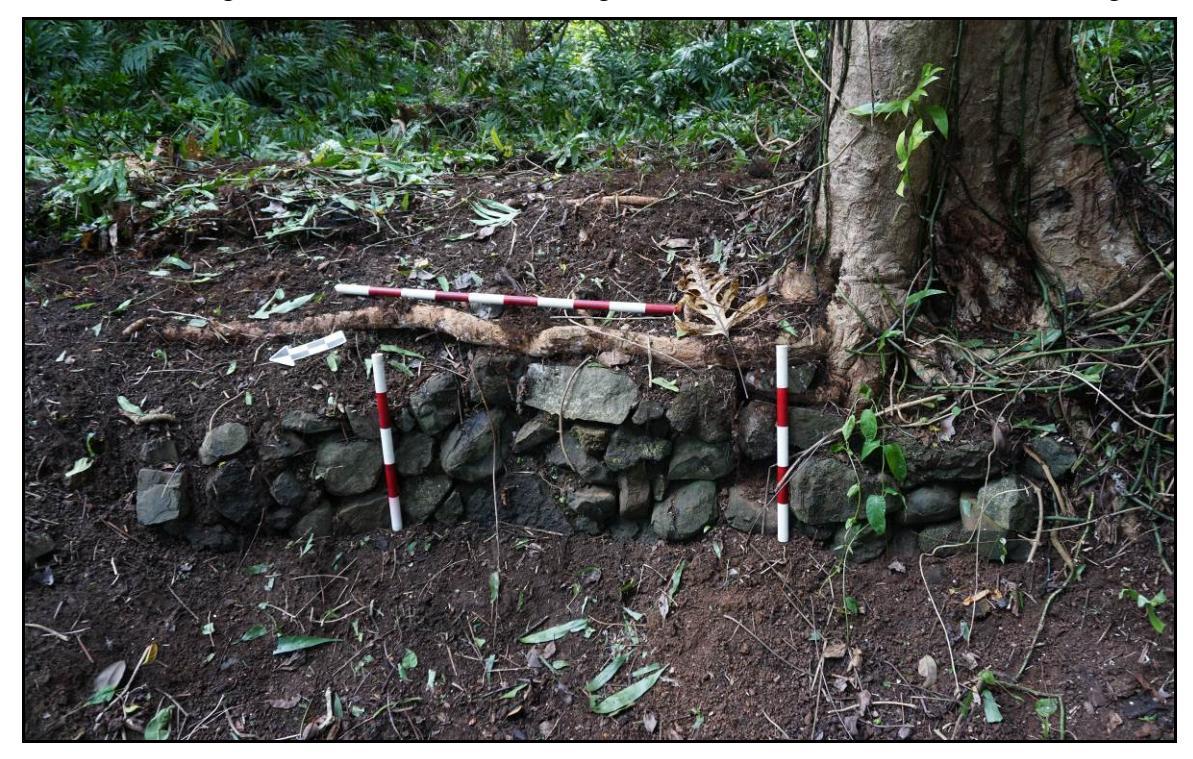
Figure 112. Photo of Honua 14, Feature C (stone wall), view to east

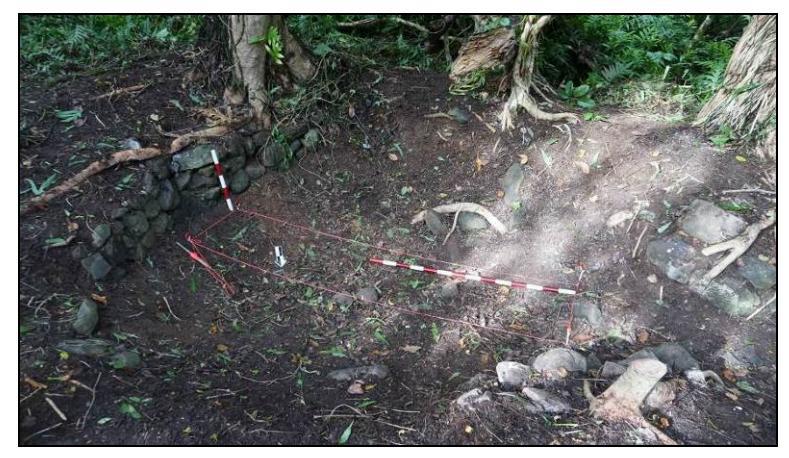
TU 1 was 2.5 m long by 0.5 m wide and was placed within the interior of site, abutting the Feature C stone wall and extending to the formal site entrance near the Feature A and B stone walls (Figure 113 and refer to Figure 110). A datum was established at ground surface (0 cm above the surface) at the southeast corner of the test unit, which was the highest point of the unit. Elevations for TU 1 were measured from the datum (cm below datum [cmbd]). Excavation proceeded in 10 cm increments. Photos and plan maps were completed for each level, Figure 114 shows representative photos and plan maps of the excavation. The test unit was excavated in two stages, the first stage excavated the entire 2.5 m long unit to approximately 72 cmbd where it was thought sterile soil had been exposed throughout the base of excavation. The second stage of excavation within TU 1 focused on the 90 cm long, eastern portion of the unit and was excavated to a maximum depth of 100 cmbd, which exposed the foundation of the kiln (Feature D).

Figure 113. Photo of Honua 14 showing placement of Test Unit 1 prior to excavation, view south

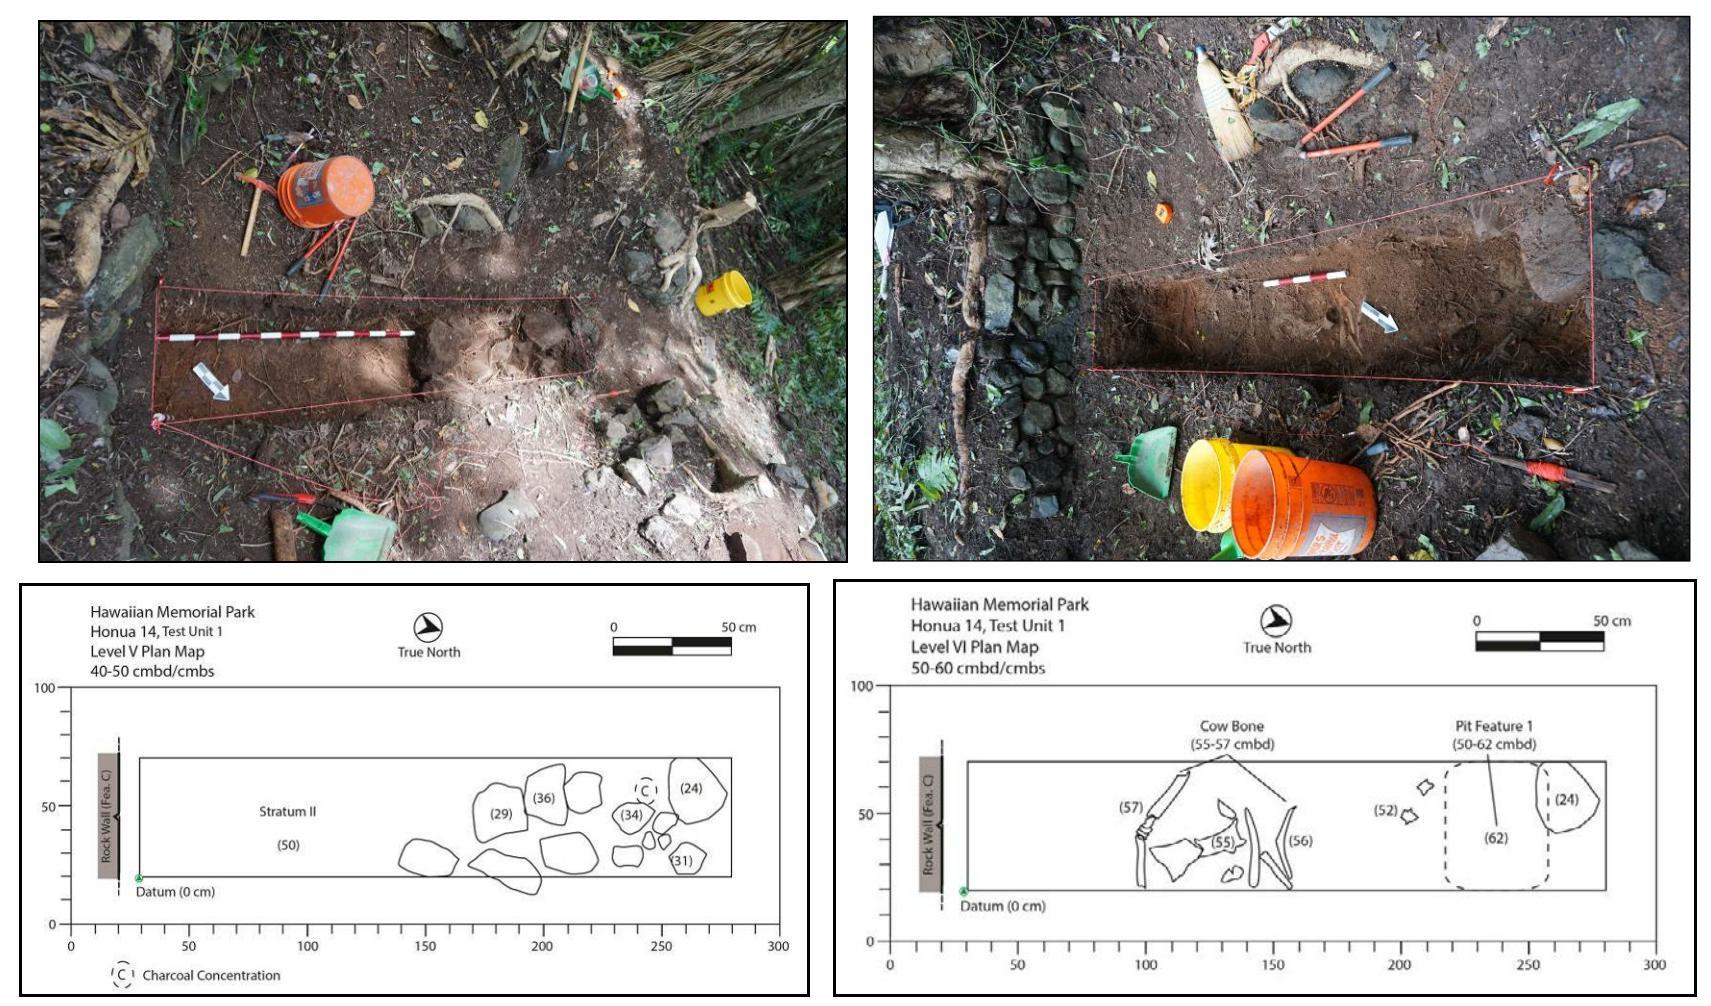
Several cultural deposits were found within TU 1, Stratum II and are shown in Figure 114 and Figure 115. A concentration of basalt cobbles were encountered within the west portion of TU 1. It is likely the cobbles represent historic rock fall from Features A and B. Directly under the basalt cobbles was a historic charcoal pit feature (Charcoal Pit Feature 1), extending from approximately 50-62 cmbd and spanning the width of the excavation. Also within Stratum II, in the center of the test unit was a partially articulated sub-adult cow, extending from approximately 52-57 cmbd. Encountered skeletal elements of the cow include ribs, scapula, axis vertebrae, and an articulated tibia, calcaneous, and foot bones. Stratigraphic documentation indicates Charcoal Pit Feature 1 is contemporary with the cow bones and is therefore historic, post-dating AD 1793, when cattle were introduced into Hawai'i.

Figure 114. Photos and Plan Map of base of TU 1, Level V (50 cmbd, top and bottom left) and Level VI (60 cmbd, top and bottom right)

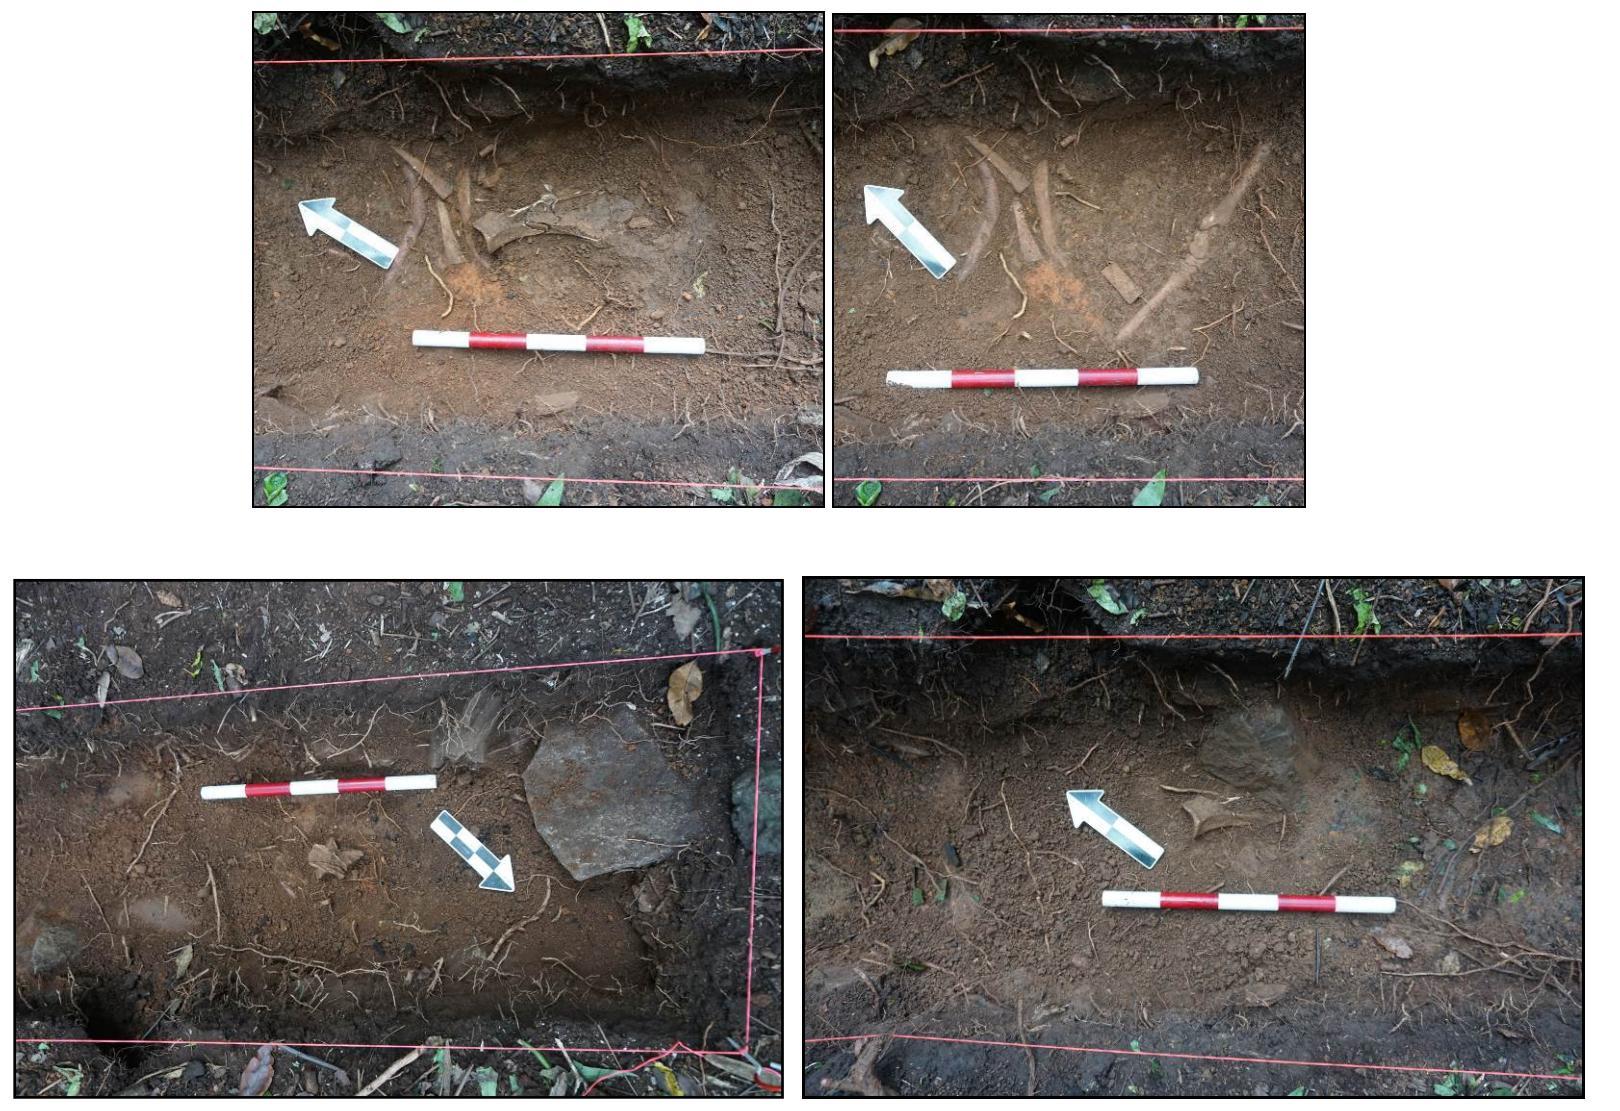
Figure 115. Photos showing cultural materials documented within TU 1, Stratum II (concentration of cow bones, on top; isolated cow bones and charcoal deposit, on bottom)

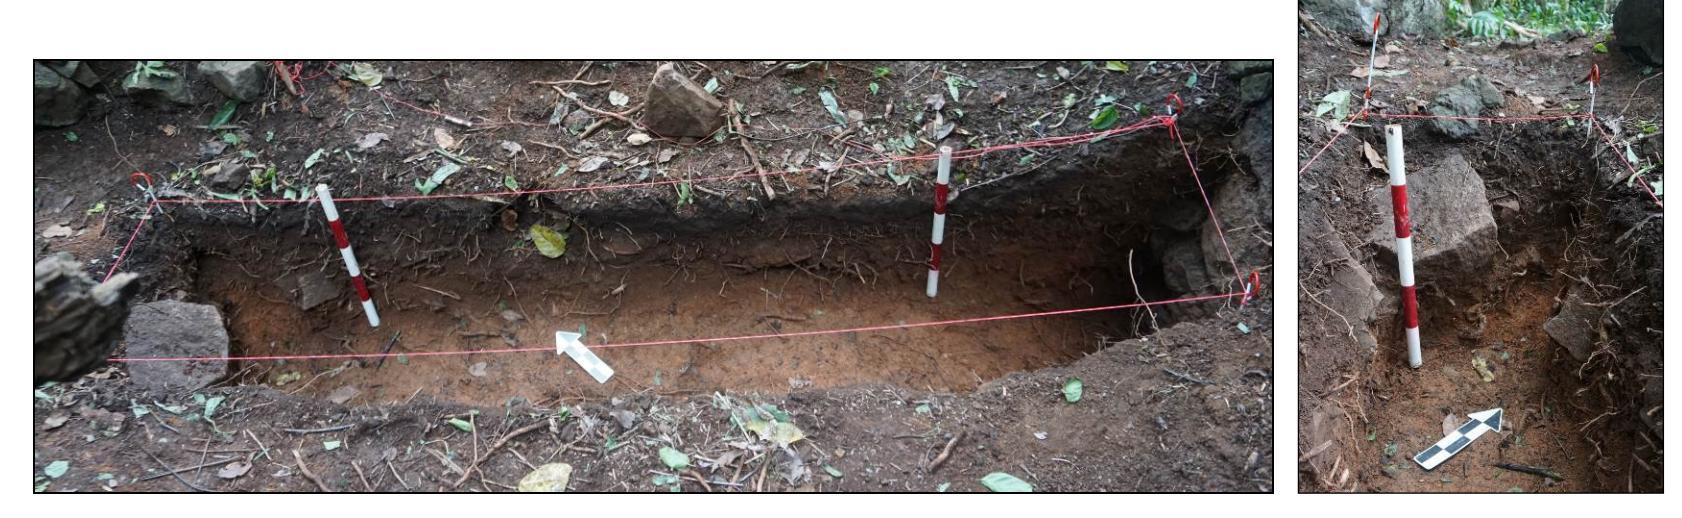
Figure 116. Photos showing Northeast (left) and Northwest (right) sidewalls of TU 1 at 70 cmbd (Stratum III)

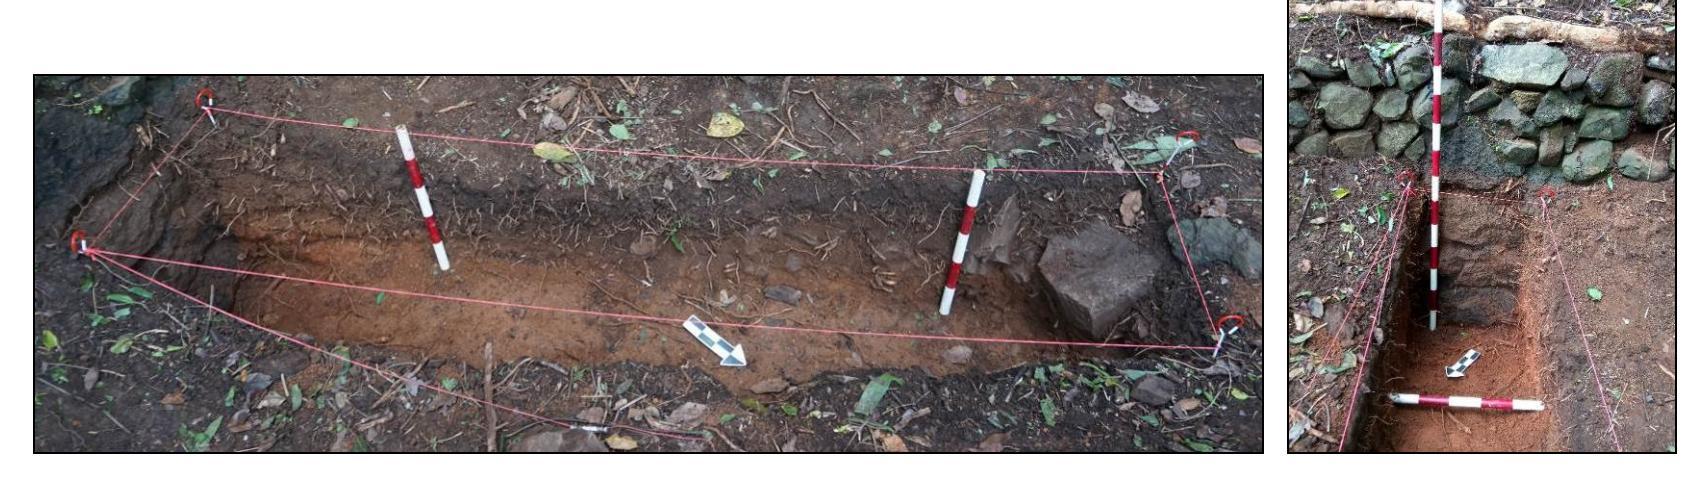
Figure 117. Photos showing Southwest (left) and Southeast (right) sidewalls of TU 1 at 70 cmbd (Stratum III)

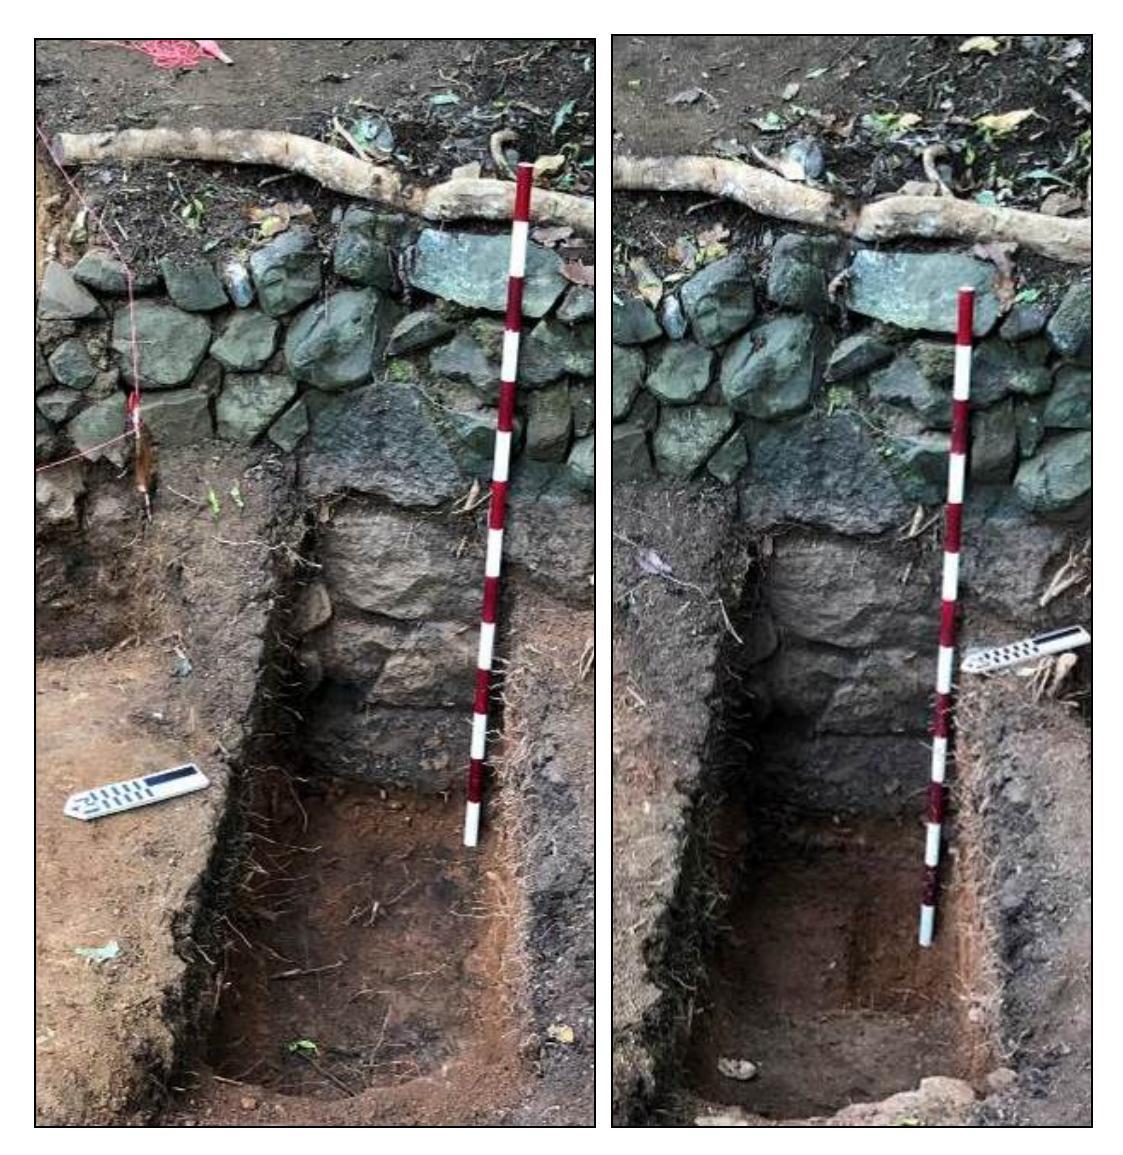
Near the base of TU 1, the floor and foundation of the charcoal kiln was encountered (Figure 118). The floor of the kiln, Stratum V, was encountered from approximately 79-81 cmbd and consisted of a thin layer of black sediment that contained a high amount of soot and charcoal. Charcoal collected from Stratum V was identified as guava (*Psidium* sp.) (see Appendix E). Production of guava charcoal was a common activity in Kane'ohe and Windward O'ahu in the latter half of the 19th century and then again in the 20th century. The foundation of the kiln, Stratum VI, was encountered from approximately 81-85 cmbd and consisted of very gravelly sediment. The gravel consisted of basalt pebbles and small cobbles, which when broken open had a purplish coloration around the perimeter; indicating evidence of being fire-affected.

Figure 118. Photo of TU 1 at floor of charcoal kiln (Feature D, Stratum V) (left) and base of TU 1 excavation (right)

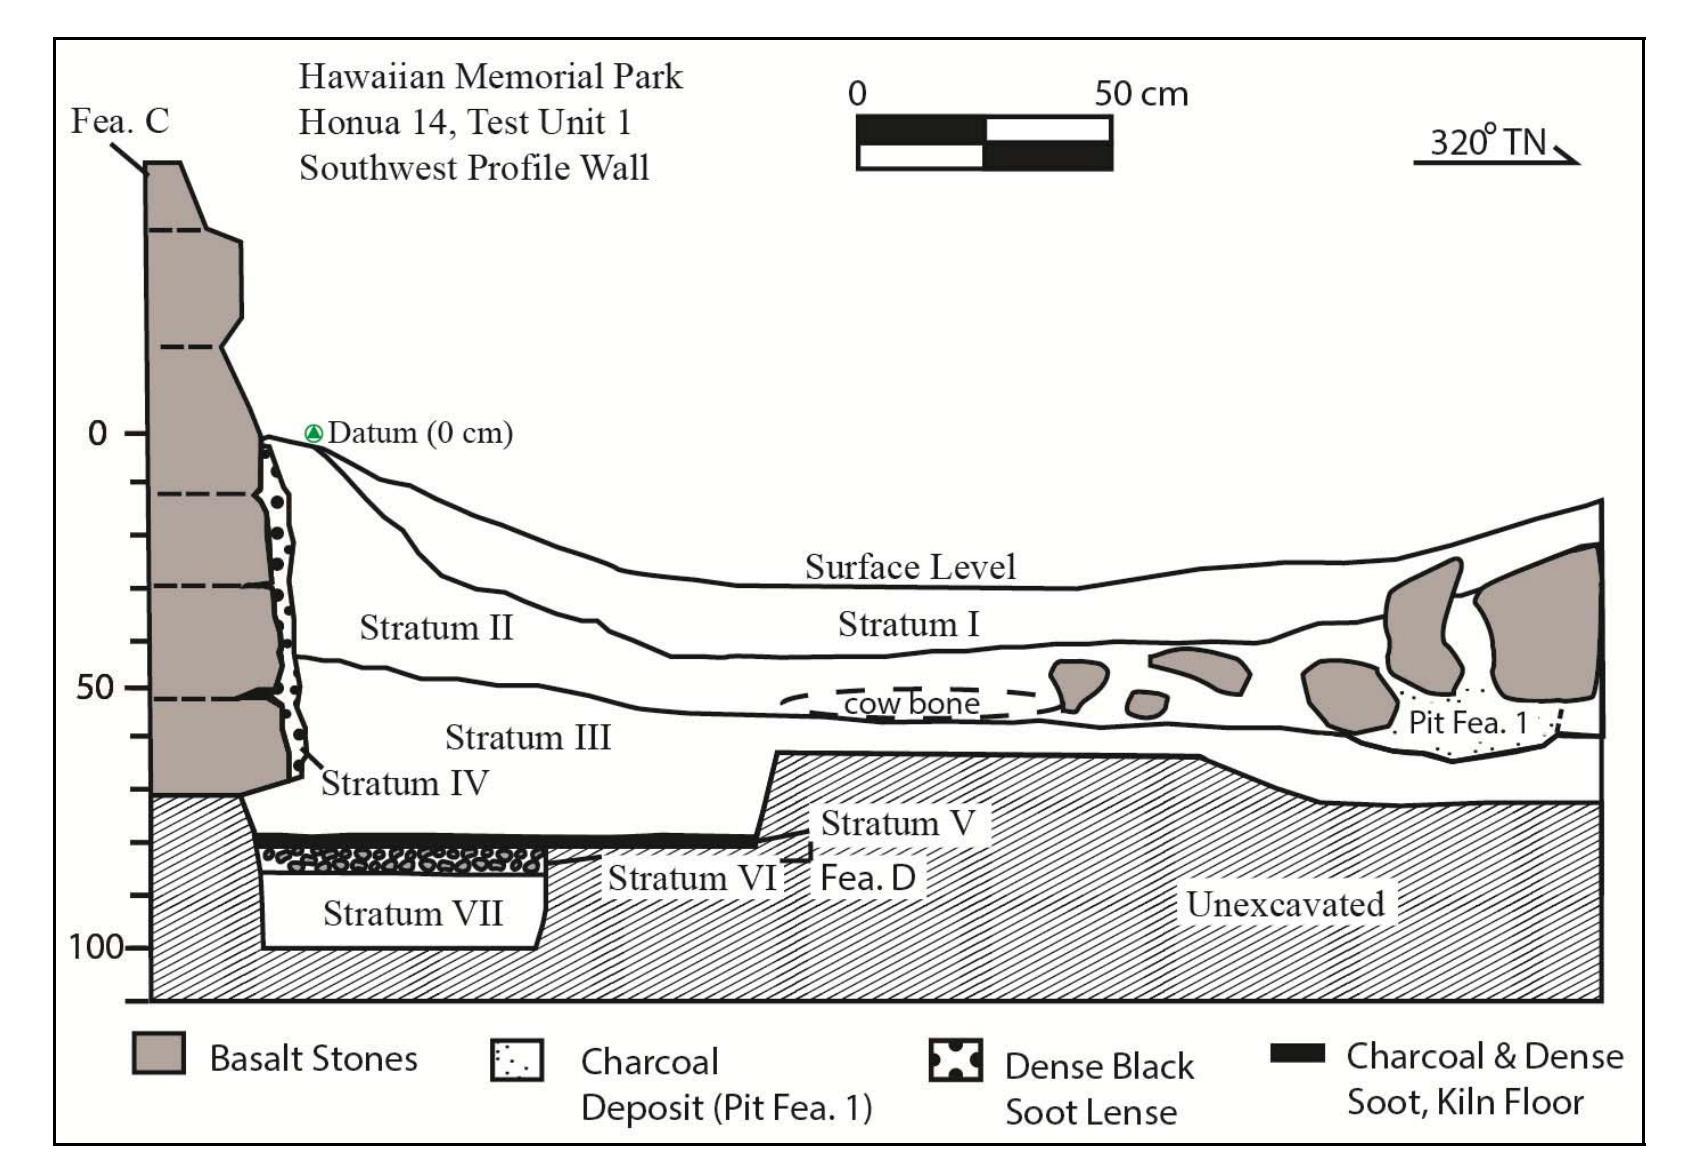
Figure 119. Photo and Profile of TU 1 Southwest Excavation Wall

Stratum I (0-43 cmbd) 10 YR 2/2 (very dark brown) silty clay; weak, medium, crumb structure; moist, friable consistency; plastic to slightly plastic; terrigenous, on-site, natural sediment; wavy, abrupt lower boundary; many fine to medium roots and rootlets; contained few fine charcoal fleckings and charred kukui shell; modern A Horizon

- Stratum II (0-60 cmbd) 7.5 YR 3/4 (dark yellowish brown) silty clay; weak, medium, crumb structure; moist, friable to loose consistency; slightly plastic; terrigenous, on-site, naturally accumulated sediment; smooth to slightly wavy, abrupt lower boundary; common fine roots, contained common charcoal flecking, basalt cobbles within the northern portion, cow bone, and a pit feature (Pit Feature 1); represents post-contact use of the site

- Stratum III (43-77 cmbd) 5 YR 4/4 (reddish brown) silty clay; weak, fine to medium, crumb structure; moist, friable to loose consistency; slightly plastic; terrigenous, on-site secondarily placed sterile soil; smooth, abrupt lower boundary; common fine to medium roots; contained decomposing basalt; natural C-Horizon soil used as fill, possibly associated with dis-use of the charcoal kiln to prevent unintended combustion

- Stratum IV (2-67 cmbd) 10YR 2/1 (black) silty clay; moderate, fine, crumb structure; moist, friable to loose consistency; slightly plastic; terrigenous, culturallyenriched natural sediment; vertical lense with smooth, discontiguous, abrupt boundary; contains a dense amount of soot; natural sediment colored black from long exposure to charcoal burning, adhering to and found within crevices of lower limits of Feature C (stone wall)

- Stratum V (77-80 cmbd) 10YR 2/1 (black) silty clay; moderate, fine, crumb structure; moist, friable to loose consistency; slightly plastic; terrigenous, culturallyenriched natural sediment; smooth, very abrupt lower boundary; contains a high amount of soot and guava charcoal; natural sediment colored black from long exposure to charcoal burning; base or floor of charcoal kiln, part of Feature D

- Stratum VI (79-83 cmbd) 5 YR 4/4 (reddish brown) gravelly silty clay; moderate, medium, crumb structure; moist, friable consistency; slightly plastic; terrigenous, on-site sediment; smooth, diffuse lower boundary; contains abundant fire-effected basalt pebbles to small cobbles; kiln foundation, part of Feature D

Stratum VII (82-95 cmbd 5 YR 3/4 (dark reddish brown) clay; moderate, medium, crumb Base of excavation [BOE]) structure; moist, firm consistency; very plastic; terrigenous, onsite, natural soil; lower boundary not observed; contained decomposing basalt; natural sterile soil

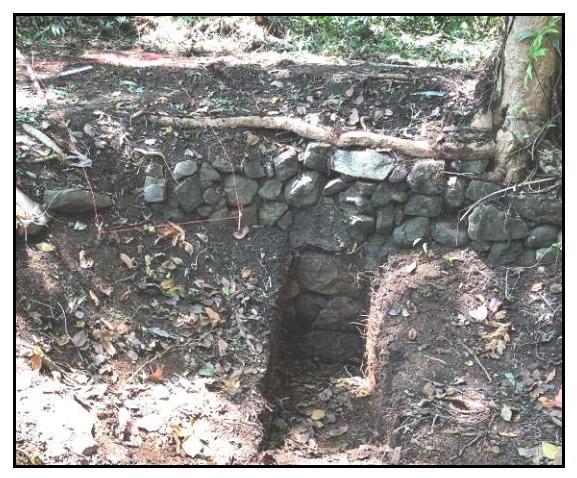
TU 2 was 2 m long by 0.7 m wide and was placed perpendicular to the Feature C stone wall, extending to the southeast or mauka (Figure 120). During excavation, sterile sediment was observed at very shallow depths within the 1 m long, east half of the unit. Therefore, the east half of TU 1 was leveled at approximately 20 cmbd and stepped to prevent the need for excavating it any further through sterile soil. The 1 m long, west portion of TU 2 was excavated around the Feature C stone wall to a depth of approximately 120 cmbd. Feature C was pedistaled and all stones of Feature C were kept in place.

Figure 120. Photo of Honua 14 showing the placement of TU 2 prior to excavation, view to east

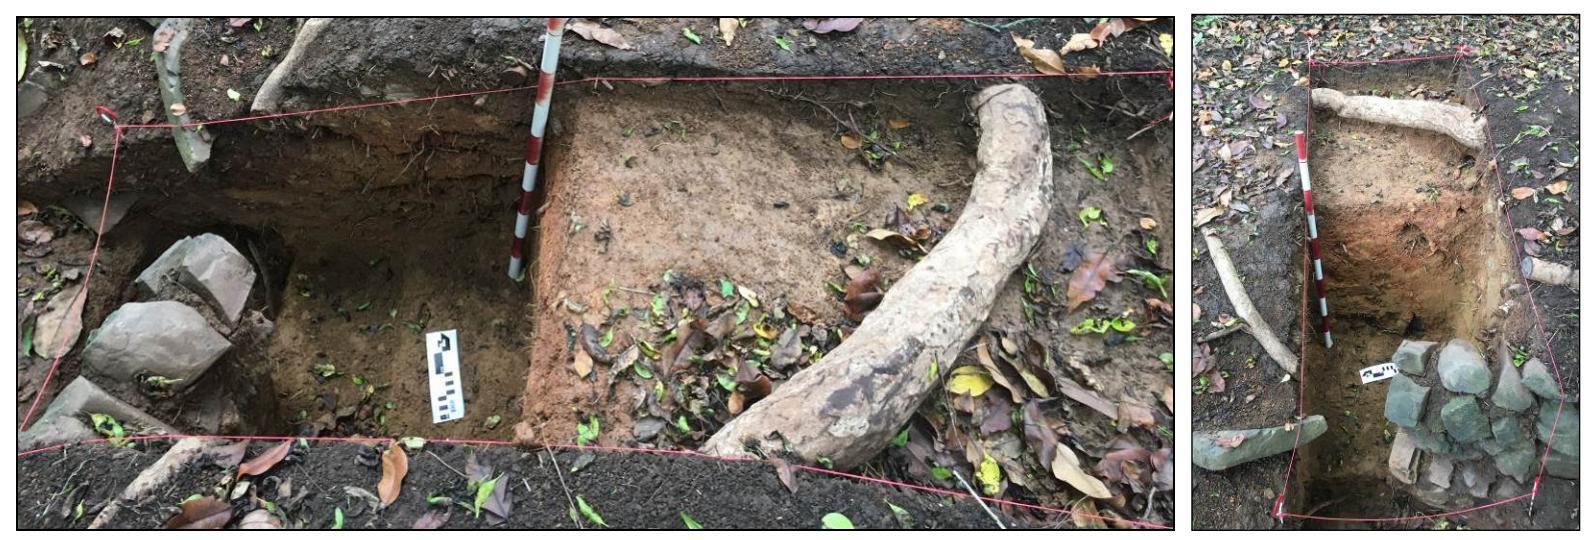
Seven strata were identified (Strata I-VII) (Figure 122 to Figure 124). Stratum I was a modern A Horizon. Stratum II was a thin layer of naturally accumulated silty clay. Stratum III was sterile C Horizon. Strata IV and V were lenses of black sediment discolored by soot and charcoal, associated with direct use of the charcoal kiln. Stratum IV was a vertical black lense found covering the lower portion of the Feature C stone wall and was less dense than Stratum IV found in TU 1. Stratum V was a black lense likely representing the base or floor of an air shaft (Feature E) built in to the Feature C stone wall. Stratum VI and VII appeared to consist of naturally accumulated sediments that eroded into the site from the surrounding site area. Cultural materials from TU 2 include a charred kukui nut from Stratum I and charcoal from Strata II, IV and V.

Figure 122. Photo of TU 2, North Wall (left) and East Wall (right)

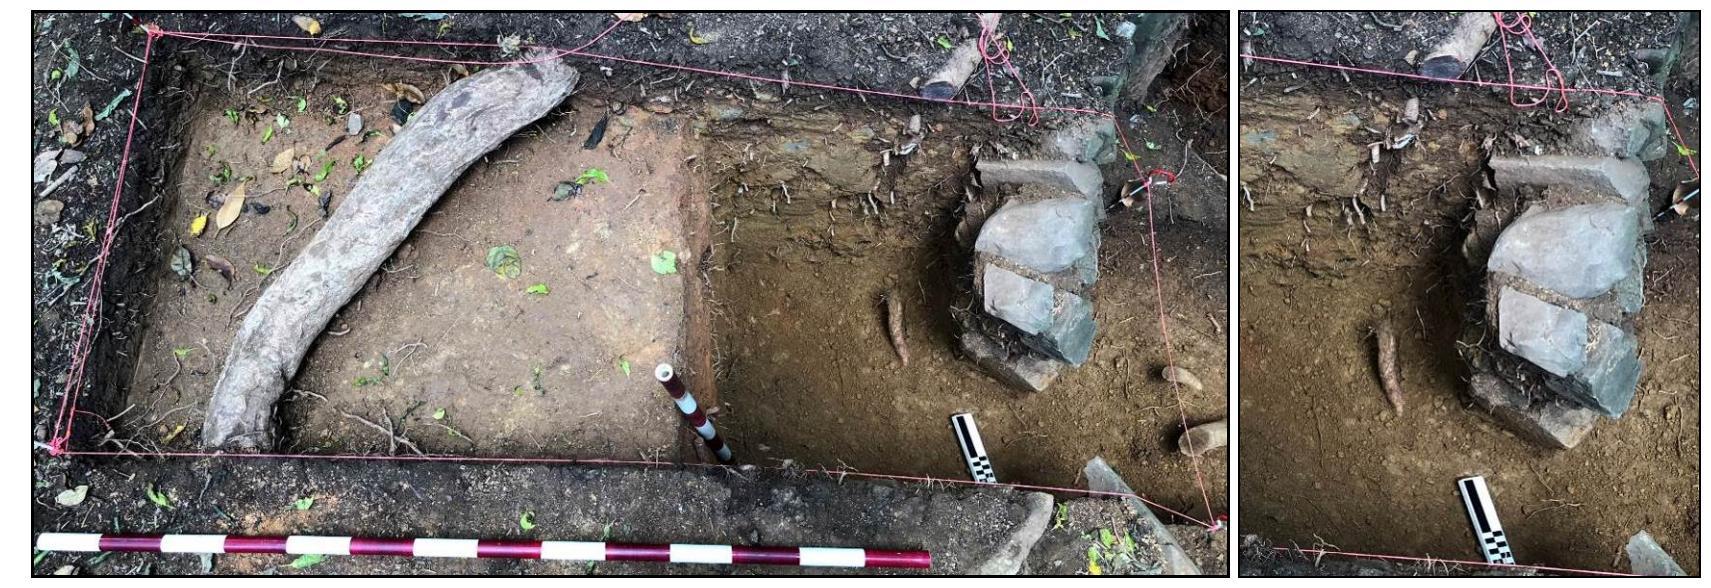
Two structural components of Honua 14 were identified within TU 2 (Feature E and Builders Trench A). The Feature C stone wall was found to be intentionally constructed with a well-defined break in the stone-stacked wall. The break in the wall was designated Feature E. Charcoal lenses abutting the Feature E break in the wall indicate it was an air vent for the charcoal kiln. In addition, while excavating adjacent to the Feature C stone wall a well-defined builders trench, designated Builders Trench A, was identified extending from approximately 22-101 cmbd and cutting through Strata II and III. Builders Trench A is located on the mauka or east side of the Feature C stone wall, indicating the feature was constructed by cutting into the natural hillside. A piece of volcanic glass (Acc. #2) was recovered from Builders Trench A at approximately 39 cmbd. The volcanic glass artifact was sent to the UH-Hilo Geo-Archaeology Lab for EDXRF analysis and it was found that the artifactual material is consistent with basalts from the Ko'olau Range, particularly those from Mokoli'i Island in Kualoa Ahupua'a, within the Ko'olaupoko District of O'ahu (see Appendix D).

Figure 123. Photo of Honua 14, TU 2 South Profile Wall (left) and close-up of Builders Trench A and Feature C (right)

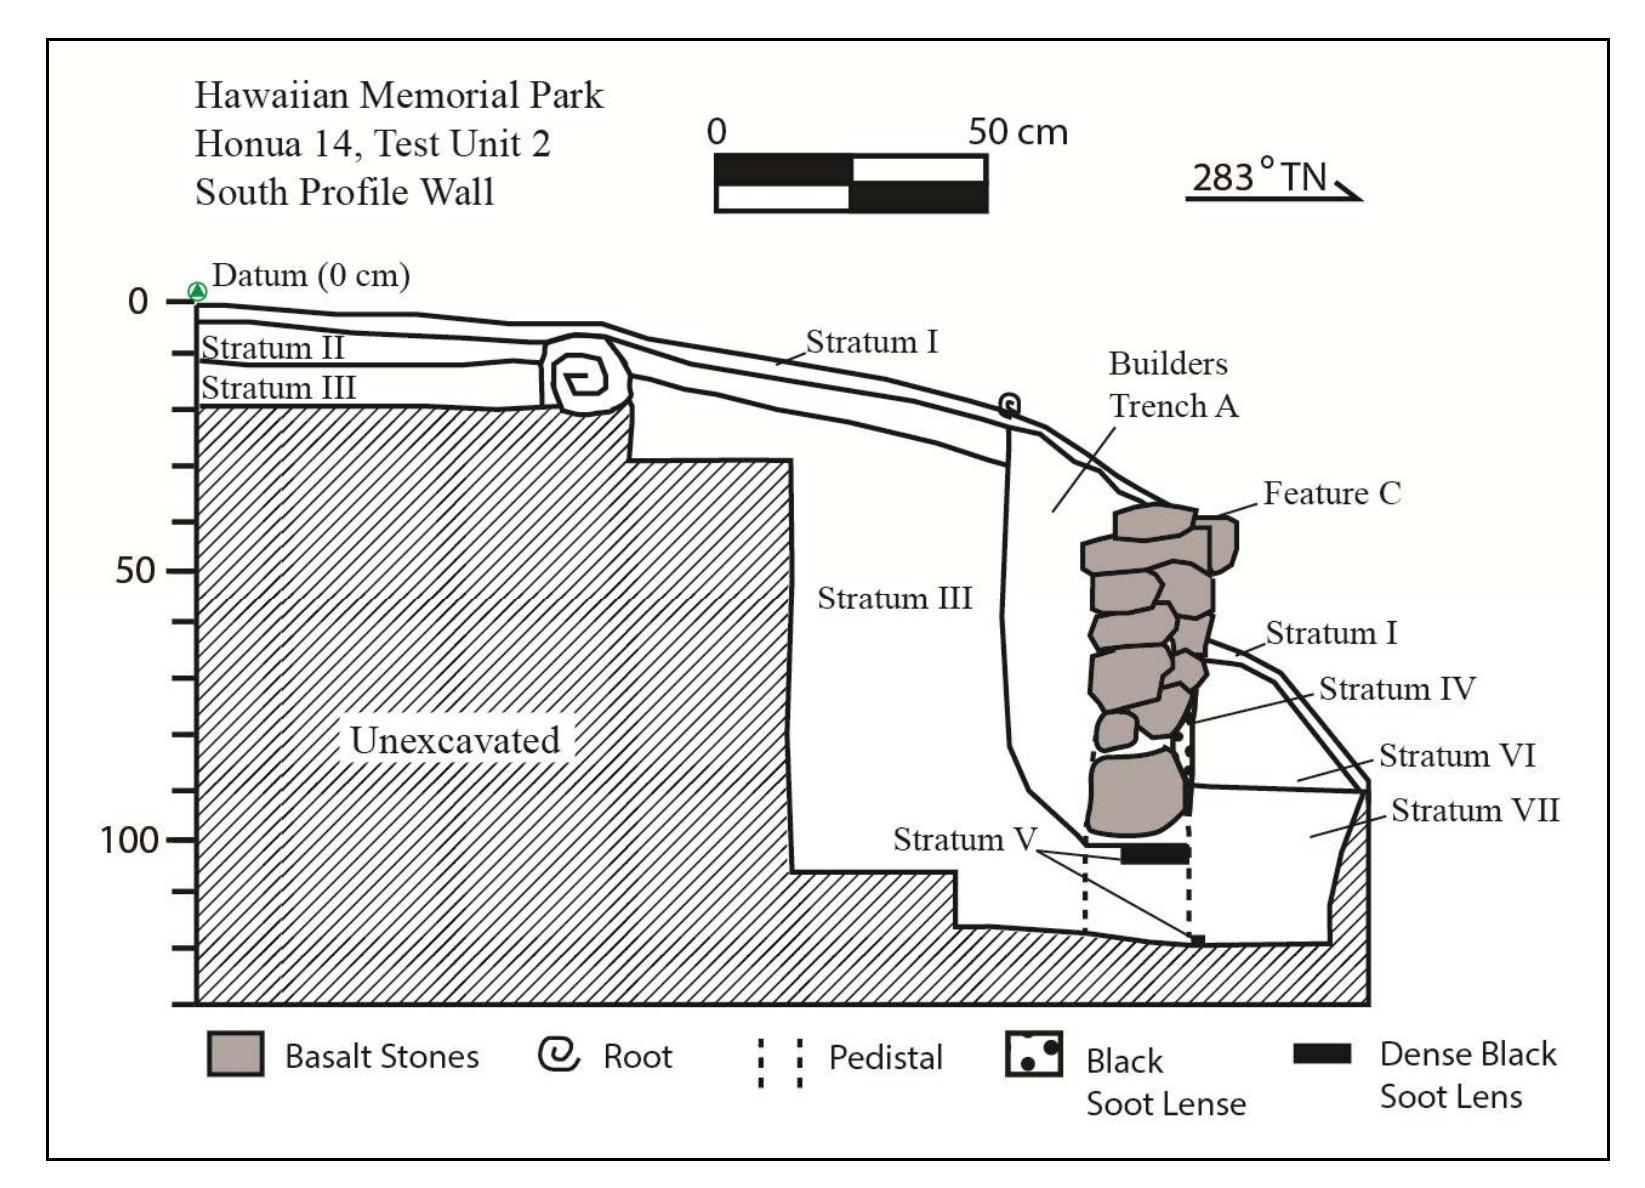
Figure 124. Profile of Honua 14, TU 2 South Excavation Wall

Stratum I (0-3 cmbd) 10 YR 2/2 (very dark brown) silty clay; weak, medium, crumb structure; moist, friable consistency; plastic to slightly plastic; terrigenous, on-site, natural sediment; smooth, diffuse lower boundary; many fine to large roots; contained few fine charcoal fleckings and charred kukui nut shell; thick mat of leaf litter and laua'e and Java Plum roots, modern A Horizon

Stratum II (0-30 cmbd) 7.5 YR 3/4 (dark yellowish brown) silty clay; moderate, medium, crumb structure; moist, friable consistency; slightly plastic; terrigenous, on-site, natural sediment; smooth, clear lower boundary; common fine to medium roots, contained charcoal flecking, Builders Trench A cuts through this stratum; natural hillside sediment

Stratum III (10-118 cmbd, 7.5 YR 4/4 (brown) silty clay, with common mottles of 5 YR 4/6 BOE) (yellowish red) and 7.5 YR 5/6 (strong brown) clay; moderate, medium to coarse, crumb structure; moist, firm consistency; plastic; terrigenous, on-site, natural sterile soil; lower boundary not observed; common fine to medium roots; contained decomposing basalt; natural, sterile C Horizon

Builders Trench A
(22-101 cmbd)
7.5 YR 3/4 (dark brown) silty clay, with mottles of 7.5 YR 6/8
(reddish yellow) and 5 YR 5/8 (yellowish red) clay; weak to moderate, medium, crumb structure; moist, friable consistency; slightly plastic; terrigenous, on-site, secondarily placed sediment; irregular, abrupt to clear lower boundary; common fine to large roots; contained decomposing basalt and common fine to medium charcoal pieces; disturbed hillside sediment used for construction of Feature C (stone wall)

- Stratum IV (70-95 cmbd) 10 YR 10/1 (black) silty clay; moderate, coarse, crumb structure; moist, loose consistency with weak cementation; slightly plastic; terrigenous, culturally-enriched natural sediment; vertical lense with an irregular, abrupt boundary; contains a high amount of soot and charcoal flecking; natural sediment colored black from long exposure to charcoal burning, not as concentrated as Stratum V; adhering to and found within crevices of lower limits of Feature C (stone wall)

- Stratum V (100-103 cmbd) 10YR 2/1 (black) silty clay; moderate, fine, crumb structure; moist, friable to loose consistency; slightly plastic; terrigenous, culturally-enriched natural sediment; smooth, discontiguous, abrupt boundary; contains a high amount of soot and charcoal; natural sediment colored black from long exposure to charcoal burning, adjacent to opening in Feature C (stone wall) interpreted as a likely air vent for the charcoal kiln (Feature E)
