5.2 SIHP # 50-80-09-2268 Waiahole Ditch System/ post-Contact Irrigation Ditch

AIS for the AES West O'ahu Solar Project, Honouliuli, 'Ewa, O'ahu

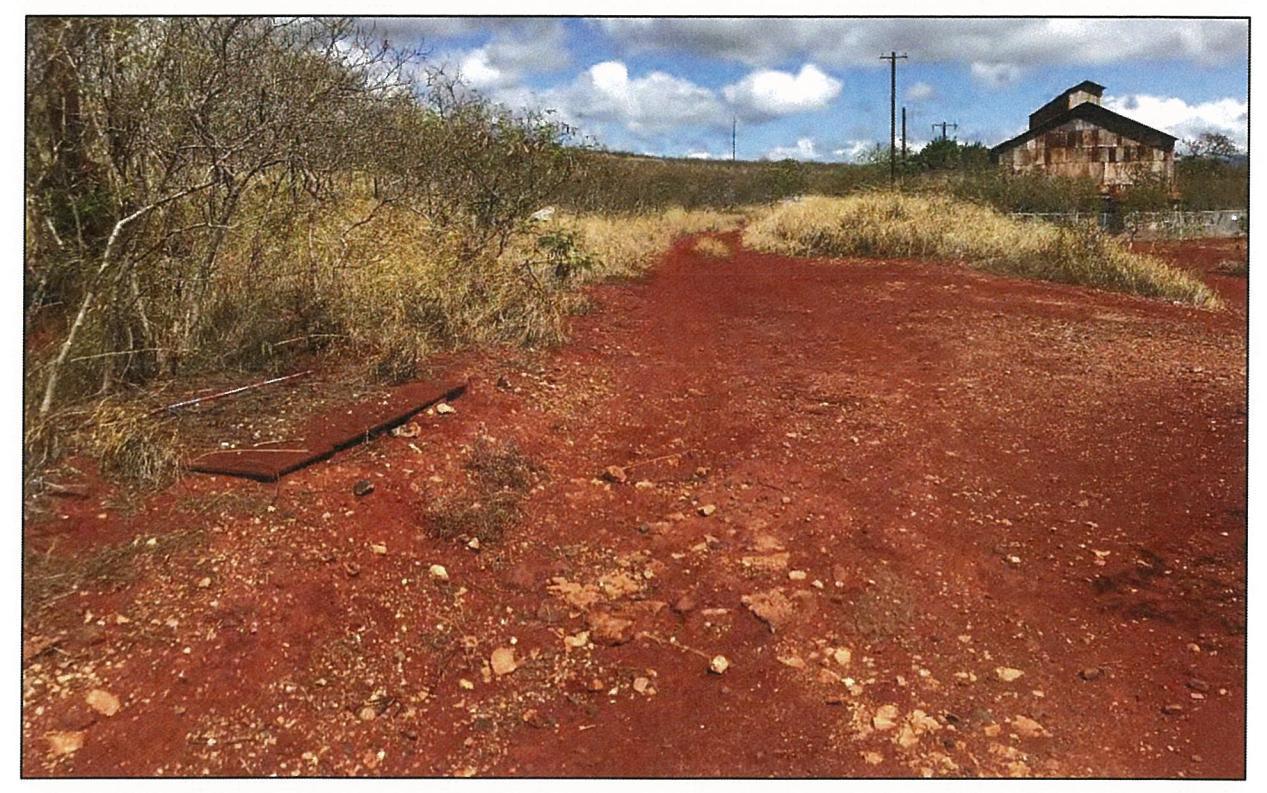
Figure 86. Overview of southern portion of SIHP # 50-80-08-5593 Feature 4D, view to northeast (Photo P; Figure 27)

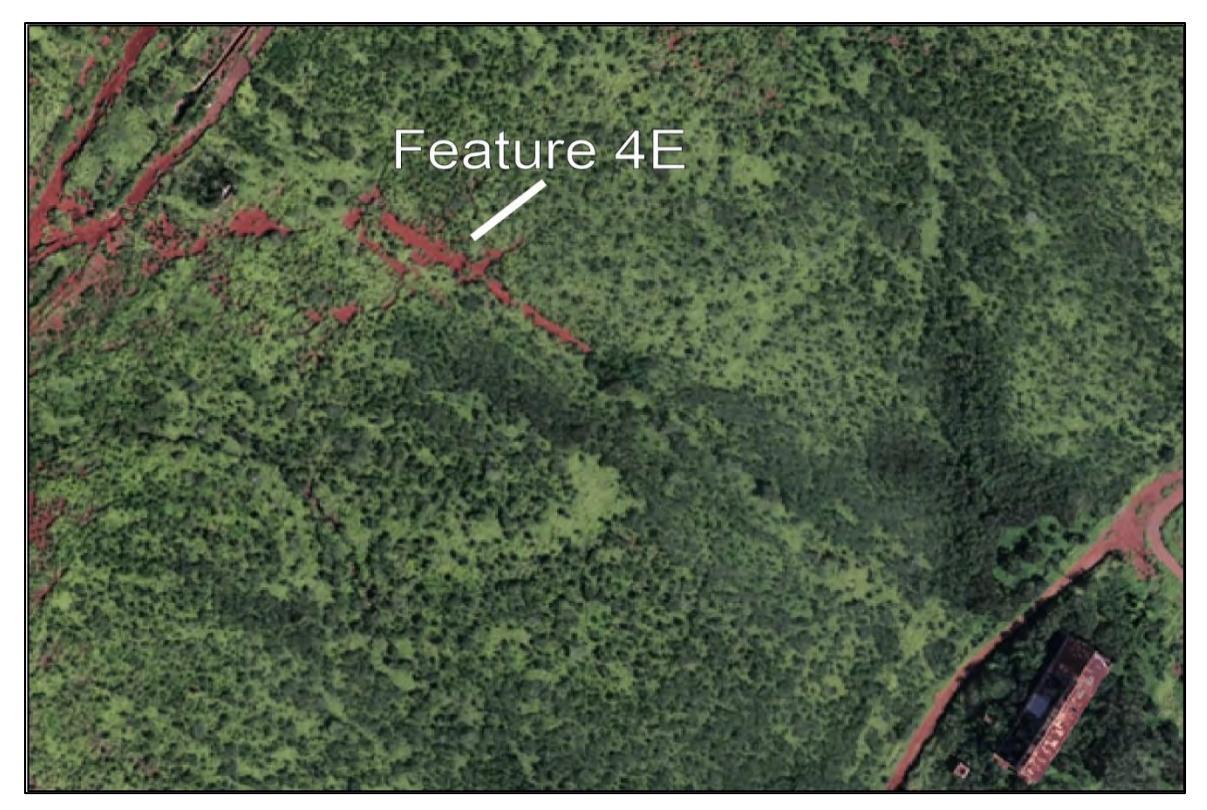
SIHP # 50-80-08-5593 Feature 4E originates at the Waiahole Ditch and extends downslope through the central project area, parallel to a large pipeline connecting the ditch and the mill building at the base of the hill (see Figure 38 and Figure 87). The documented portion of Feature 4E extends for 245.3 m in length and measures on average 6.0 m wide. The road is oriented northwest-southeast and intersects Feature 4F at its northwest end. Feature 4E is immediately adjacent to many of the components of the Feature 2 complex (see Figure 69 and Figure 74). The southern portion of Feature 4E is covered by overgrown vegetation.

Figure 87. Aerial view of SIHP # 50-80-08-5593 Features 4E (Google Earth 2020)

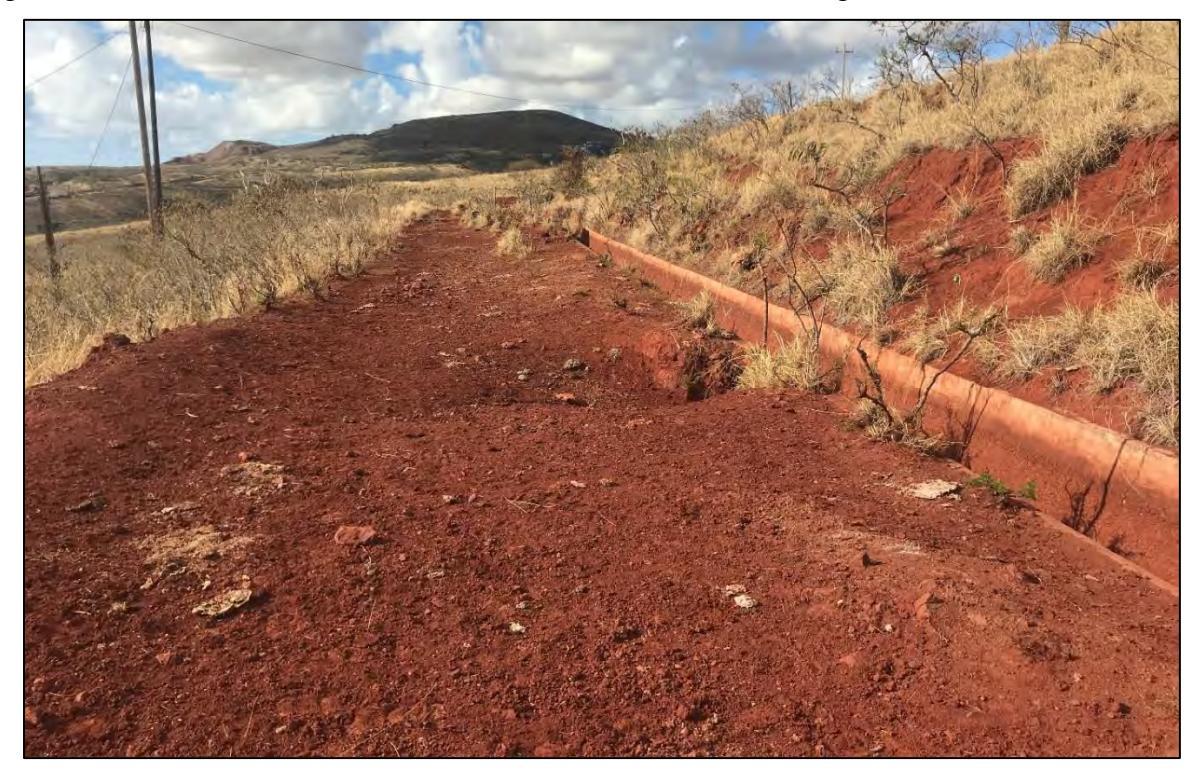
SIHP # 50-80-08-5593 Feature 4F originates north of the northern-most corner of the project area and extends along the edge of the northern boundary before crossing through to the southern project area, generally following the trajectory of the Waiahole Ditch (see Figure 38 and Figure 88). The documented portion of Feature 4F extends for 1344.5 m in length and measures on average 6.0 m wide. The road is generally oriented northeast-southwest, though it winds slightly to follow the contours of the landscape. Feature 4F intersects with Feature 4D at its north end, Feature 4E and Feature 4C within the central project area, and Feature 4B in the southern project area.

Figure 88. Overview of SIHP # 50-80-08-5593 Feature 4F, showing Waiahole Ditch running parallel to the access road (right), view to southwest (Photo Q; Figure 27)

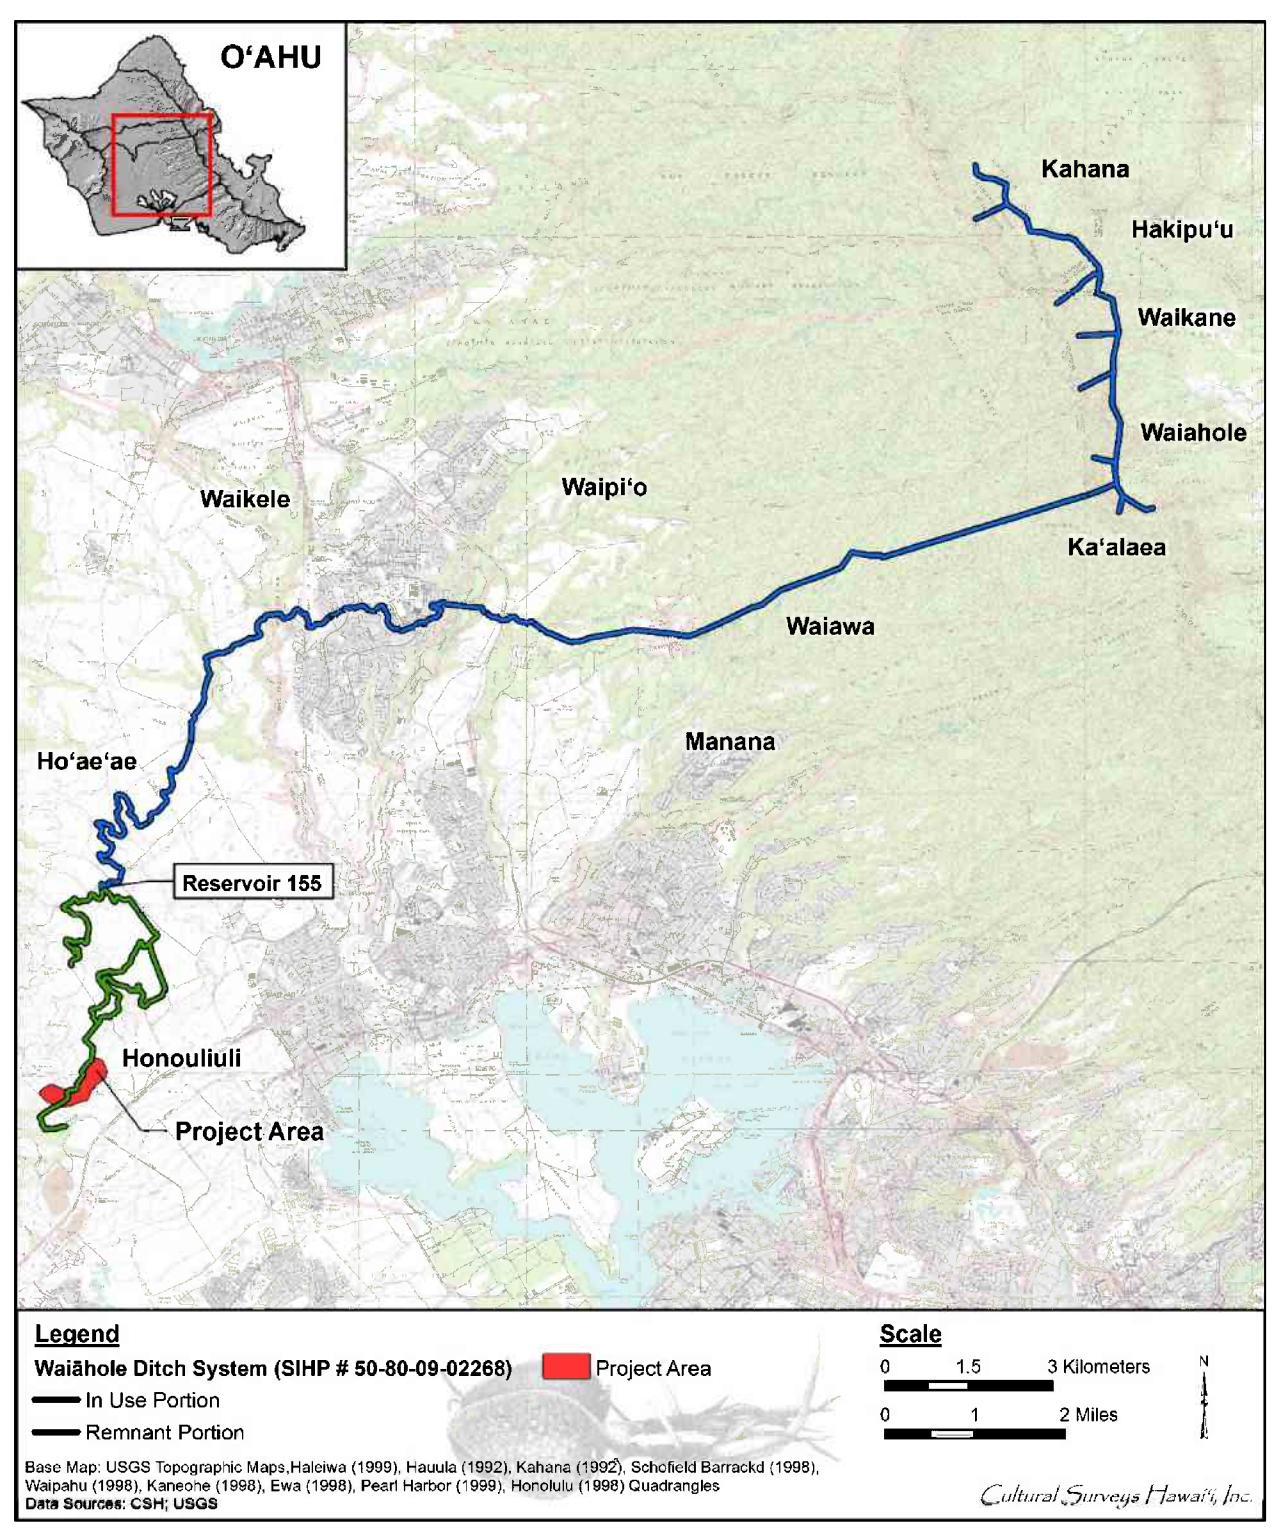
Currently, a portion of the Waiahole Ditch remains active (see Figure 89). This active portion begins on the windward side of the island and terminates at Reservoir 155 in Honouliuli. Various features associated with the active portions of the Waiahole Ditch have been identified, including the reservoirs, flumes, sluices, and siphons (Goodman and Nees 1991; Groza et al. 2014; Hammatt and Borthwick 1988; Hammatt et al. 1996; Tulchin et al. 2009). Descriptions of the in-use stretch of the Waiahole Ditch range from a concrete-lined ditch to only a metal siphon structure crossing over gulches.

Figure 89. Route of the Waiahole Ditch System in relation to the present project area, showing in-use and remnant portions, depicted on a 1992–1999 USGS topographic quadrangle map

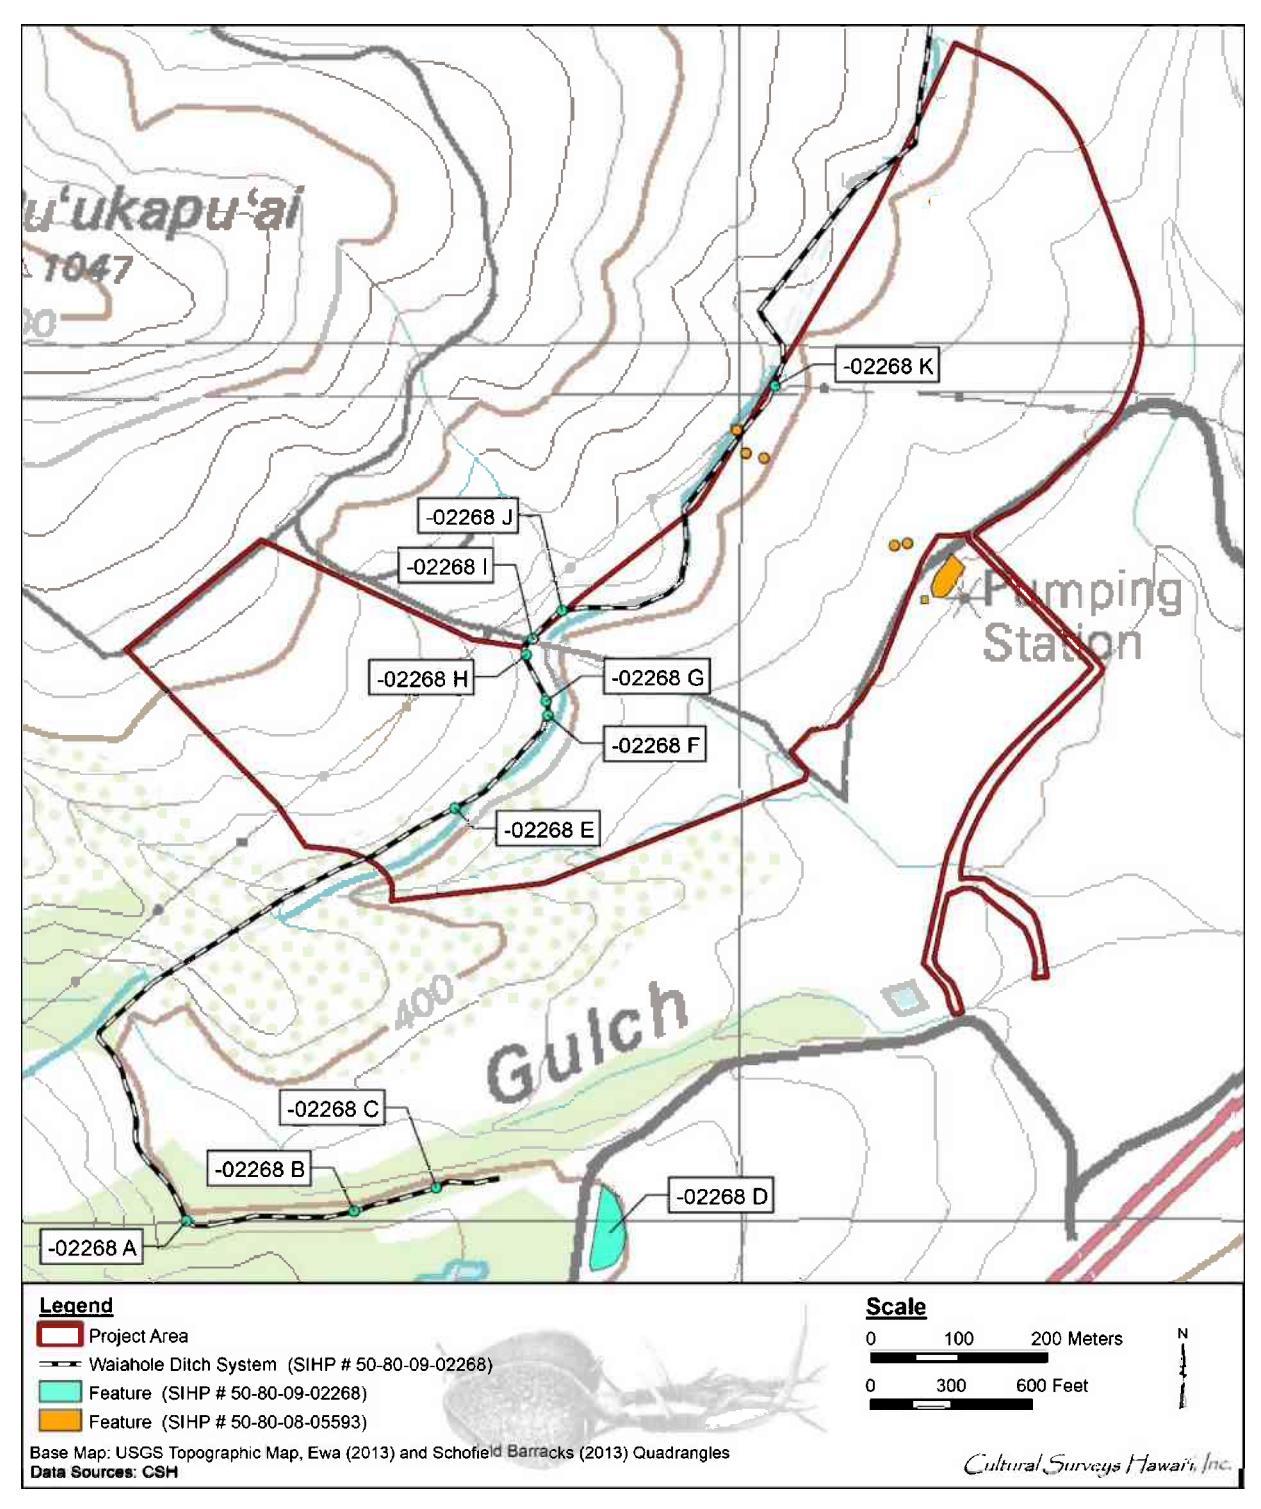
SIHP # 50-80-09-2268 consists of the entire Waiahole Ditch System, a post-Contact irrigation ditch dating from 1916. The historic property spans approximately 22 miles (Figure 89) transporting water from the windward side of the Ko'olau Range through the Ko'olau Range by a system of tunnels, across central O'ahu and on to the 'Ewa Plain (Condé and Best 1973). Approximately 380 linear m of the Waiahole Ditch was identified in the northern and western portions of the project area. The ditch extends along the northern boundary, crossing the central project area as it extends southwest down the natural sloping landscape, exiting the southern boundary and continuing to extend southwest away from the project area (Figure 90).

Figure 90. 2013 Ewa and Schofield Barracks USGS topographic quadrangles with the distribution of portions of SIHP # 50-80-09-2268 Feature A through D (identified in previous studies outside the project area, SIHP # 50-80-09-2268 Feature E through Feature K identified within the current project area

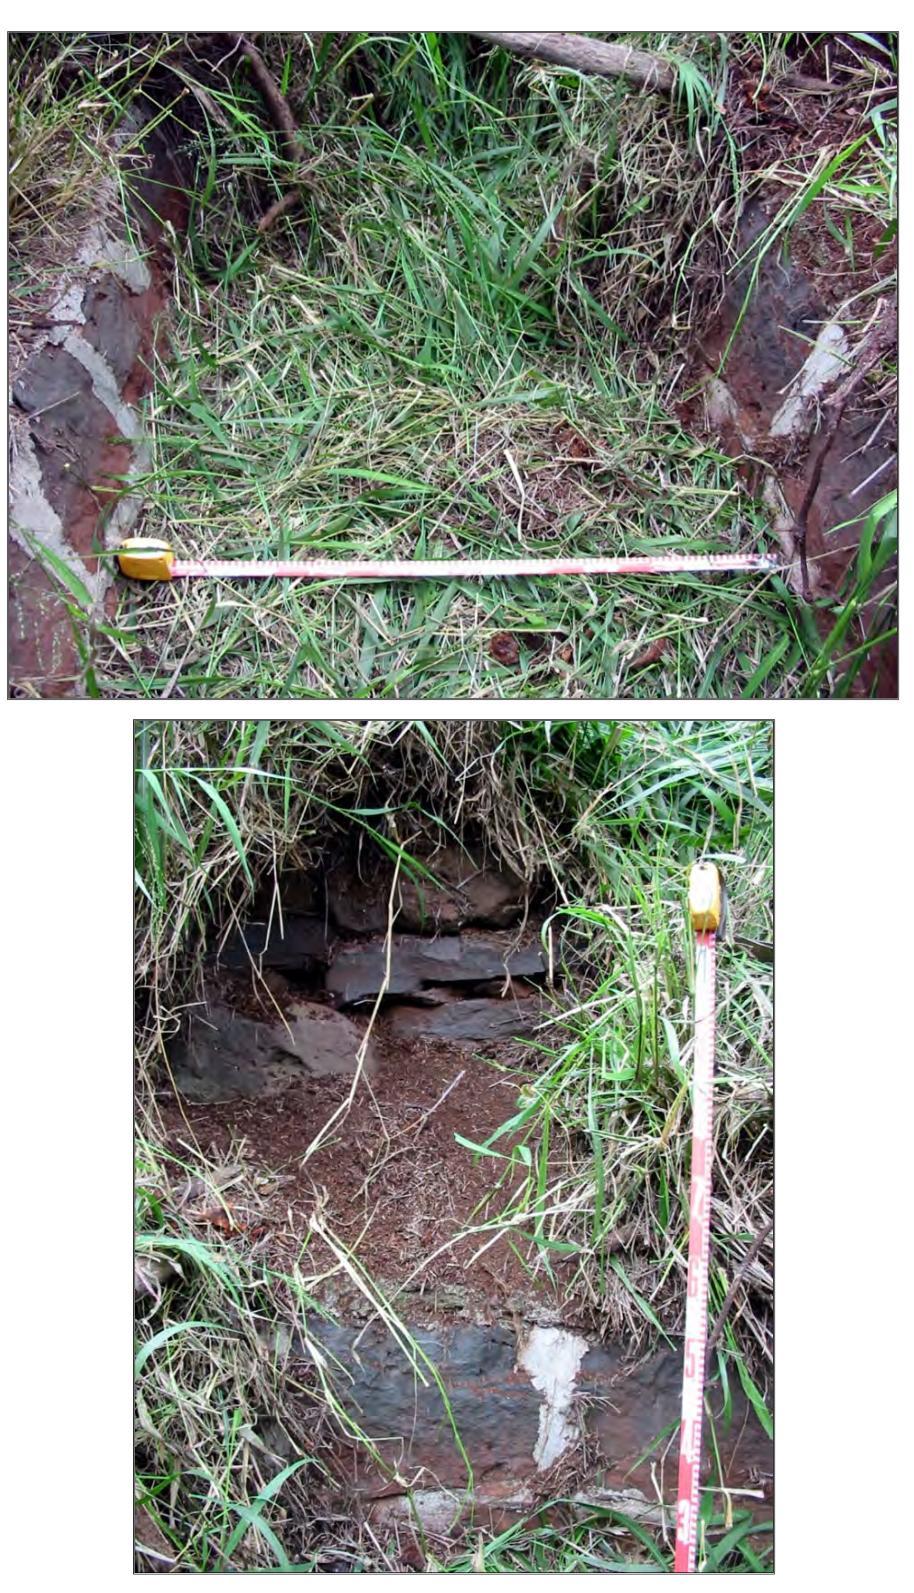
The improved ditch appeared to be constructed in a U-shaped configuration, with a flat bottom and nearly vertical sidewalls. However, heavy sedimentation within the interior of the ditch did not allow for direct observation of the base of the ditch. The main constructed portion of the ditch measured 90 cm [centimeter] wide and 1 m [meter] in height. The sidewalls were of cut basalt stone and mortar construction [present Figure 92]. In areas where the ditch was cut deeply into the slope, loosely stacked basalt boulder and cobble retaining walls were constructed along the top edges of the ditch as necessary. The stones composing the retaining wall appeared to be flaked, likely during the fashioning of cut basalt blocks. [Tulchin and Hammatt 2004:52]

Figure 92. SIHP # 50-80-09-2268 showing the dressed basalt boulder and mortar Waiahole Ditch (top), and stacked basalt boulder and cobble retaining wall (below) (Tulchin and Hammatt 2004:53)

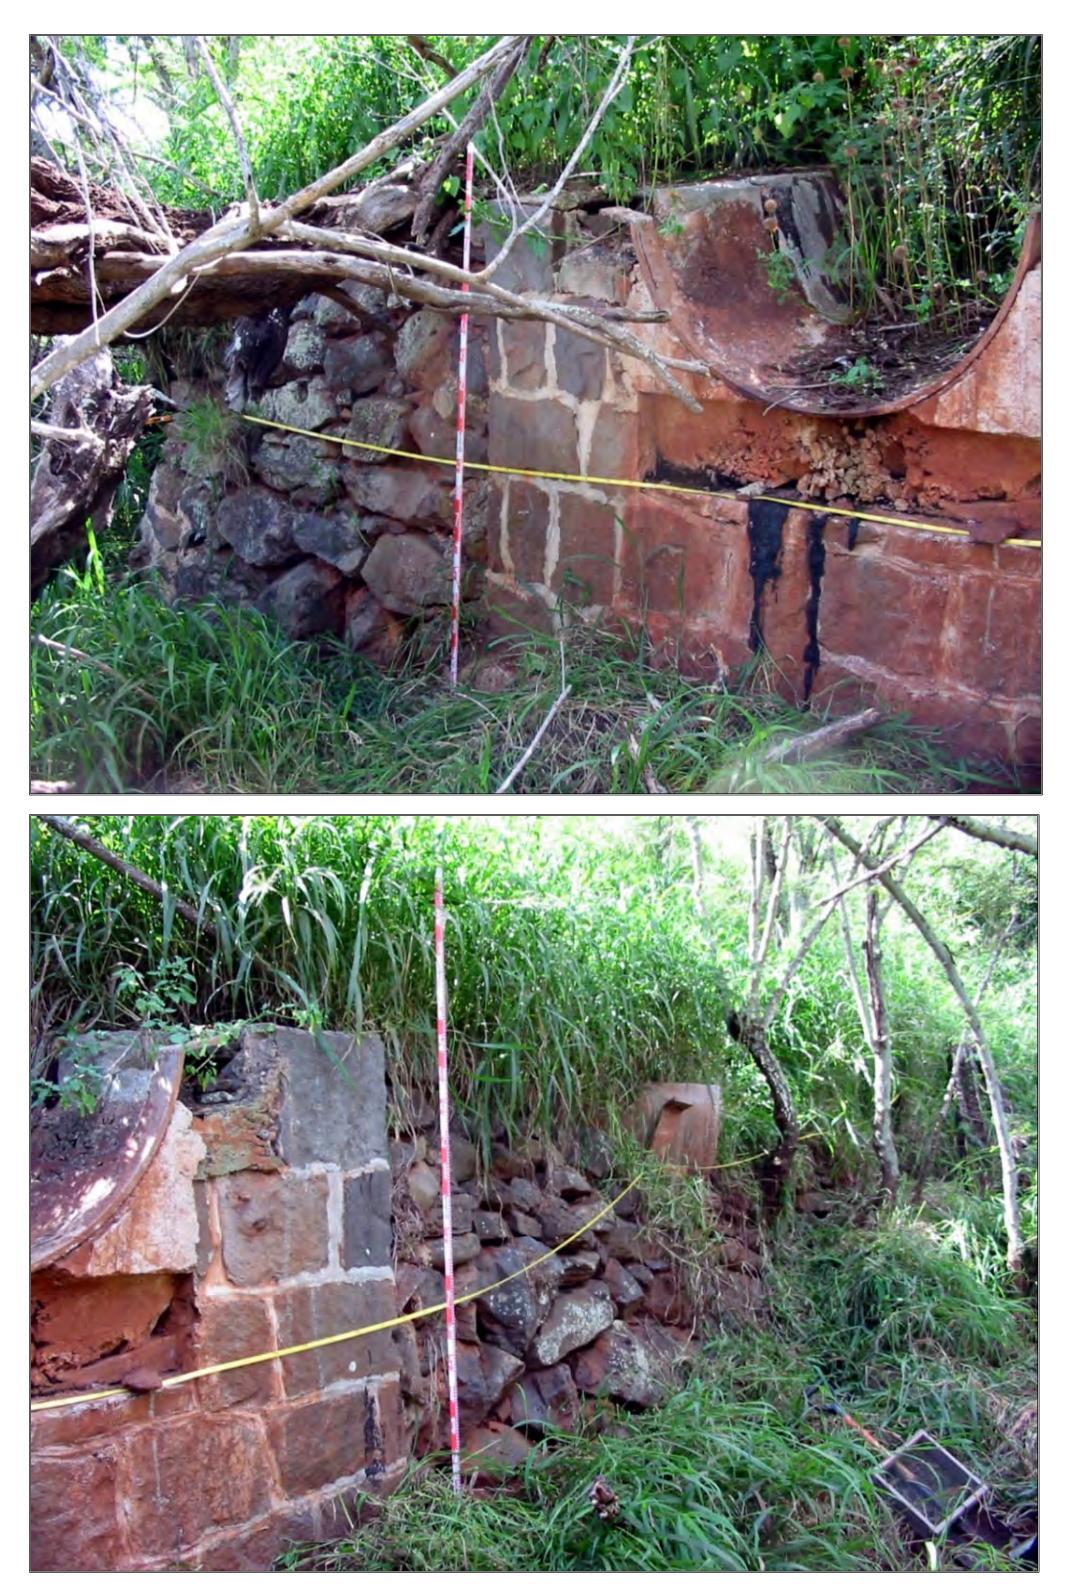
Near the easternmost point of the project area, the ditch crosses an unnamed drainage gully which empties into Kalo'i Gulch. In order to cross the gully, foundations were constructed at each edge of the gully to support a metal flume section spanning the approximately 4.8 m gap. At the time of the inventory survey, the metal flume was not intact, though remnants were observed in the brush in the immediate vicinity of the structure. Each foundation consisted of a central portion constructed of cut basalt boulders and mortar, measuring 2.8 m wide and a maximum height of 1.8 m [Figure 94 and Figure 93]. In addition to the central stone and mortar constructed portion, additional stacked basalt boulder and cobble retaining walls were constructed along the edges of the gully both up and down slope of the main ditch foundation. The retaining walls extended approximately 7.2 m upslope and 3.4 m down slope of the main ditch foundation. The stones were stacked a maximum of 7-8 courses high, with a maximum height of 2.2 m. The retaining walls were generally constructed of loosely stacked stones, though mortar was observed at the interface between the retaining wall and the ditch foundation, as well as at the down slope terminus of the retaining wall. Wooden fence posts with attached barbed wire were observed to run along the top of the retaining walls and over the ditch foundations. [Tulchin and Hammatt 2004:52]

Figure 93. Showing the eastern (top, view to east) and western (bottom, view to south) ends of the southern portion of SIHP # 50-80-09-2268 Feature A: flume bridge (Tulchin and Hammatt 2004:55)

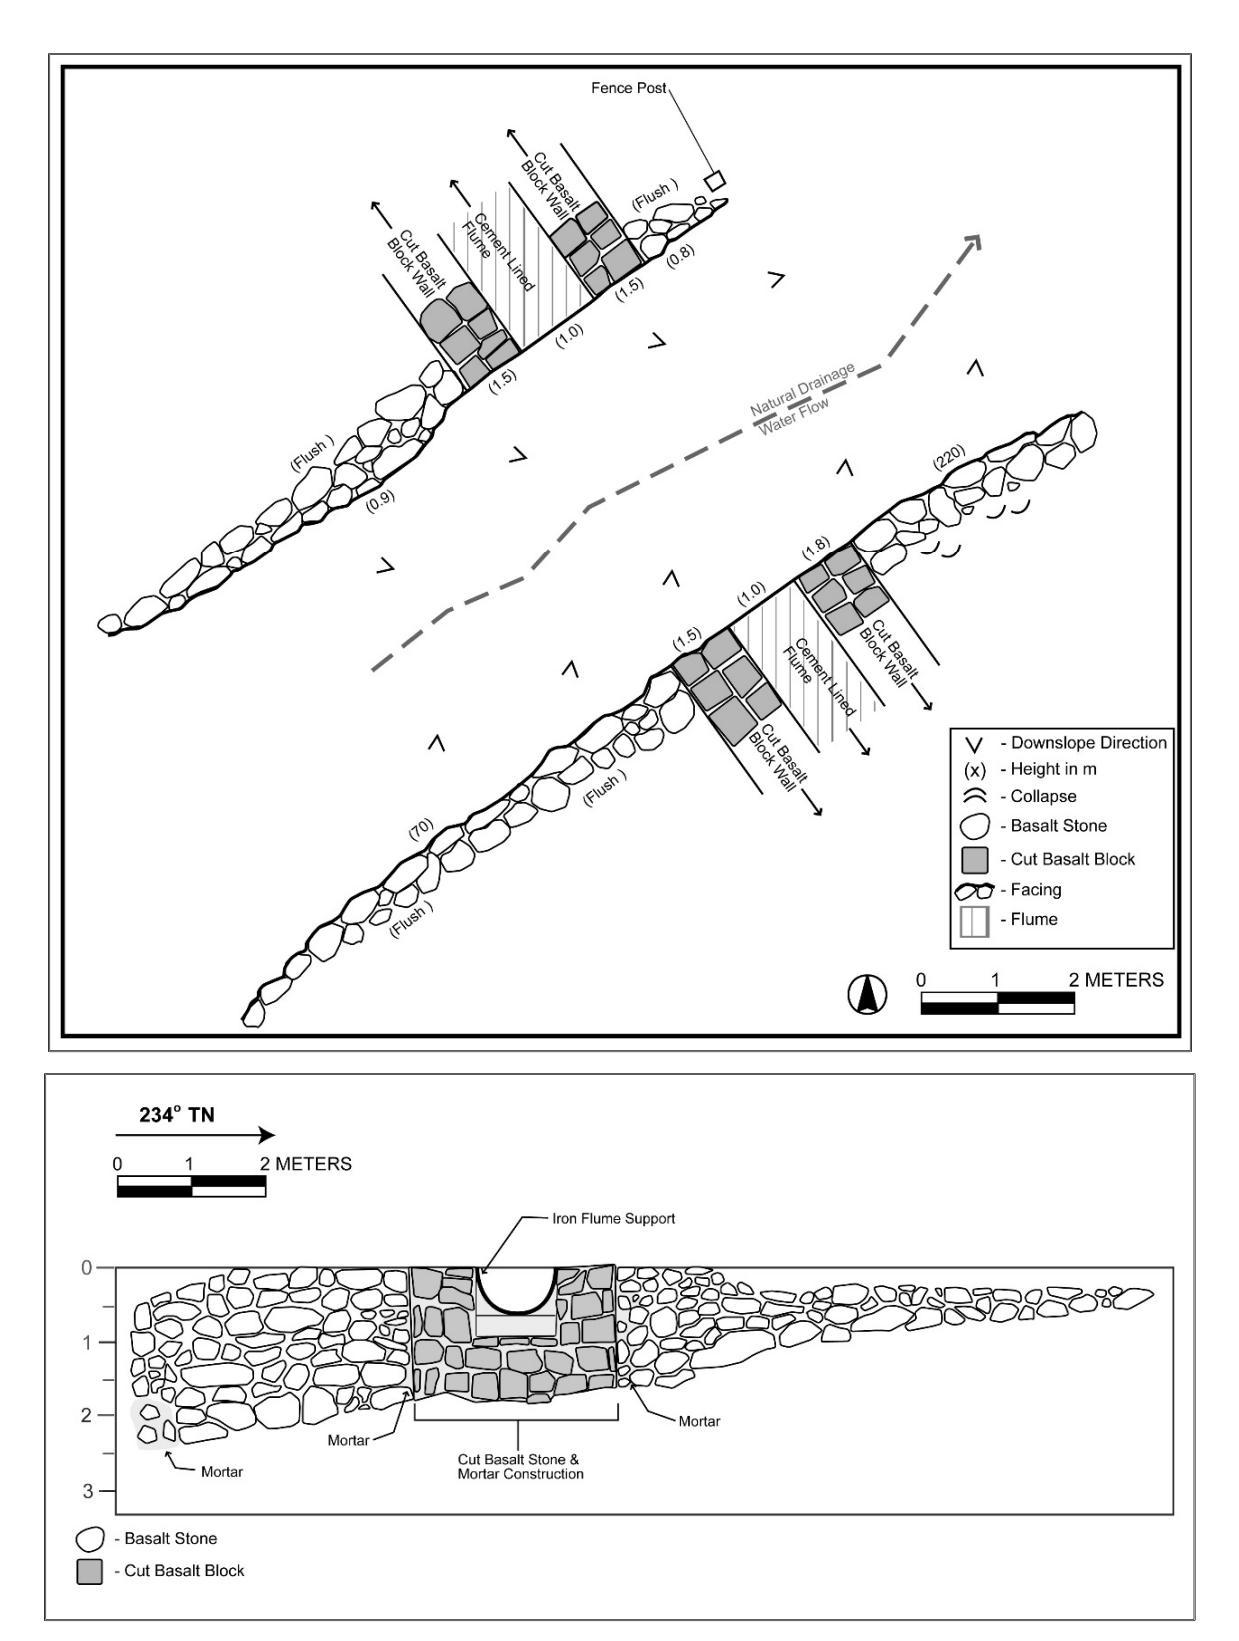
Figure 94. Plan view diagram (top) and profile (bottom) of SIHP # 50-80-09-2268 Feature A: flume bridge (Tulchin and Hammatt 2004:54)

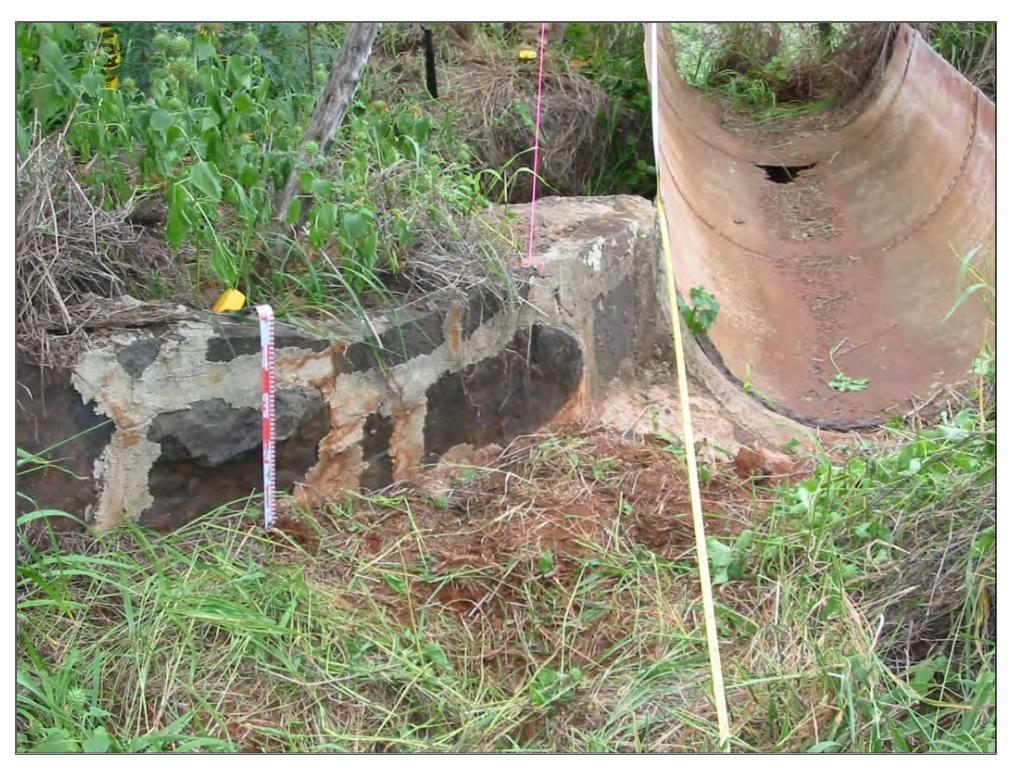
Feature B is an improved drainage channel and short flume section. Feature B is located in the central portion of the project area, where the Waiāhole Ditch crosses a small drainage channel along the Kalo'i Gulch slope. The drainage channel appears to have been improved by excavation of loose soil and stones to improve water flow. Feature B consists of a metal half-pipe flume section constructed over the Waiāhole Ditch [Figure 97 and Figure 98]. The metal flume is constructed of three (3) riveted sections of U-shaped sheets of iron. The flume is oriented perpendicular to the ditch, with the upslope end of the flume located in the center of the drainage channel. The flume is supported on the upslope end by a stone and mortar foundation and retaining walls that direct the water flow from the drainage channel into the flume [Figure 95]. The central portion of the flume is supported by wooden support beams and crossed with wooden cross beams. The down slope portion of the flume rests on the soil berm down slope of the ditch, with a stackedstone retaining wall constructed along the berm in the vicinity of the flume. Down slope of the end of the metal flume section are remnants of a wooden flume that likely connected to the end of the metal flume [Figure 96]. Feature B functions as a drainage improvement associated with the Waiāhole Ditch. The flume collects storm water from an improved drainage channel and transports the water over the ditch and down the gulch slope, thereby reducing damage to and sedimentation of the ditch during periods of heavy rainfall. [Hunkin and Hammatt 2009:47]

Figure 95. SIHP # 50-80-09-2268 Feature B, showing stone and mortar flume support foundation, view to north (Hunkin and Hammatt 2009:50)

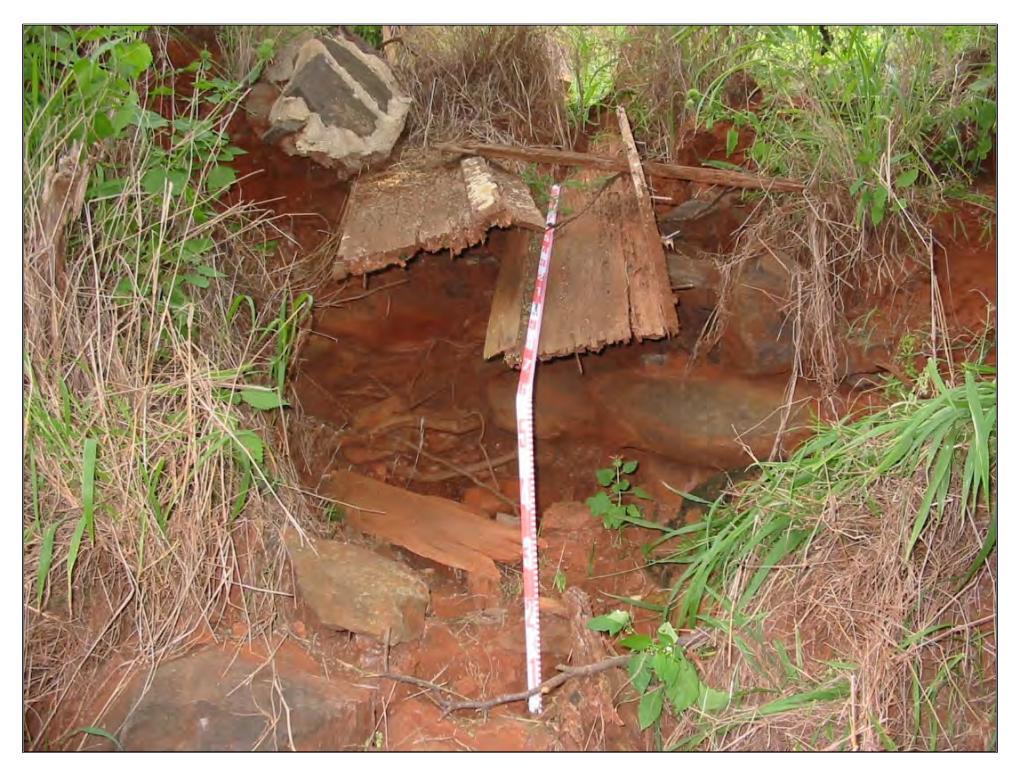
Figure 96. SIHP # 50-80-09-2268 Feature B flume, showing wooden flume extension (Hunkin and Hammatt 2009:50), view to southeast

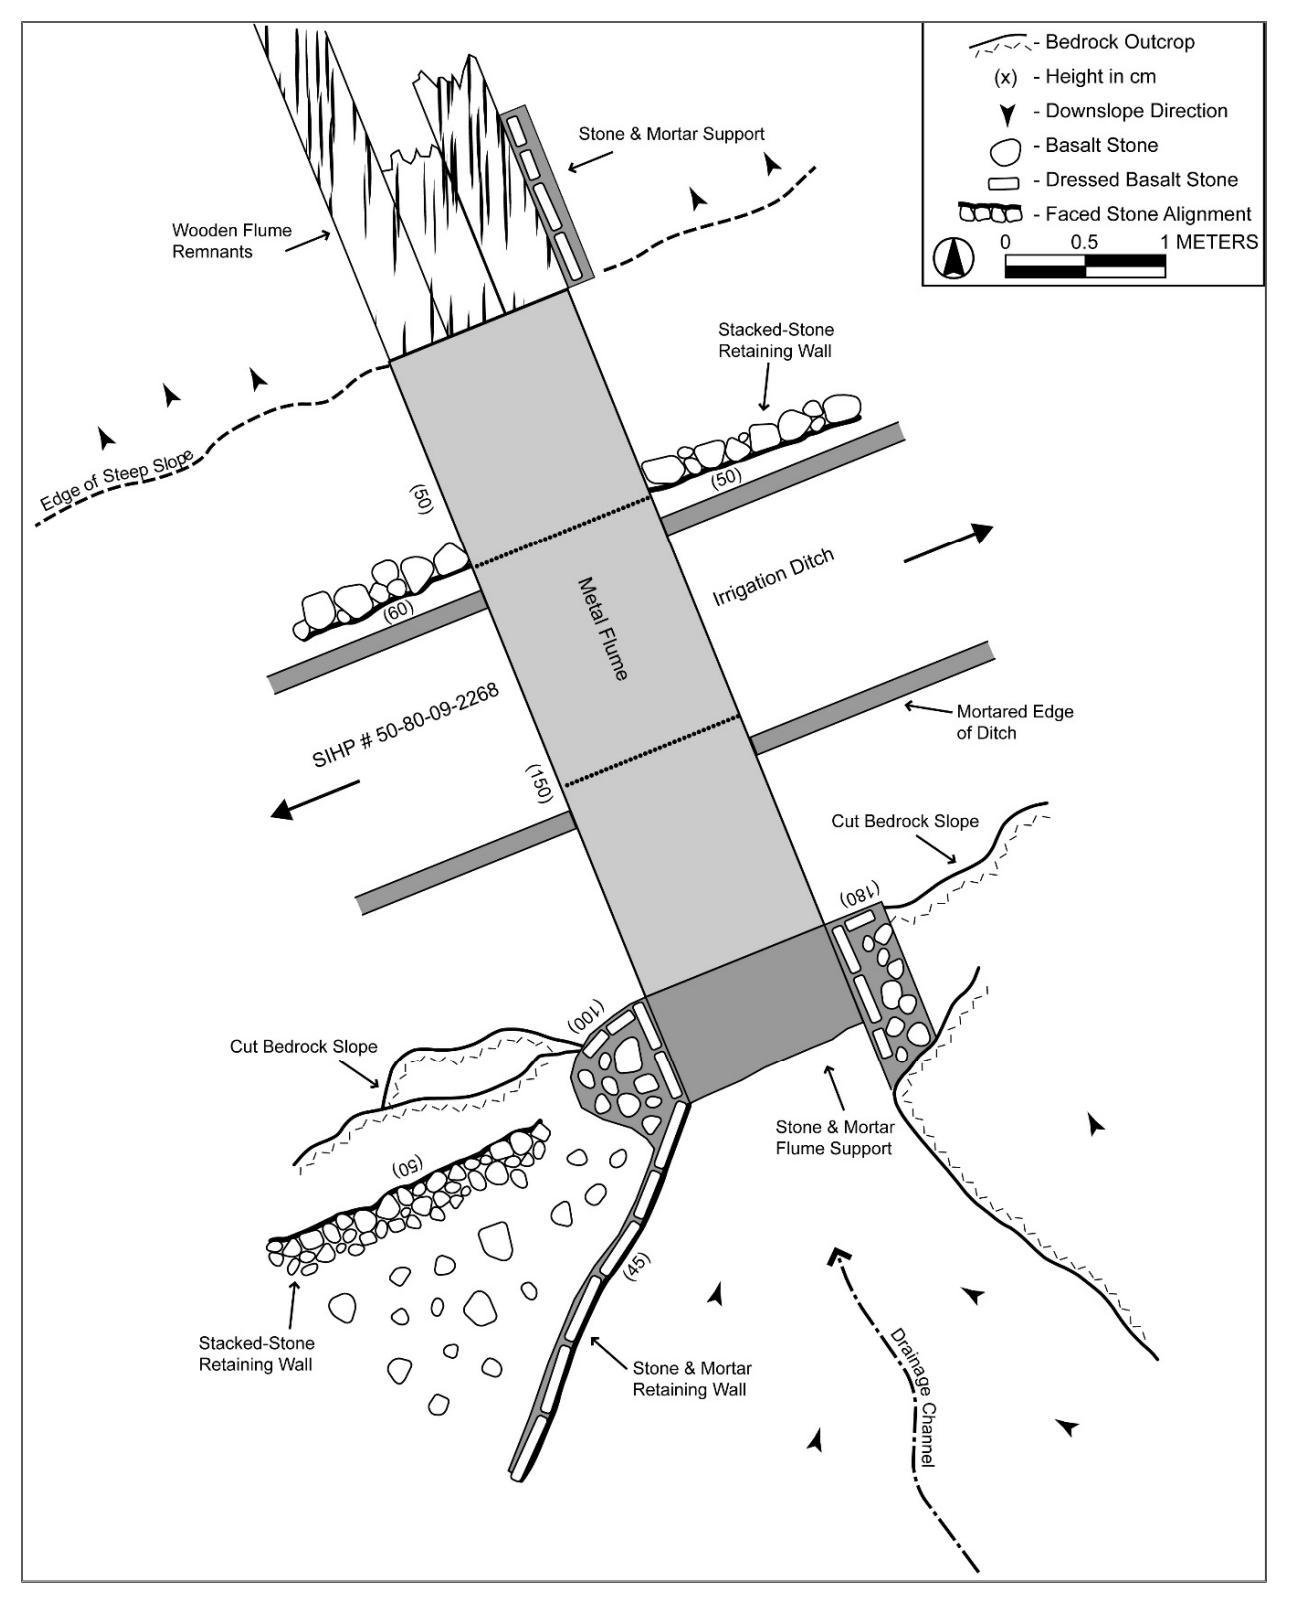
Figure 97. Plan view of SIHP # 50-80-09-2268 Feature B (Hunkin and Hammatt 2009:48)

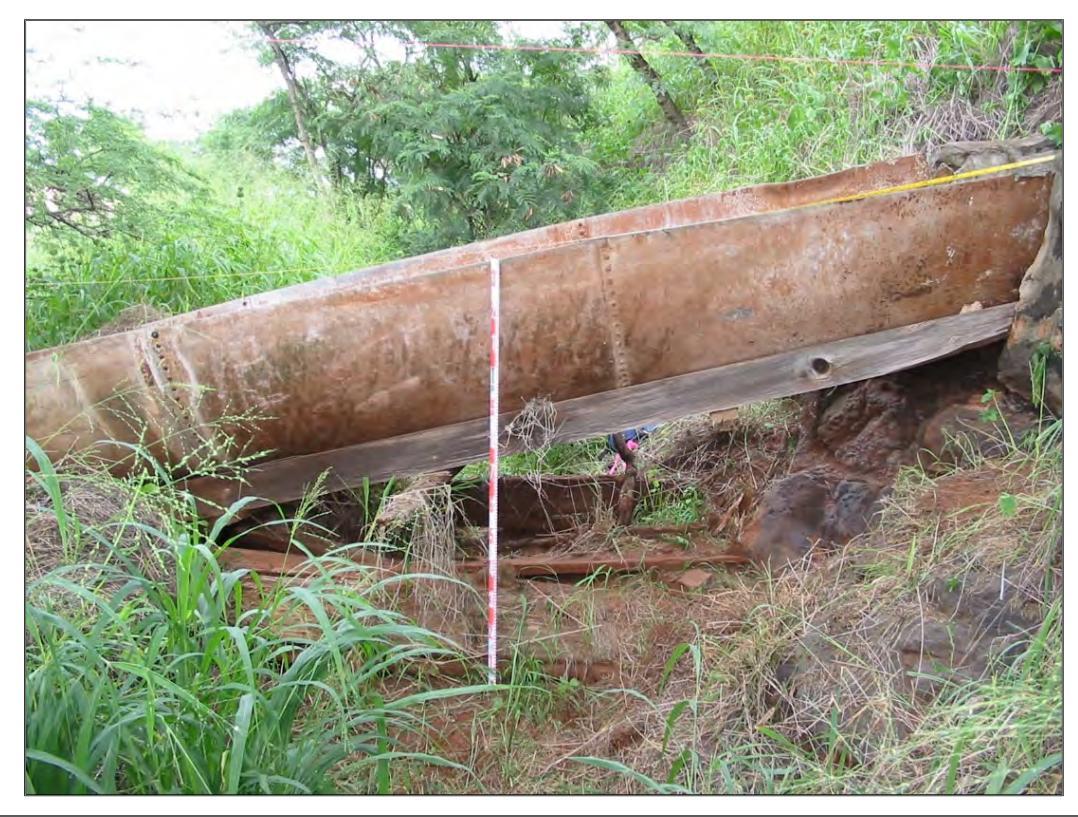
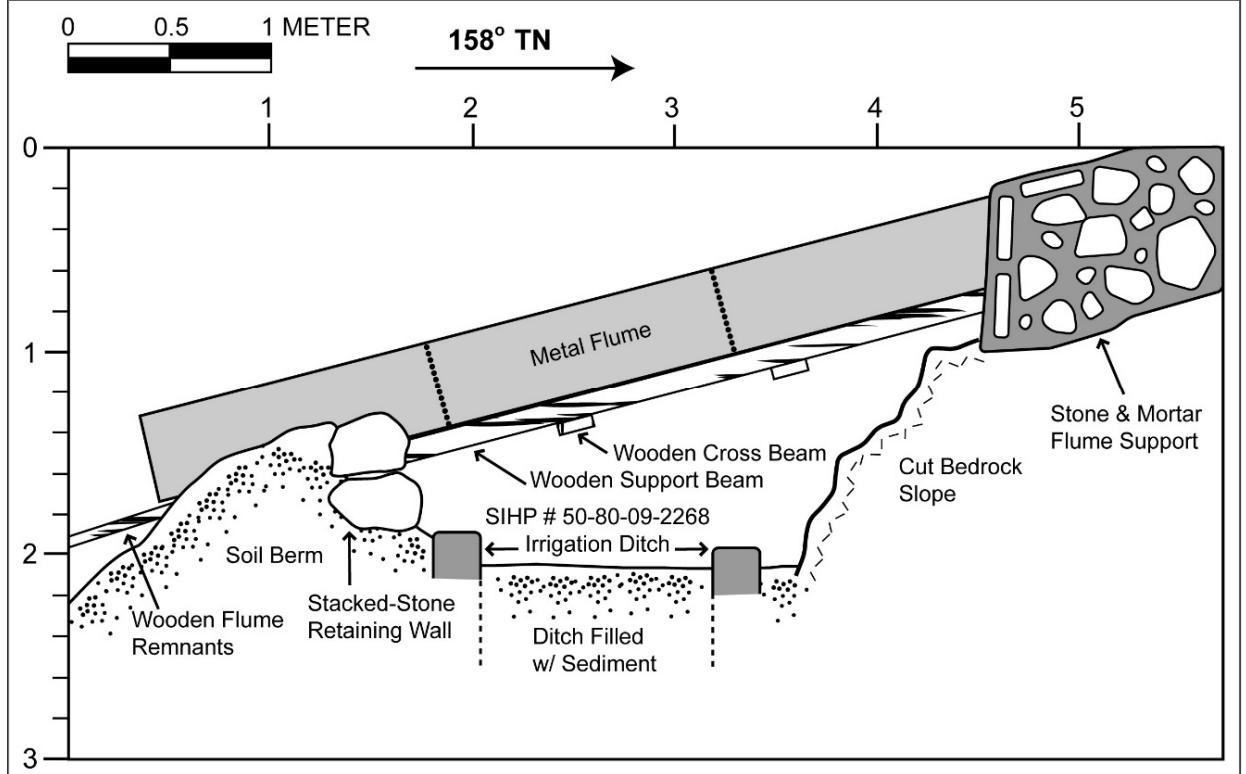
Figure 98. Photograph (top, view to east) and cross-section map (bottom) of SIHP # 50-80-09-2268 Feature B flume (Hunkin and Hammatt 2009:49)

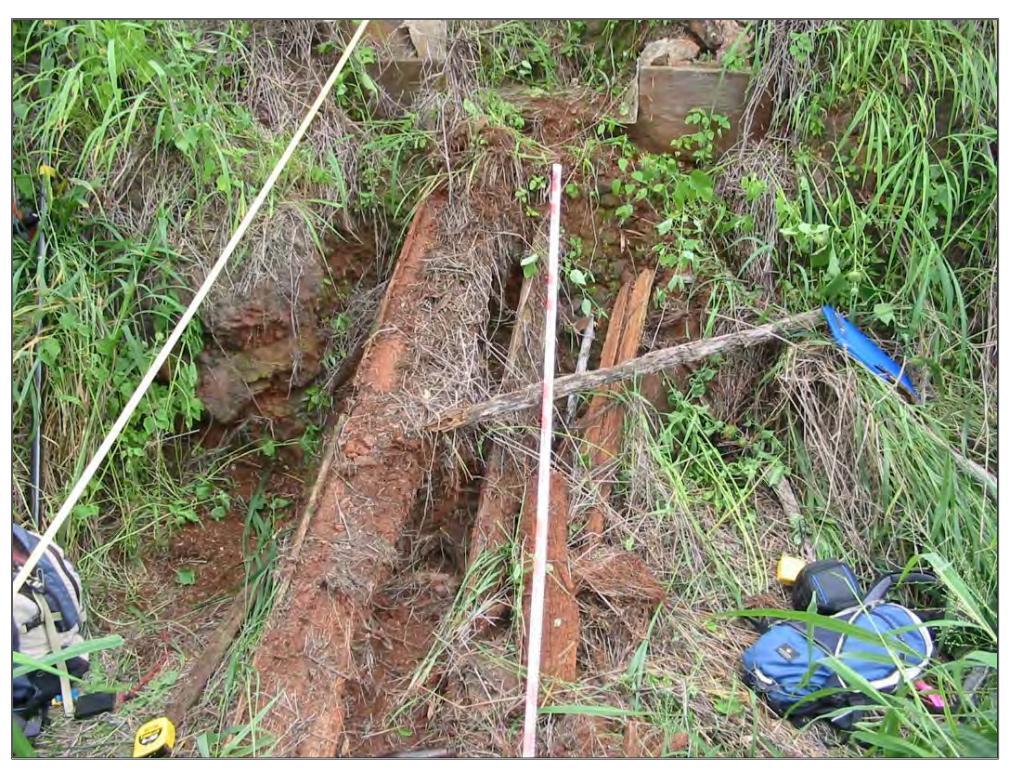
Feature C is an improved drainage channel and short flume section, similar to Feature B. Feature C is located where the Waiahole Ditch crosses a small drainage channel, approximately 100 m east of Feature B. The drainage channel appears to have been improved by excavation of loose soil and stones to improve water flow. Feature C consists of a wooden U-shaped flume section constructed over the Waiahole Ditch (Figure 101 through Figure 100). The flume is oriented perpendicular to the ditch, with the upslope end of the flume located in the center of the drainage channel. The flume is supported on the upslope end by a stone and mortar foundation and retaining walls that direct the water flow from the drainage channel into the flume. The downslope portion of the flume rests on the soil berm downslope of the ditch. Feature C functions as a drainage improvement associated with the Waiahole Ditch. The flume collects storm water from an improved drainage channel and transports the water over the ditch and down the gulch slope, thereby reducing damage to and sedimentation of the ditch during periods of heavy rainfall. Due to its wooden construction, much of the Feature C flume has deteriorated. [Hunkin and Hammatt 2009:47]

Figure 99. SIHP # 50-80-09-2268 Feature C, view to south (Hunkin and Hammatt 2009:52)

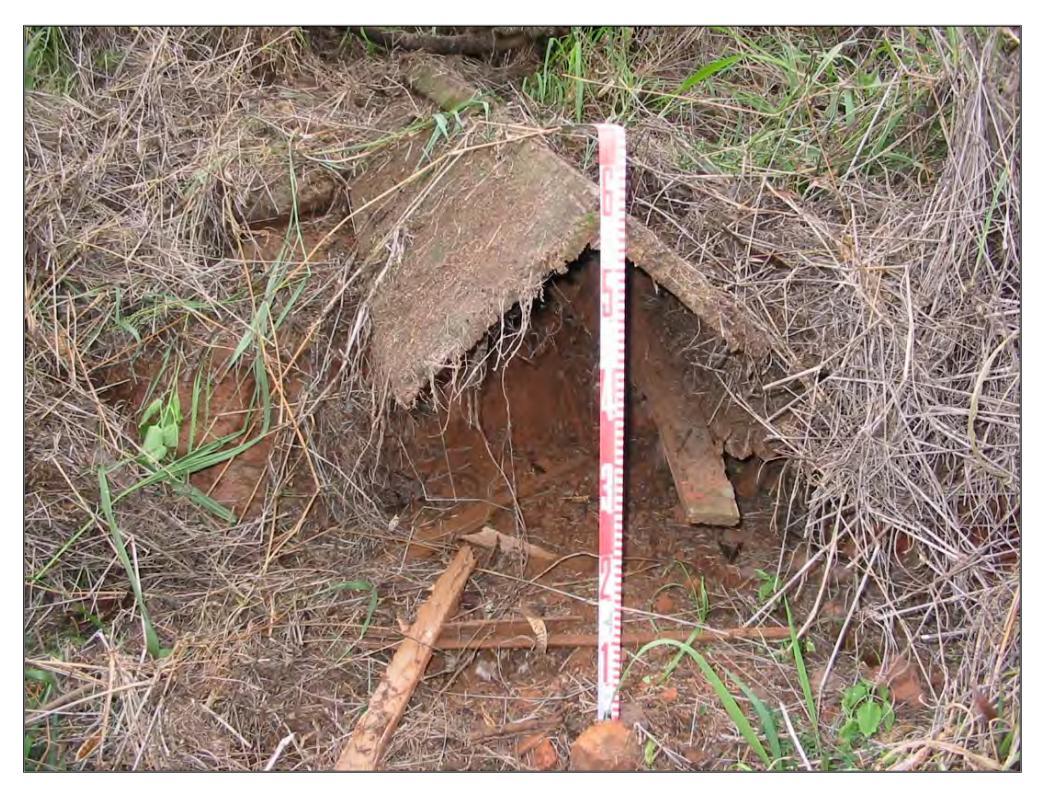
Figure 100. SIHP # 50-80-09-2268 Feature C, showing partially intact wooden flume section, view to south (Hunkin and Hammatt 2009:52)
