5.2 SIHP # 50-80-09-2268 Waiahole Ditch System/ post-Contact Irrigation Ditch

AIS for the AES West O'ahu Solar Project, Honouliuli, 'Ewa, O'ahu

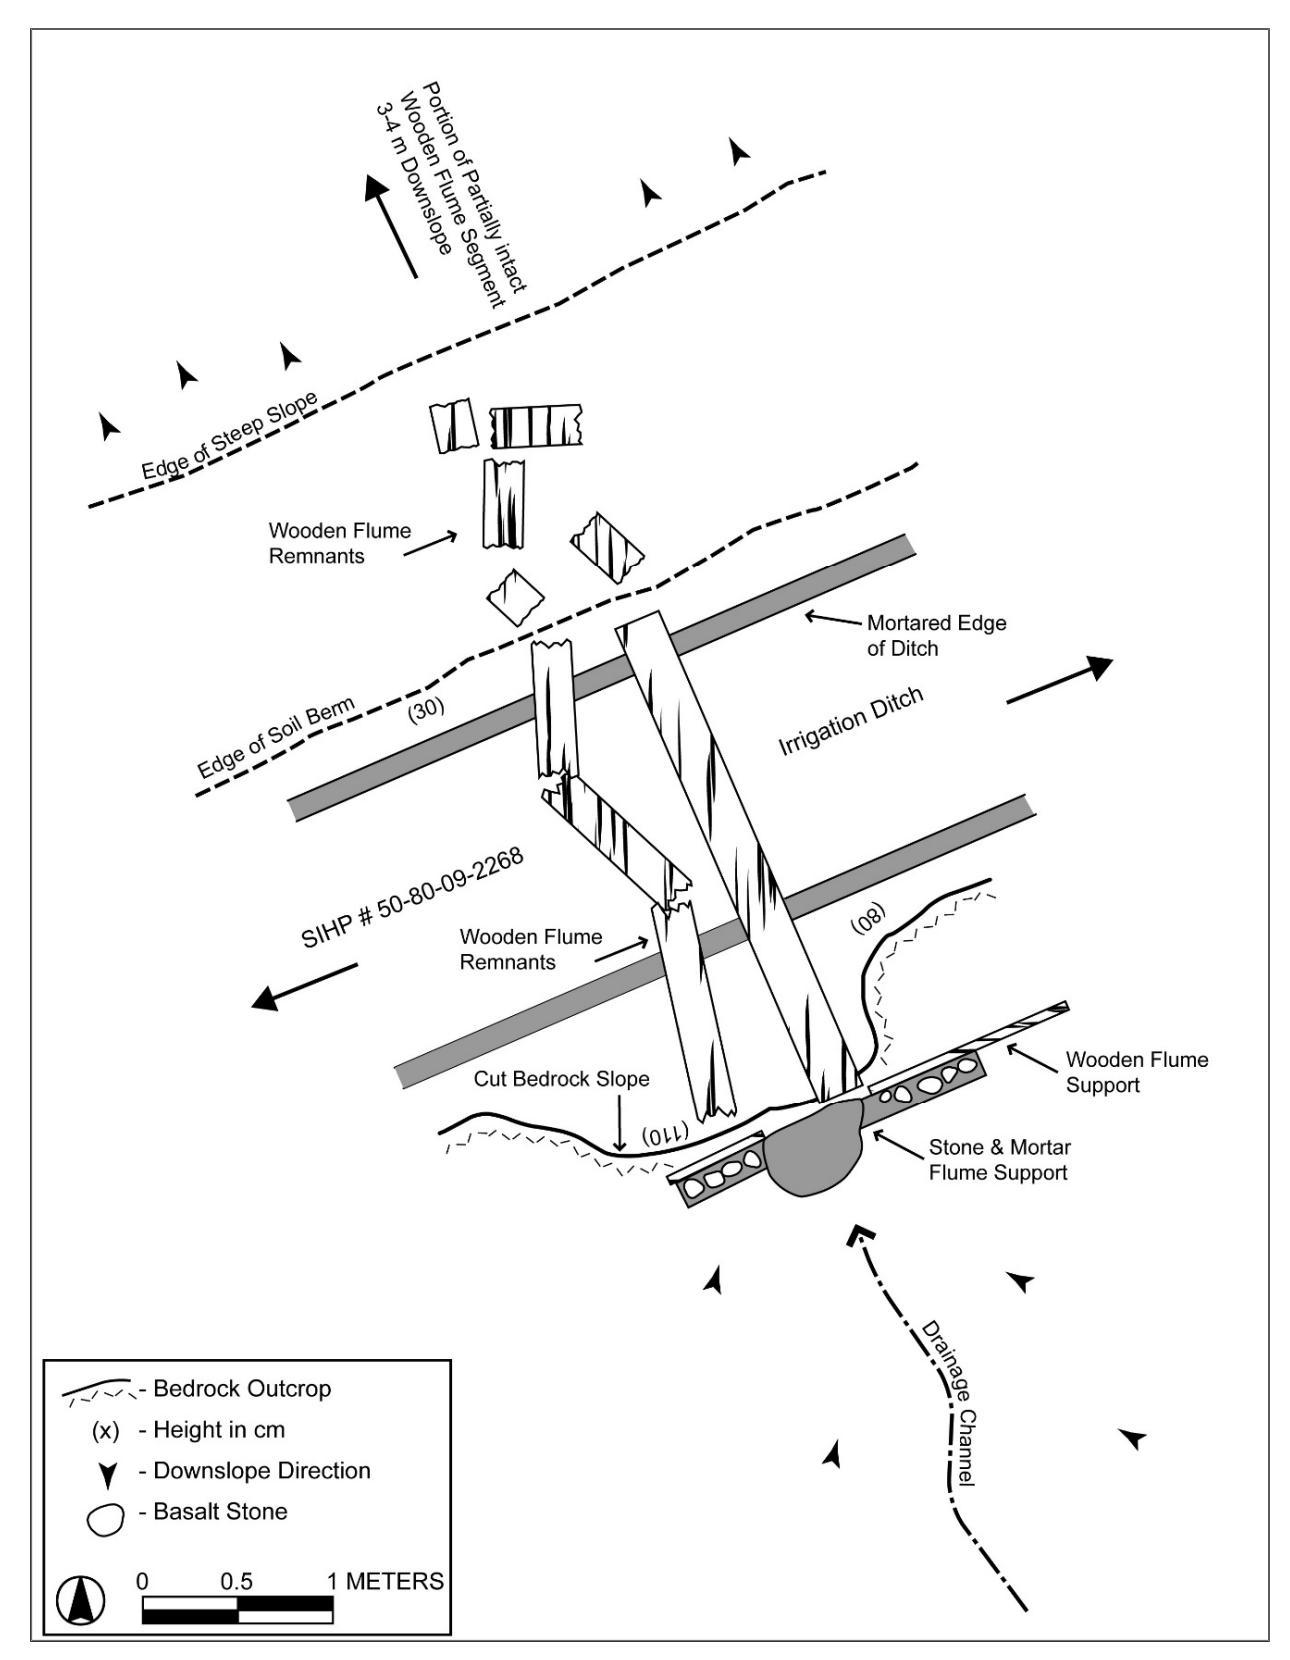
Figure 101. Plan view of SIHP # 50-80-09-2268 Feature C (Hunkin and Hammatt 2009:51)

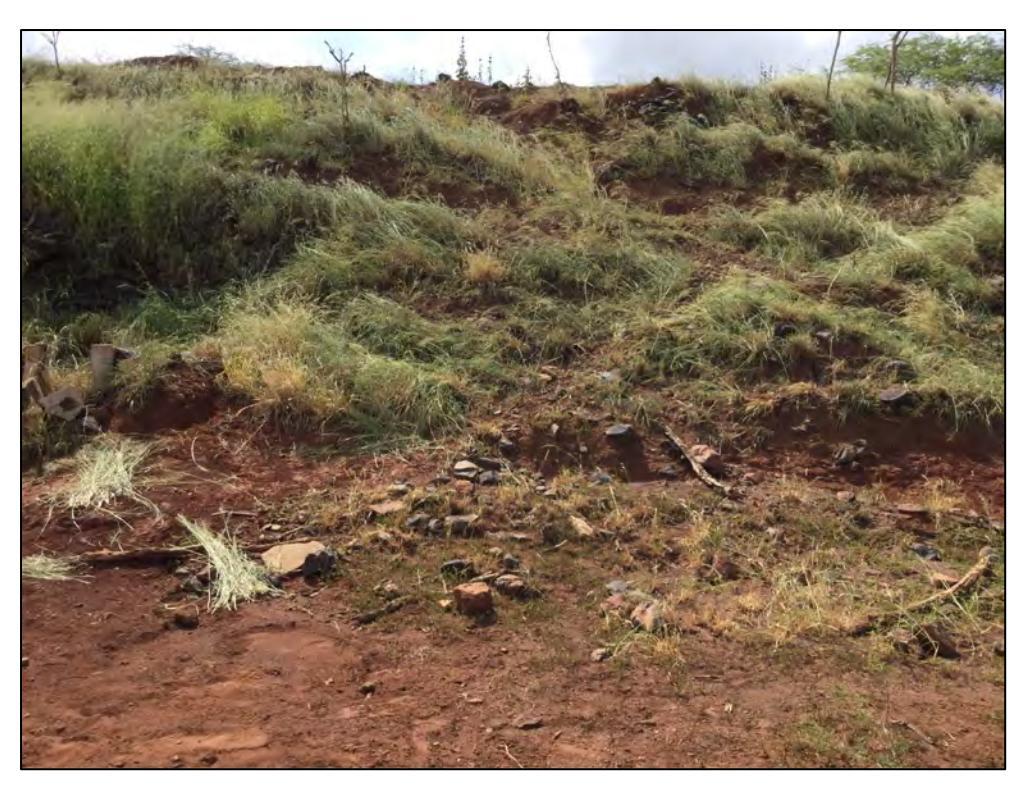
The newly identified Feature D is a large earthen mound and stacked stone wall [Figure 102 and Figure 103] located in the northeastern portion of the project area running adjacent to SIHP # 50-80-12-6951 and is likely the remnants of the reservoir that can be seen on historic maps at the terminus of the Waiahole Ditch System...Sometime after 1977, the reservoir was filled in with sediment resulting in the current state of Feature D. [draft Zapor et al. 2018:76]

Figure 102. SIHP # 50-80-09-2268 Feature D, earthen mound, view to southwest (Zapor et al. 2018:79)

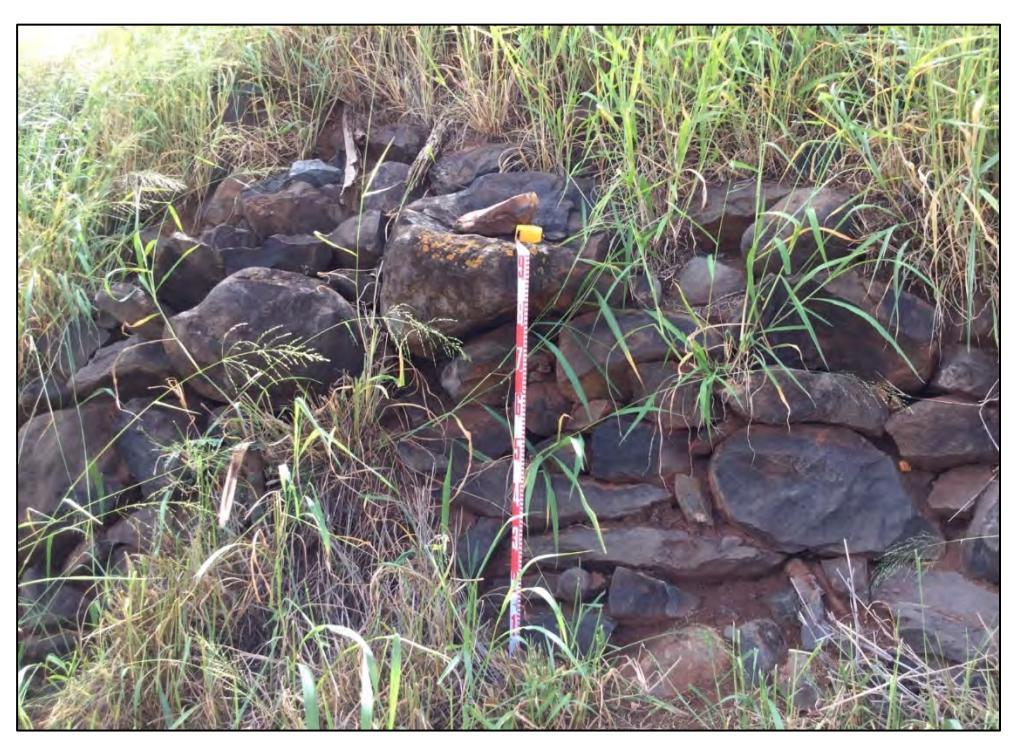
Figure 103. SIHP # 50-80-09-2268 Feature D, stacked stone wall, view to southwest (Zapor et al. 2018:79)

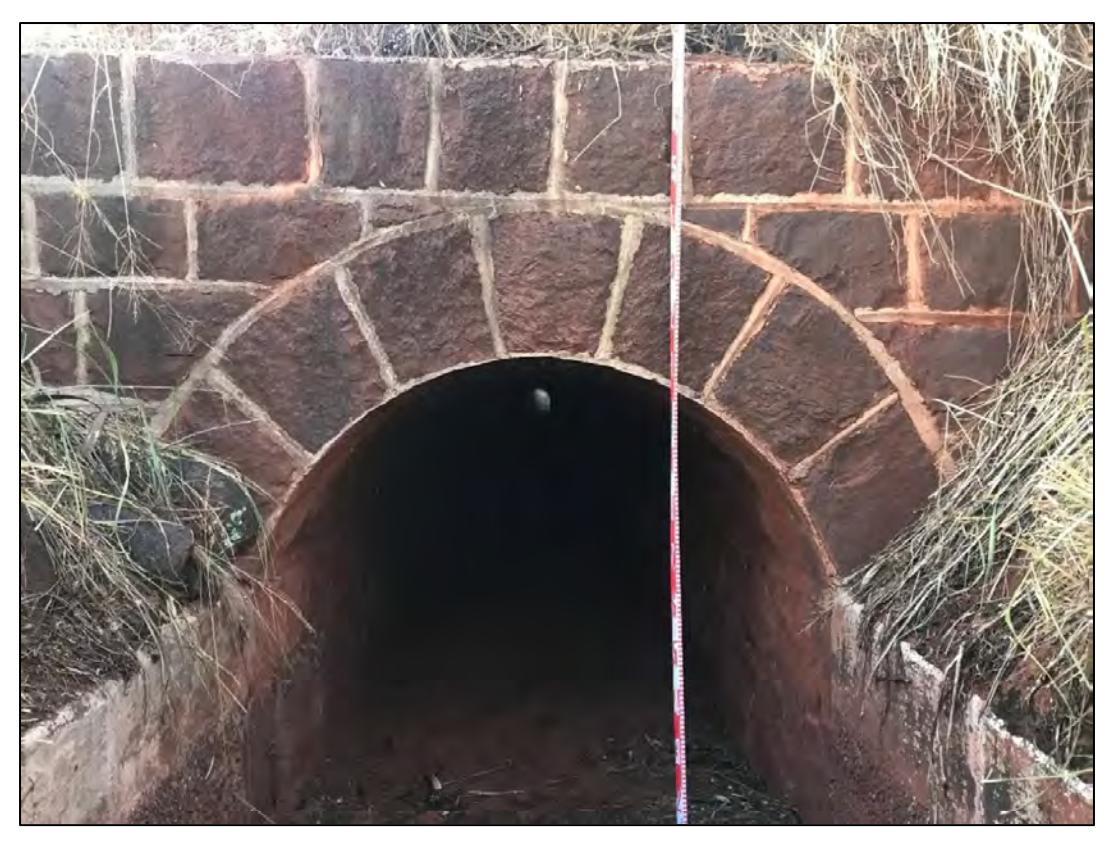
Figure 104. Culvert of SIHP # 50-80-09-2268, Waiahole Ditch, northwest of (outside) the project area, view to southwest (Photo R; Figure 27)

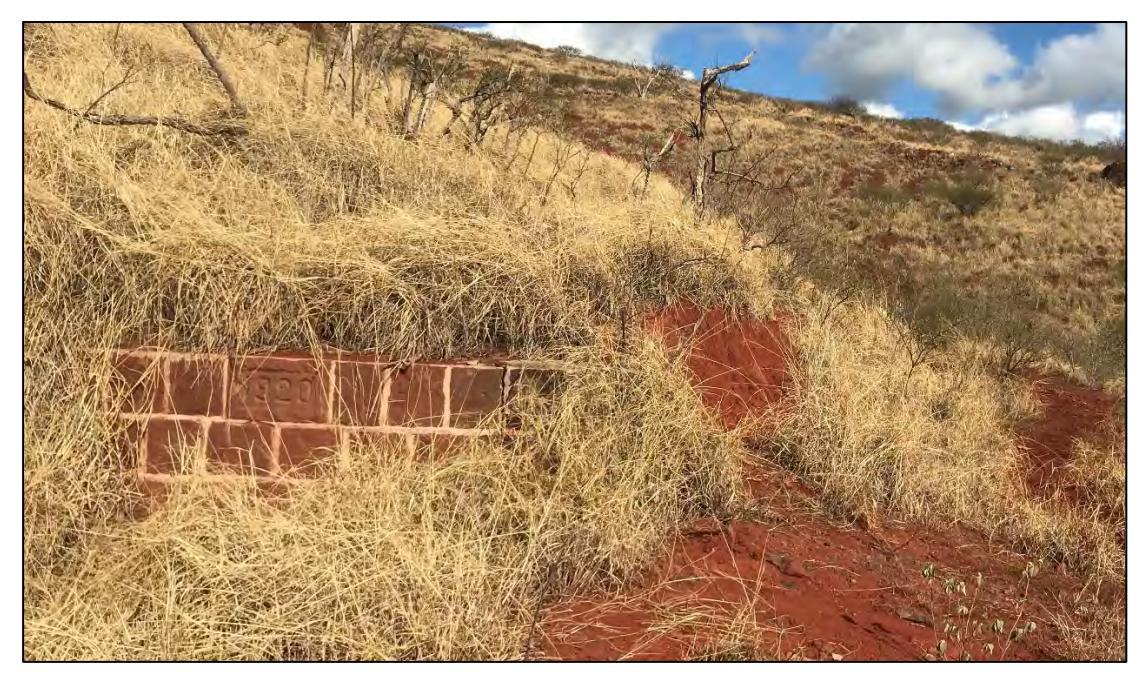
Figure 106. Portion of SIHP # 50-80-09-2268, Waiahole Ditch outside (north) of project area, with date "1920" inscribed on basalt and mortar culvert, view to northeast (Photo T; Figure 27)

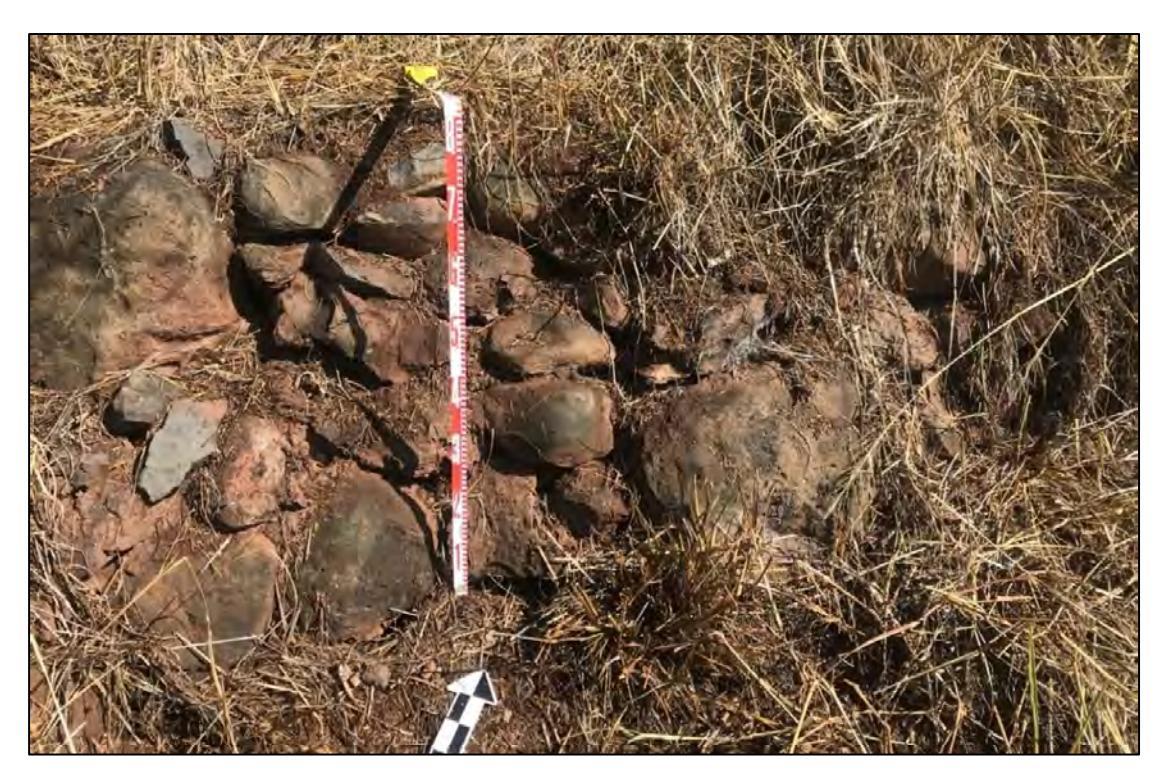
Several variations of the Waiahole Ditch were observed during the current study. Along the northern boundary of the project area, the ditch consists of a more formal construction, with mortared basalt sides and tunnels (Figure 104 through Figure 107). Concrete-lined portions were also observed at the north edge or just outside of the project area, as were several tunnel entrances and sluice gate features (Figure 107 and Figure 108). Much of the length of the Waiahole Ditch runs underground in concrete-lined tunnels. In the central portion of the project area, the ditch was observed as an informal earthen ditch, largely overgrown (Figure 109). In the southwest portion of the project area, dry-stacked basalt sides were observed (Figure 110 and Figure 111). As

Figure 110. Representative photo of SIHP # 50-80-09-2268, Waiahole Ditch in southwest project area, dry-stacked basalt, view to north (Photo X; Figure 27)

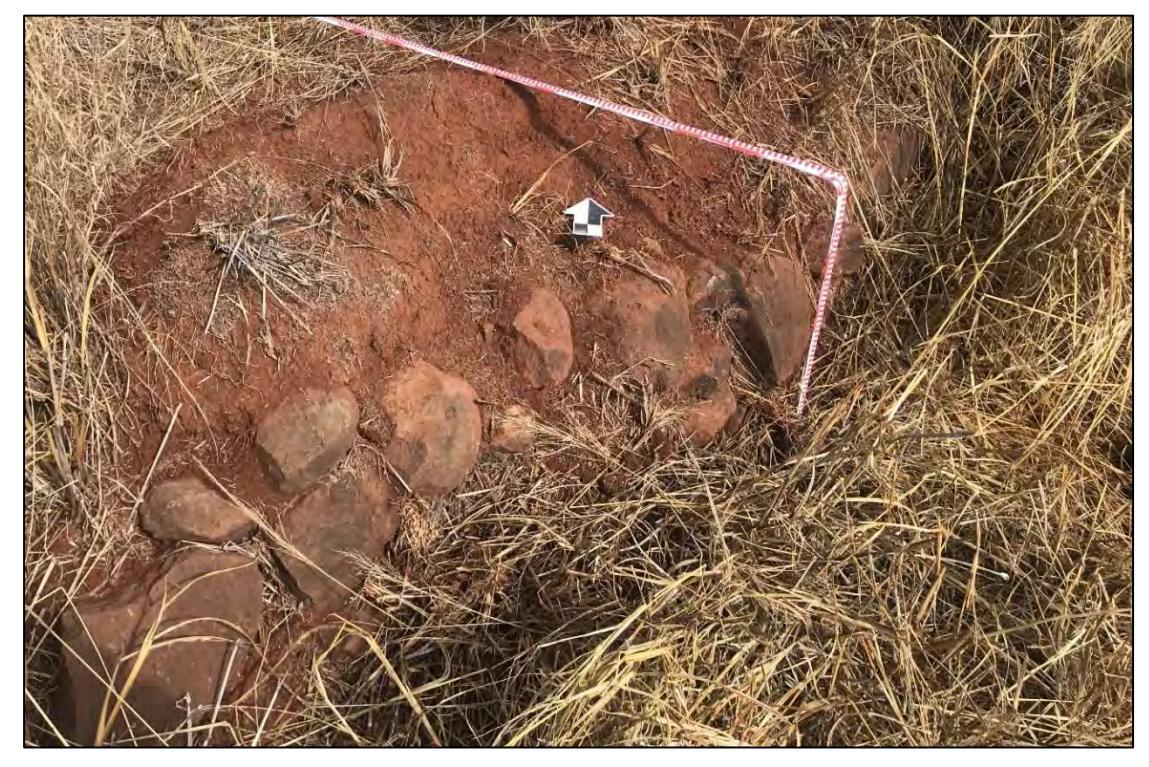
Figure 111. Representative photo of SIHP # 50-80-09-2268, Waiahole Ditch in southwest project area, view to north (Photo Y; Figure 27)

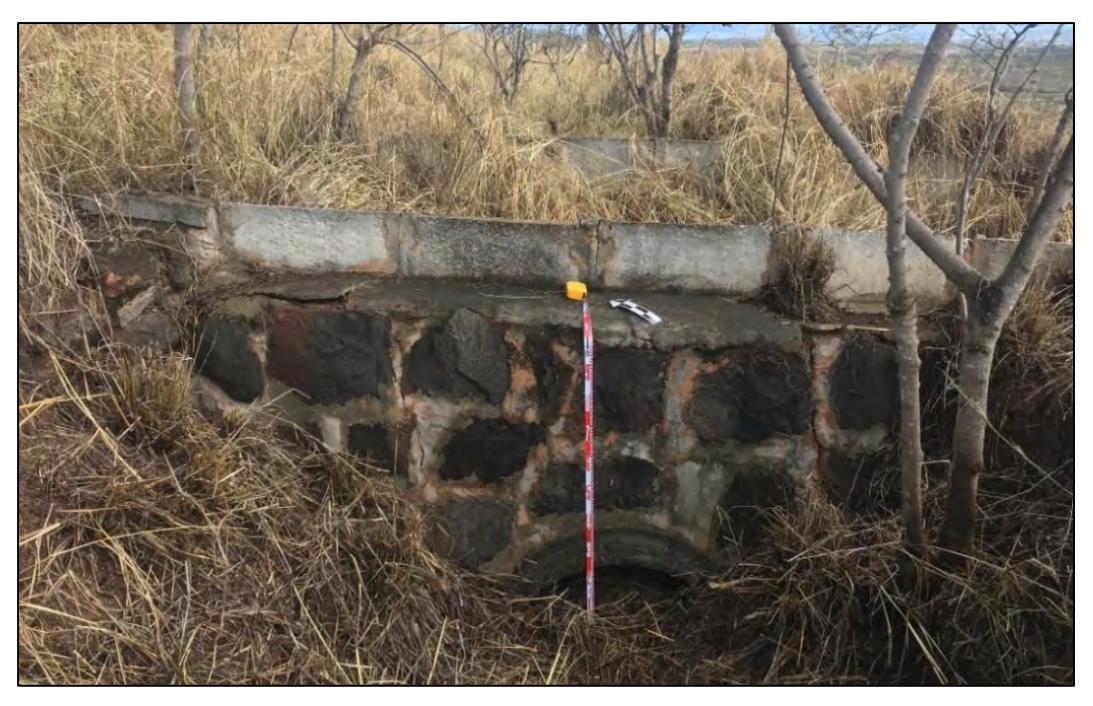
Portions of the Waiahole Ditch within and surrounding the project area have additional components related to water control including culverts, metal pipes, sluice gates, and bridges. The first designated feature of the Waiahole Ditch for the current project, SIHP # 50-80-09-2268 Feature E, consists of a culvert associated with the ditch, documented in the southwest portion of the project area (Figure 112 through Figure 115). The culvert consists of mortared cut basalt blocks, two to three courses high, constructed around a largely buried concrete drain pipe (see Figure 112). Both sides of the tunnel are faced, and a concrete slab extends over top of the culvert. The concrete slab is approximately 6.5 m long and 1.5 m wide (Figure 113). The faces of the culvert are approximately 3.5 m wide, and the height of the exposed portion is 1.3 m. The observed portion of the mouth of the pipe is 50 cm in diameter. These components are in fair condition. The southeast portion of the concrete slab is damaged due to partial collapse.

Figure 112. SIHP # 50-80-09-2268 Feature E, culvert and bridge components of the Waiahole Ditch in southern project area, view to northeast

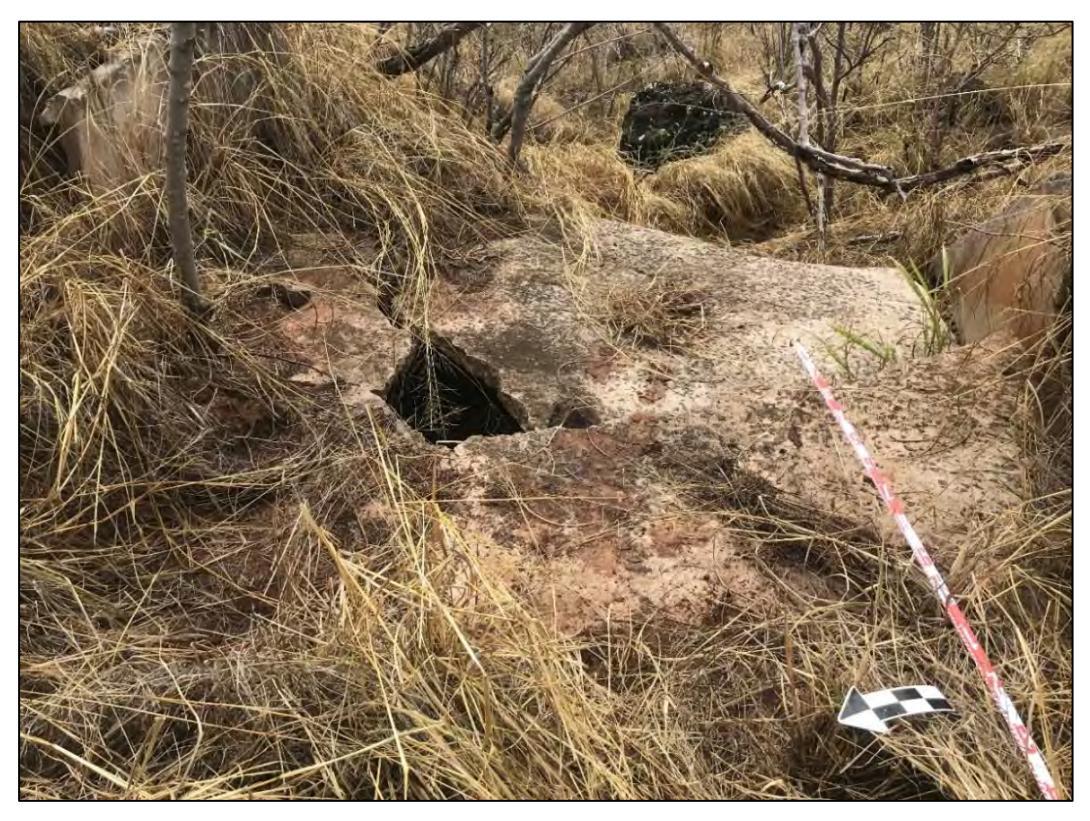
Figure 113. SIHP # 50-80-09-2268 Feature E bridge overlying culvert of Waiahole Ditch in southern project area, view to east

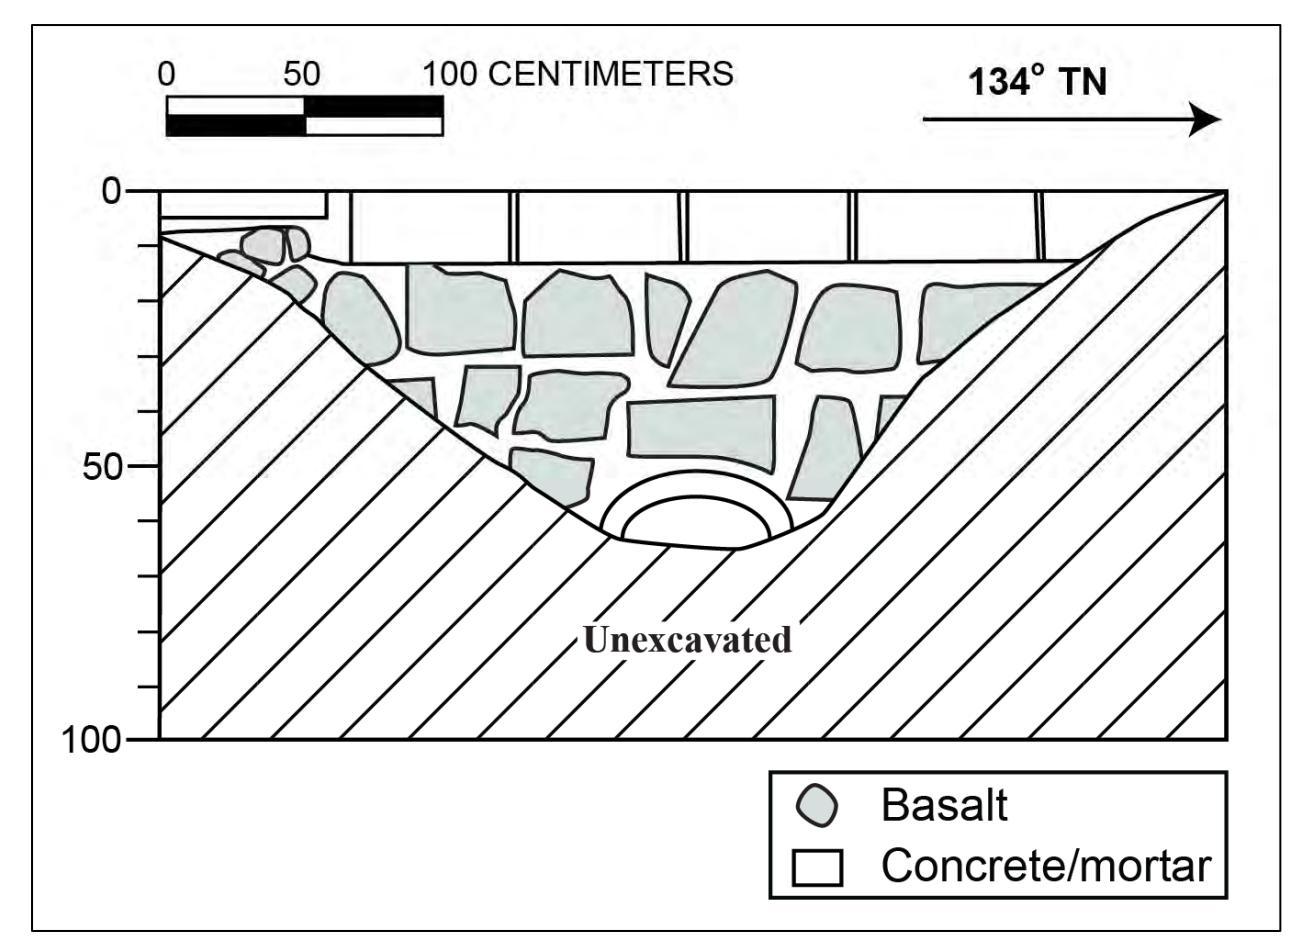
Figure 114. SIHP # 50-80-09-2268 Feature E southwest face of culvert profile

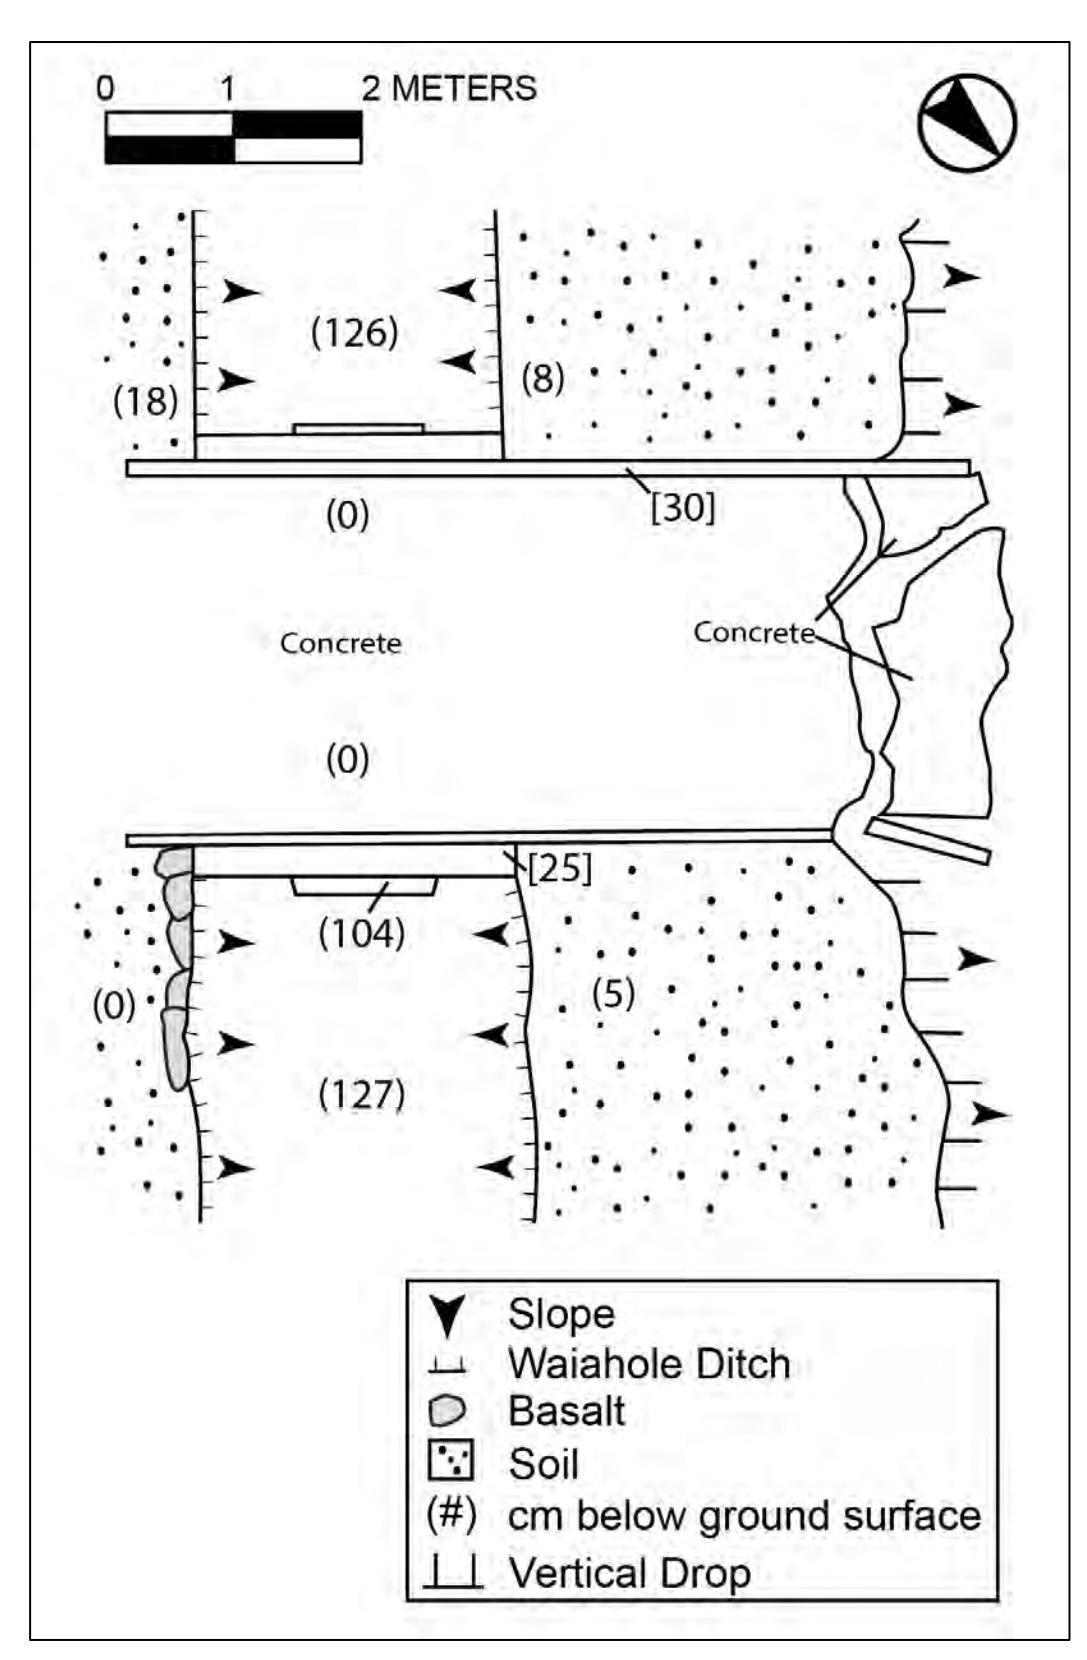
Figure 115. SIHP # 50-80-09-2268 Feature E culvert and ditch plan map

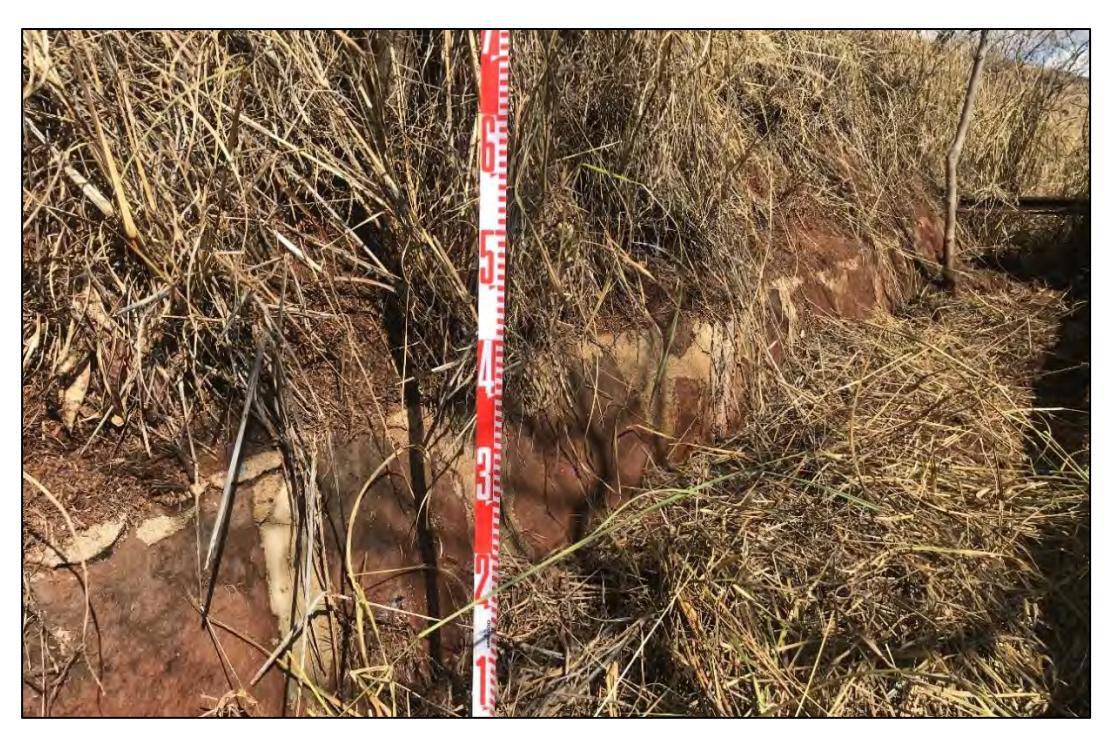
SIHP # 50-80-09-2268 Feature F of the ditch system was identified as part of a two-course mortared basalt portion of the ditch in the central portion of the southwest project area (Figure 116 through Figure 121). Feature F consists of a portion of the ditch with pipes, cross beams, and sluice gate components. A metal pipe extends north-south within the ditch, and two metal cross beams extend perpendicular across the ditch face, positioned under the metal pipe directly overlying the ditch surface (see Figure 117). The metal pipe extends beyond both of the cross beams. The metal cross beams are 10 cm wide and are spaced 7.1 m apart. Additionally, a channel extends southeast from the main ditch, which is blocked by a sluice gate feature, the wooden gate of which is still intact (see Figure 118 and Figure 119). The main ditch measures 1.2 m wide, and the channel extending from it is 0.7 m wide, widening to 1.7 m as it extends to the southeast. Depths of the ditch range from 40 to 80 cm, due to the accumulation of sediment in the base of the ditch. The sluice gate component is 0.7 m wide and 0.5 m tall. Notches for a second sluice gate are present in the concrete approximately 12 cm from the intact sluice gate component. The wood of this second sluice feature is no longer intact. Additional sluice notches were noted inside the main ditch as well, approximately 0.5 m southwest of the channel portion. A representative plan view and profile were completed for this section of the ditch (see Figure 120 and Figure 121). All of these components including this portion of the Waiahole Ditch are in fair condition.

Figure 116. SIHP # 50-80-09-2268 Feature F, basalt and mortar-lined ditch, with metal cross beam (right background), view to north

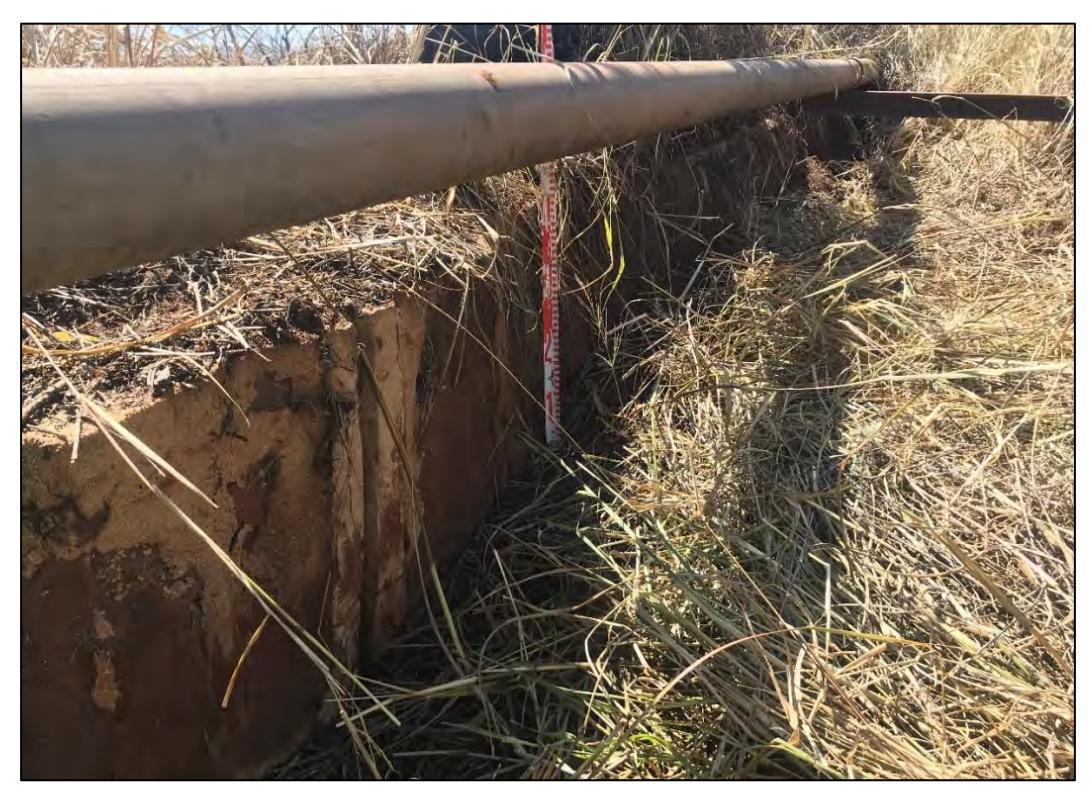
Figure 117. SIHP # 50-80-09-2268 Feature F, basalt and mortar ditch portion, with metal pipe and cross beam, view to south

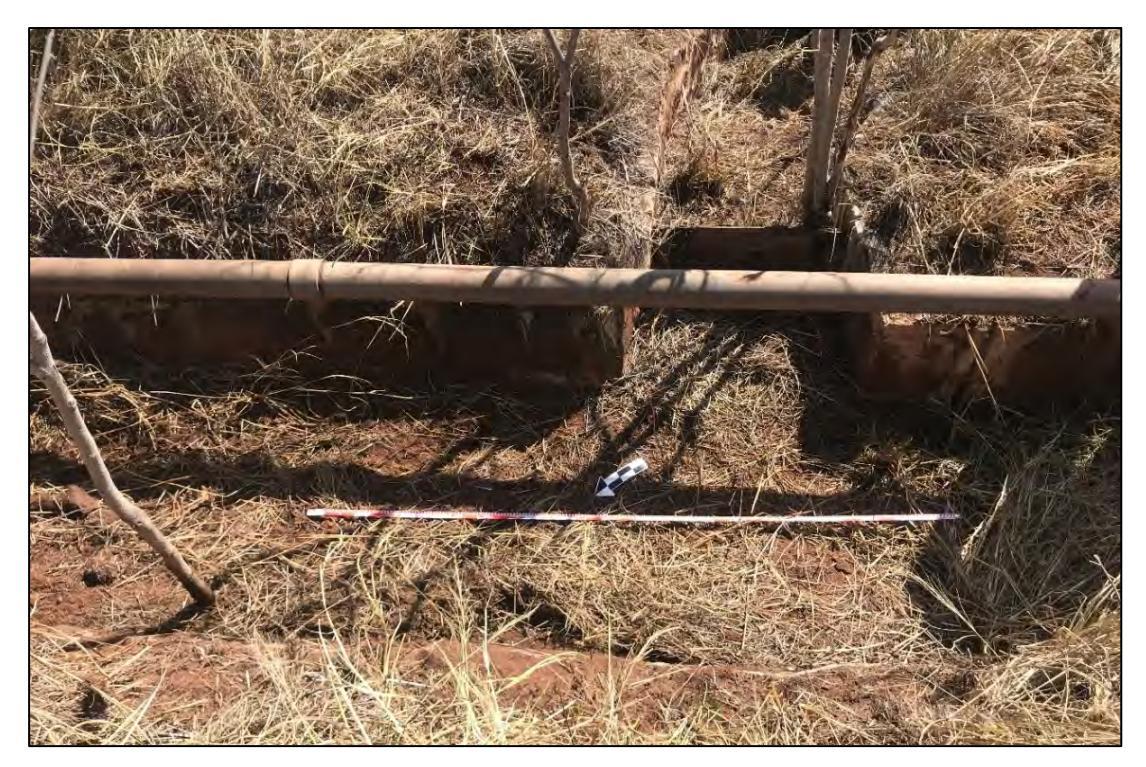
Figure 118. Plan view of SIHP # 50-80-09-2268 Feature F, showing pipe, southeast channel, and sluice gate components

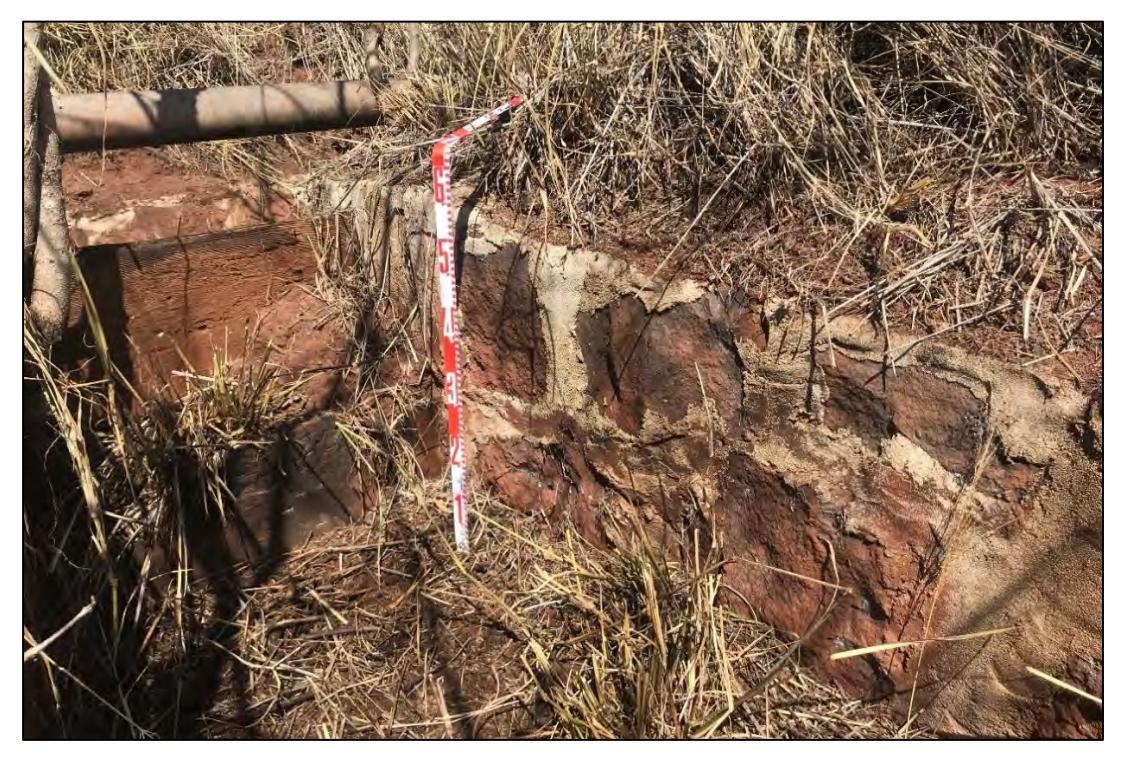
Figure 119. SIHP # 50-80-09-2268 Feature F, close-up of southeast channel and sluice gate component, view to north

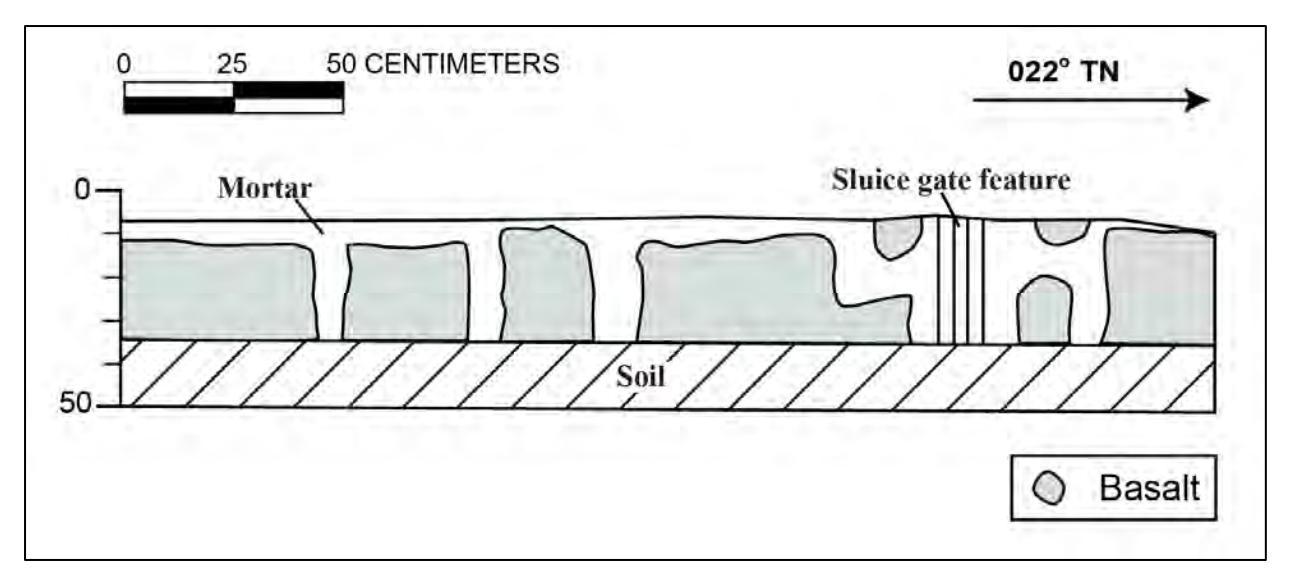
Figure 120. SIHP # 50-80-09-2268 Feature F, west wall of ditch representative profile

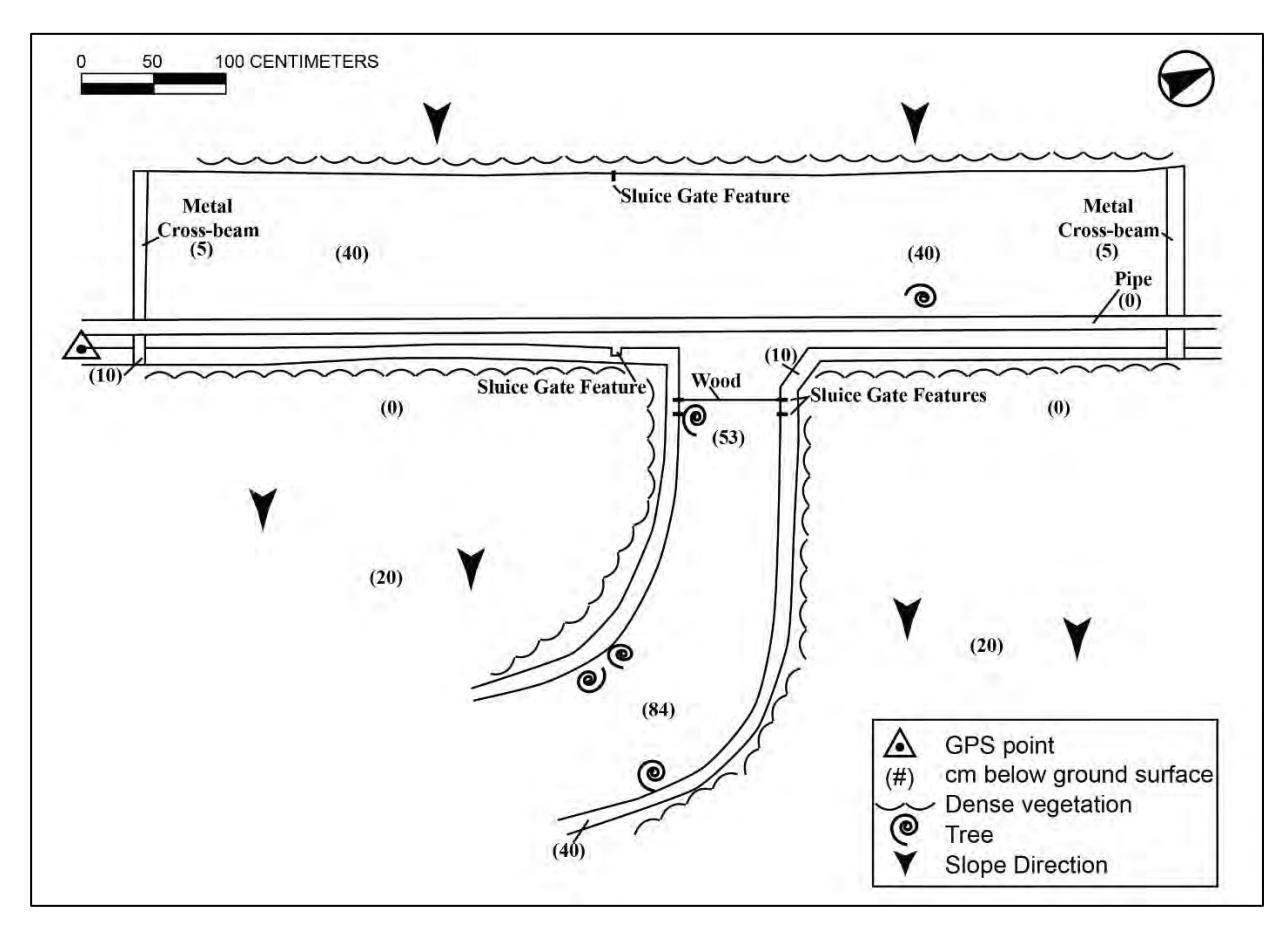
Figure 121. SIHP # 50-80-09-2268 Feature F plan map

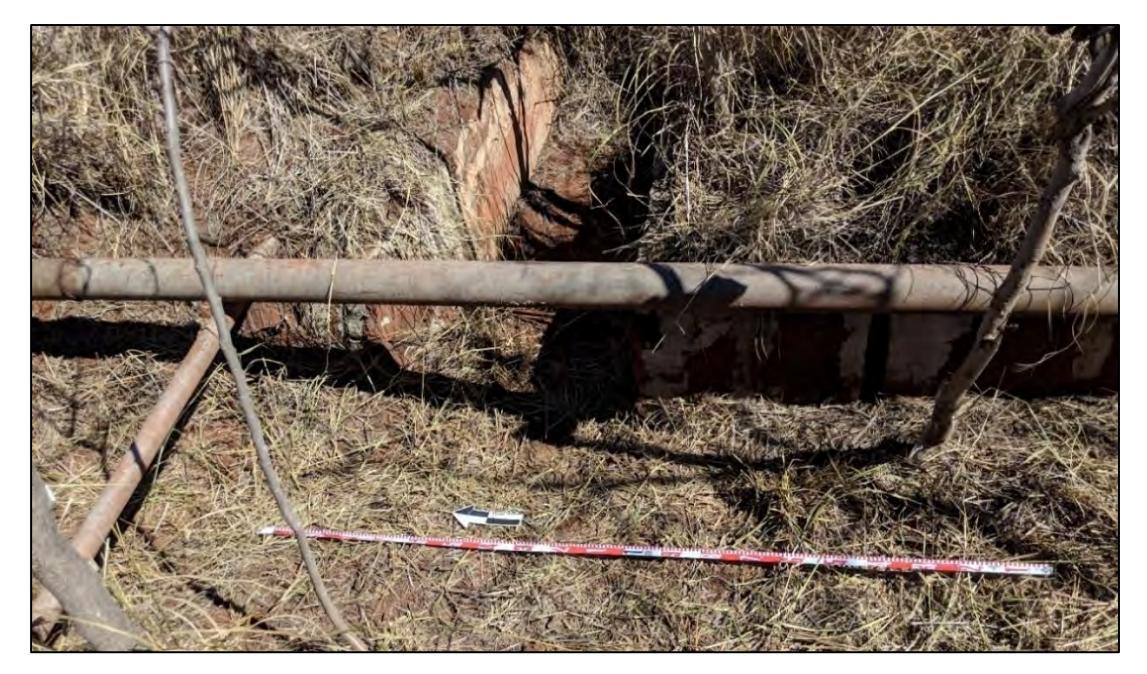
SIHP # 50-80-09-2268 Feature G, a second, similar portion of the ditch was documented approximately 18 m northeast of Feature F (Figure 122 and Figure 123). Feature G consists of a mortared cut basalt portion of the ditch, with three pipes (one parallel and two perpendicular), and sluice gate remnants. Here the ditch is oriented north-south and measures 1.3 m wide and ranges from 33 cm to 45 cm deep. Note that much sediment has accumulated in the base of the ditch. A channel extends east off the main ditch which measures 0.7 m wide and 67 cm deep. The same metal pipe detailed above extends parallel along the east edge of the ditch. Additionally, two 5 cm pipes extend perpendicular across the ditch 30 cm north of the east-extending channel, spaced 1.2 m apart. There are notches for two sluice gate features in the east-extending channel.

Figure 122. SIHP # 50-80-09-2268 Feature G, showing sluice gate component and two metal pipes, view to east

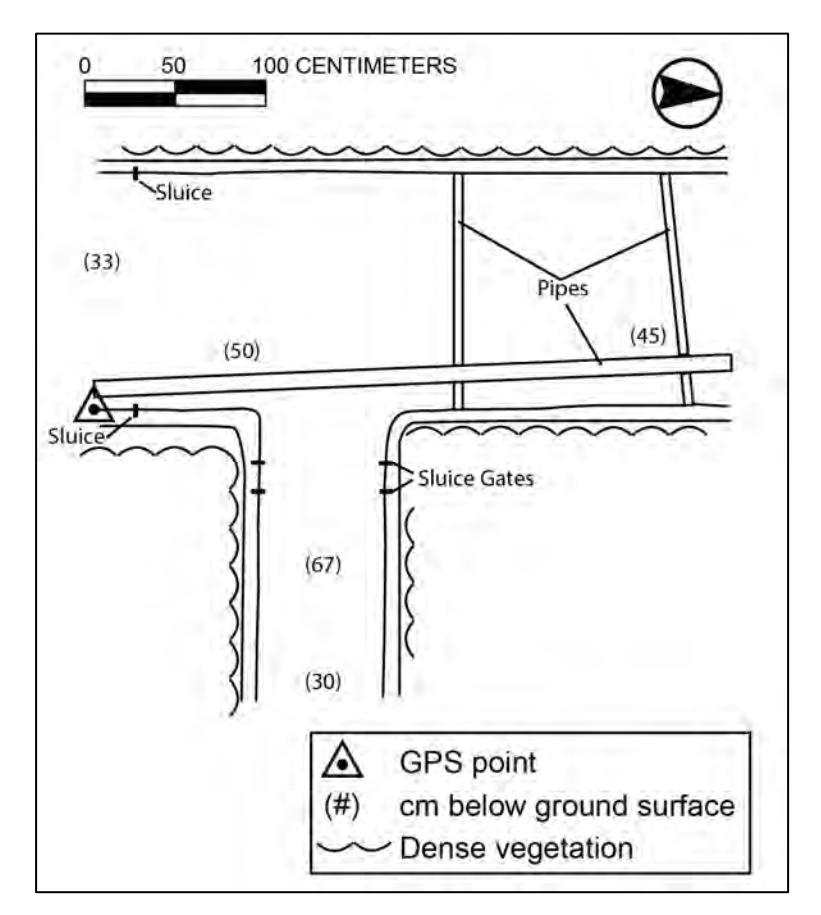
Figure 123. SIHP # 50-80-09-2268 Feature G plan map

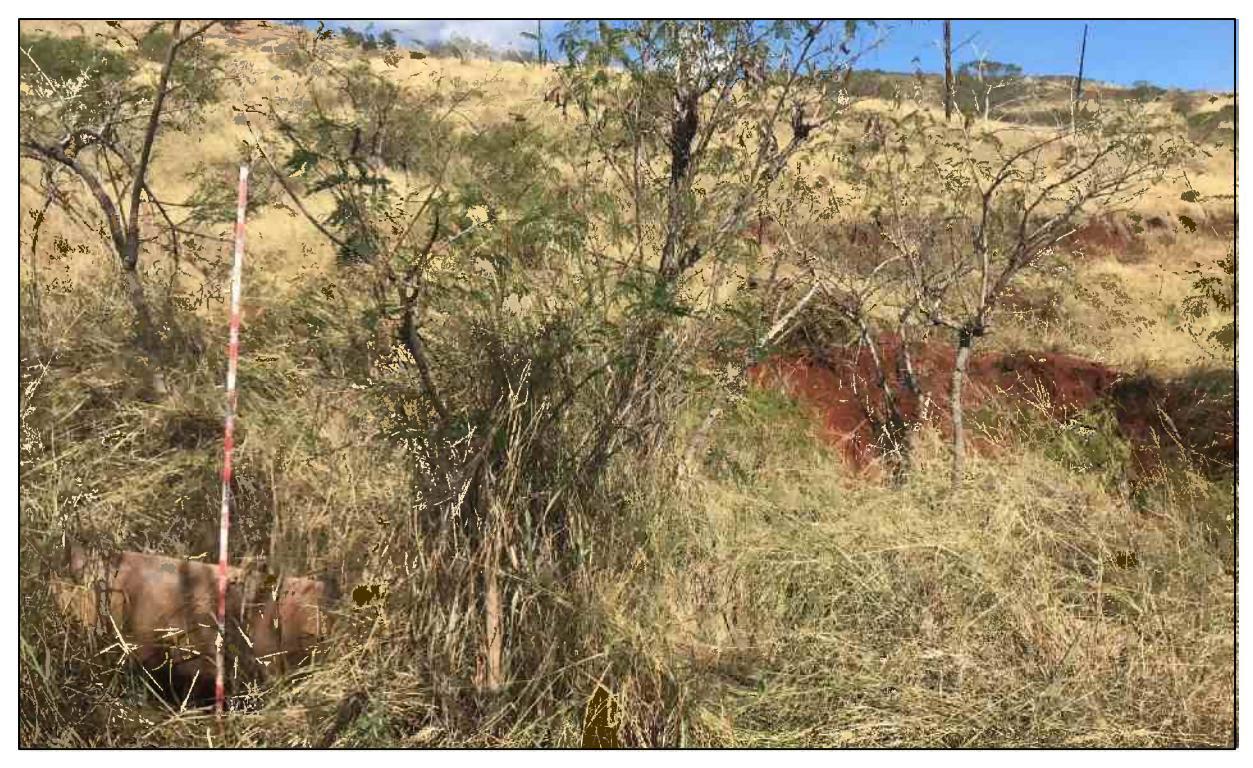
SIHP # 50-80-09-2268 Feature H consists of a metal drainage flume feature documented in the northern portion of the southwest project area (Figure 125 and Figure 124). Feature H is oriented northeast-southwest and measures 1.1 m wide and 5.0 m long, and a maximum 56 cm

Figure 124. Overview of SIHP # 50-80-09-2268 Feature H (left)
