5.2 SIHP # 50-80-09-2268 Waiahole Ditch System/ post-Contact Irrigation Ditch

AIS for the AES West O'ahu Solar Project, Honouliuli, 'Ewa, O'ahu

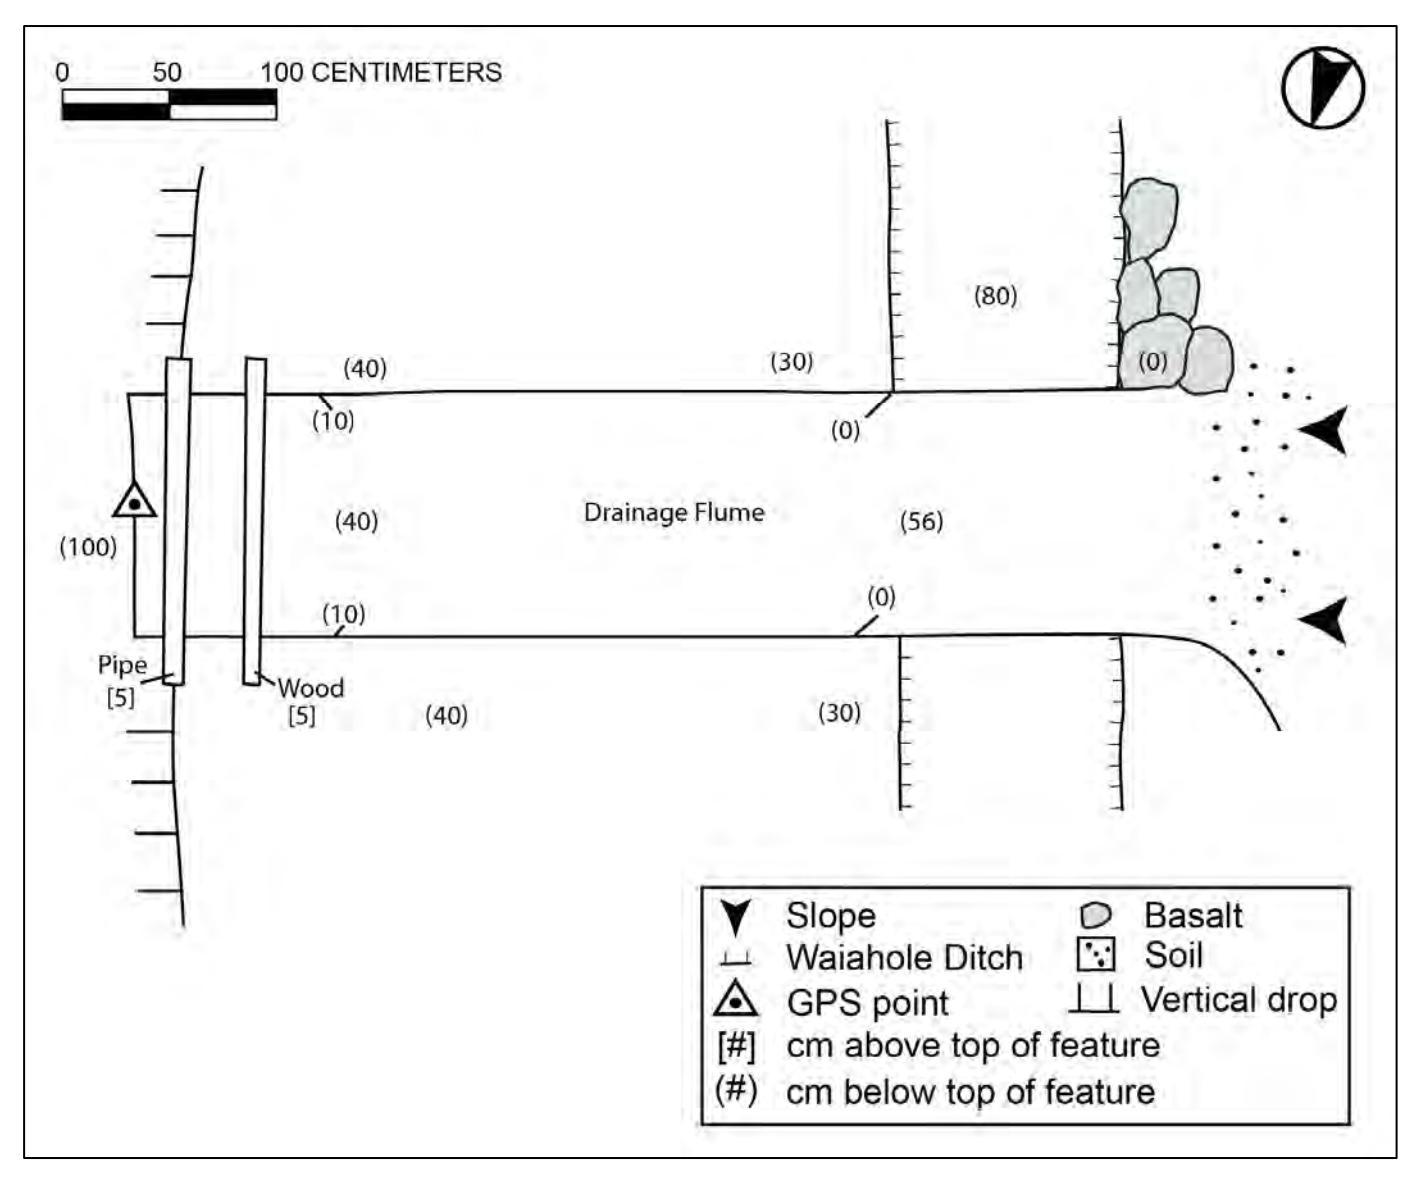
SIHP # 50-80-09-2268 Feature H consists of a metal drainage flume feature documented in the northern portion of the southwest project area (Figure 125 and Figure 124). Feature H is oriented northeast-southwest and measures 1.1 m wide and 5.0 m long, and a maximum 56 cm

Figure 125. SIHP # 50-80-09-2268 Feature H plan map

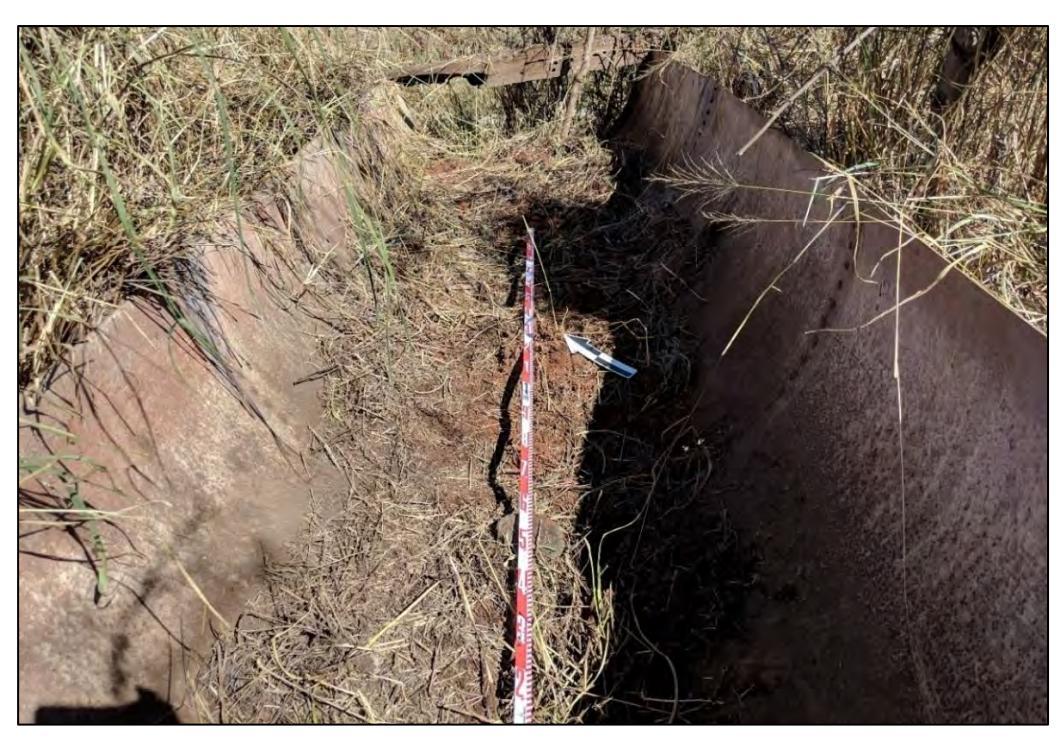
deep (Figure 126). The flume extends toward a vertical drop, at one time funneling water into the gulch below. A decaying wood portion extends perpendicular over the northeast end of the metal chute. Approximately 20 cm from the wood, a metal pipe extends perpendicular over the top of the flume. At the southwest end of the chute, on the south side, there is a pile of mortar and basalt cobbles measuring 1 m wide and 90 cm tall (Figure 127). The flume extends over top of the Waiahole Ditch.

Figure 126. SIHP # 50-80-09-2268 Feature H, drainage flume, along north edge of project area, view to northeast

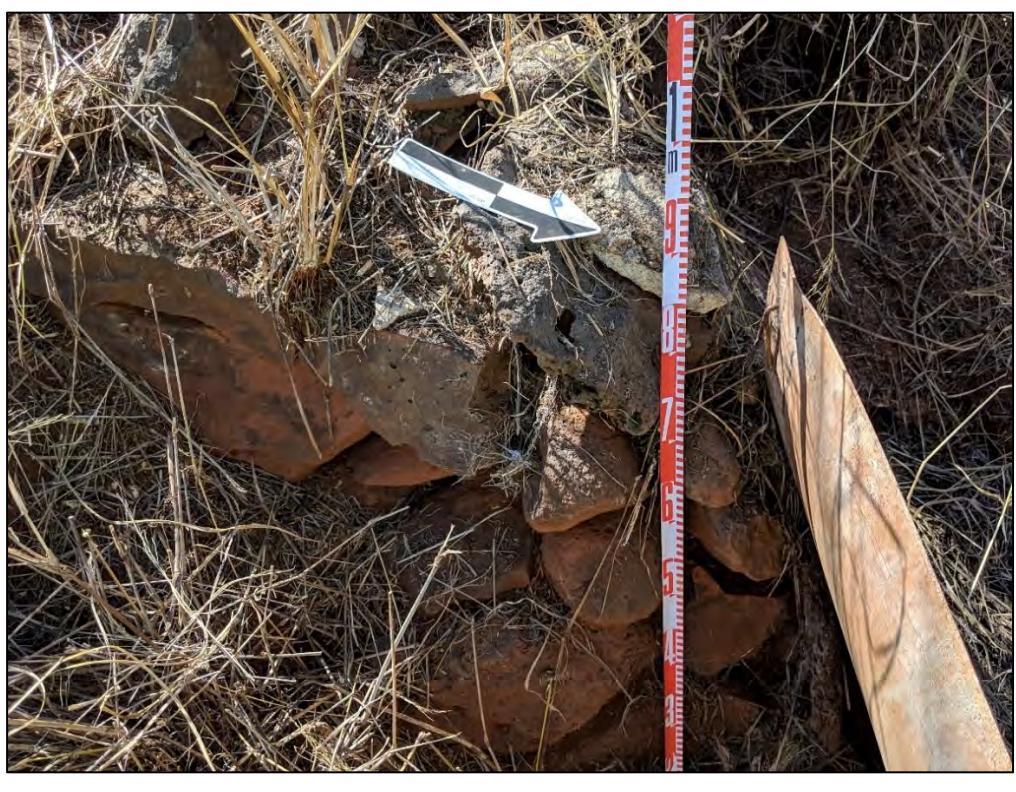
Figure 127. Mortar and basalt pile south end of SIHP # 50-80-09-2268 Feature H, drainage flume, view to west

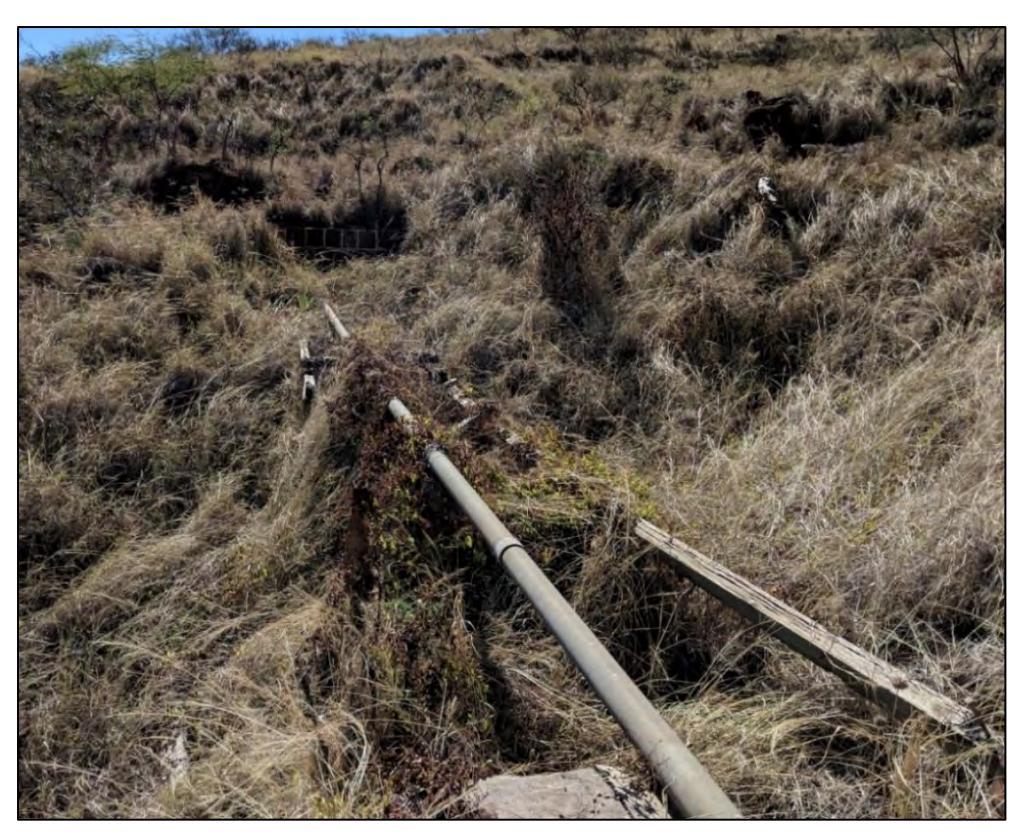
Figure 128. Collapsed bridge component of SIHP # 50-80-09-2268 Feature I, view to south

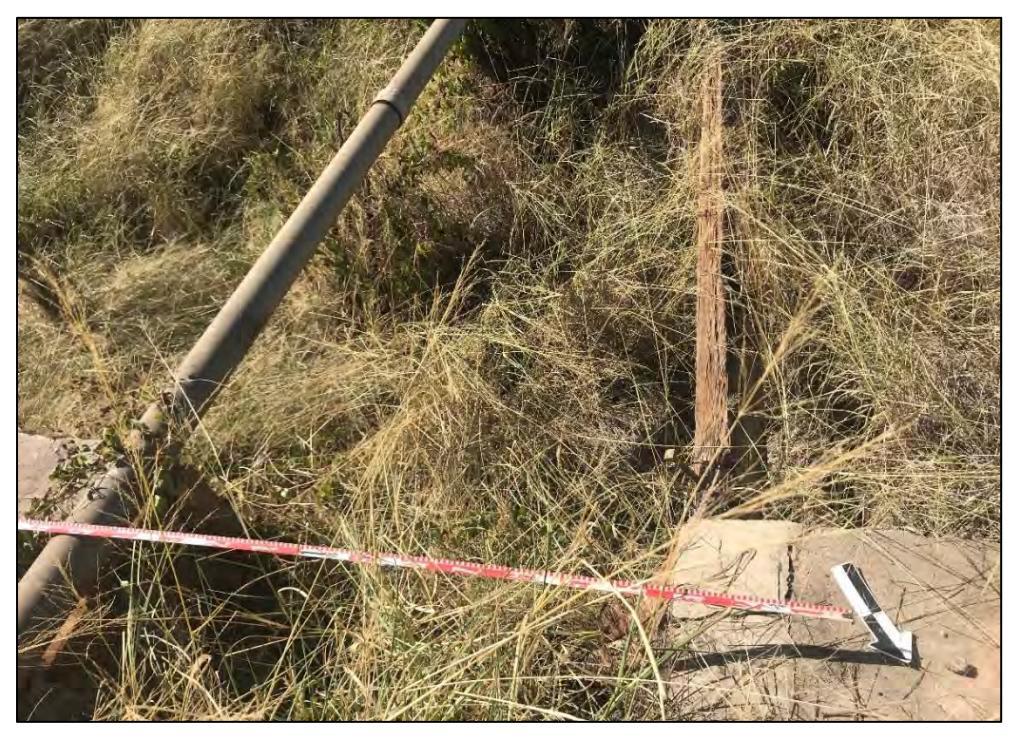
SIHP # 50-80-09-2268 Feature I consists of a portion of the ditch with several associated features, constructed to carry the water over the gulch in the area. This bridge component has four mortared basalt block pillars (Figure 129 through Figure 131). At one time an elevated metal half pipe connected the pillars, the middle of which appears to have collapsed. In the north end a portion of the metal in between the two pillars was still visible, and an incised line was noted, possibly a former space for a sluice gate or similar component (see Figure 130). The middle portion of this feature has largely collapsed, and with much of the footings obscured by earth. Approximately 3.5 m to the south, a basalt and mortar headwall and culvert were observed, measuring 2.5 m long, 20 cm wide, and 95 cm tall.

Figure 129. Collapsed bridge component of SIHP # 50-80-09-2268 Feature I, view to southwest

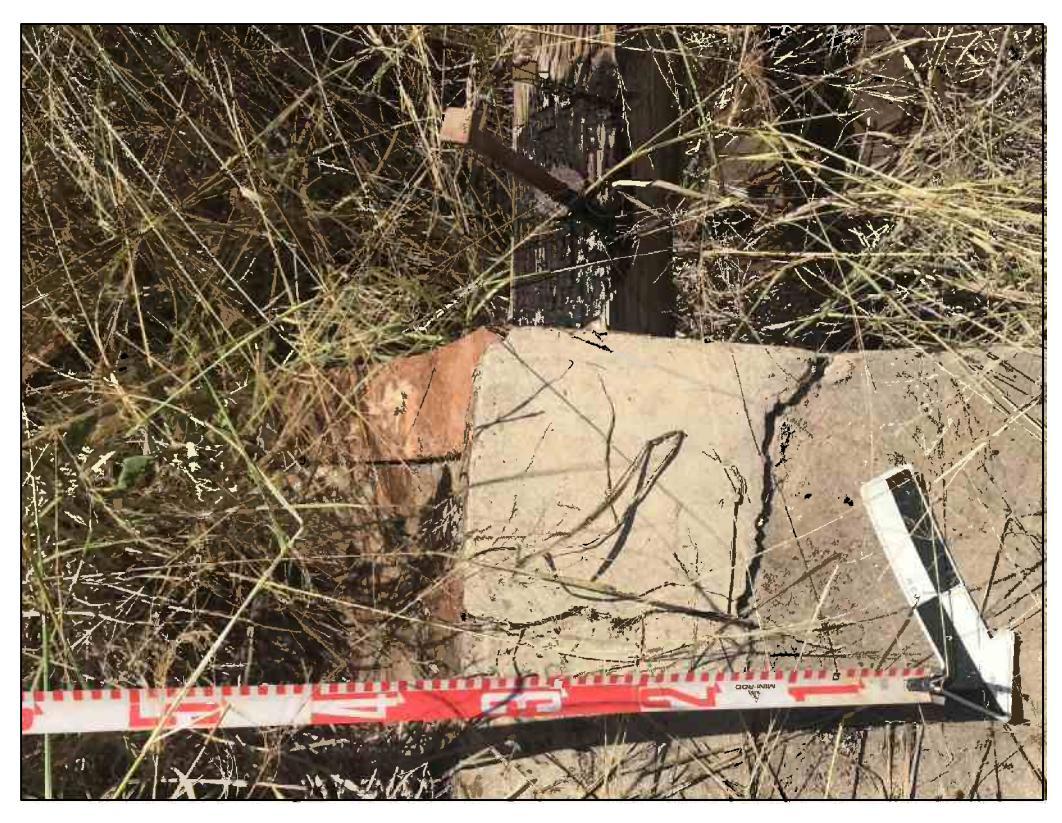
Figure 130. Close-up plan view showing metal portion, collapsed bridge component of SIHP # 50-80-09-2268 Feature I

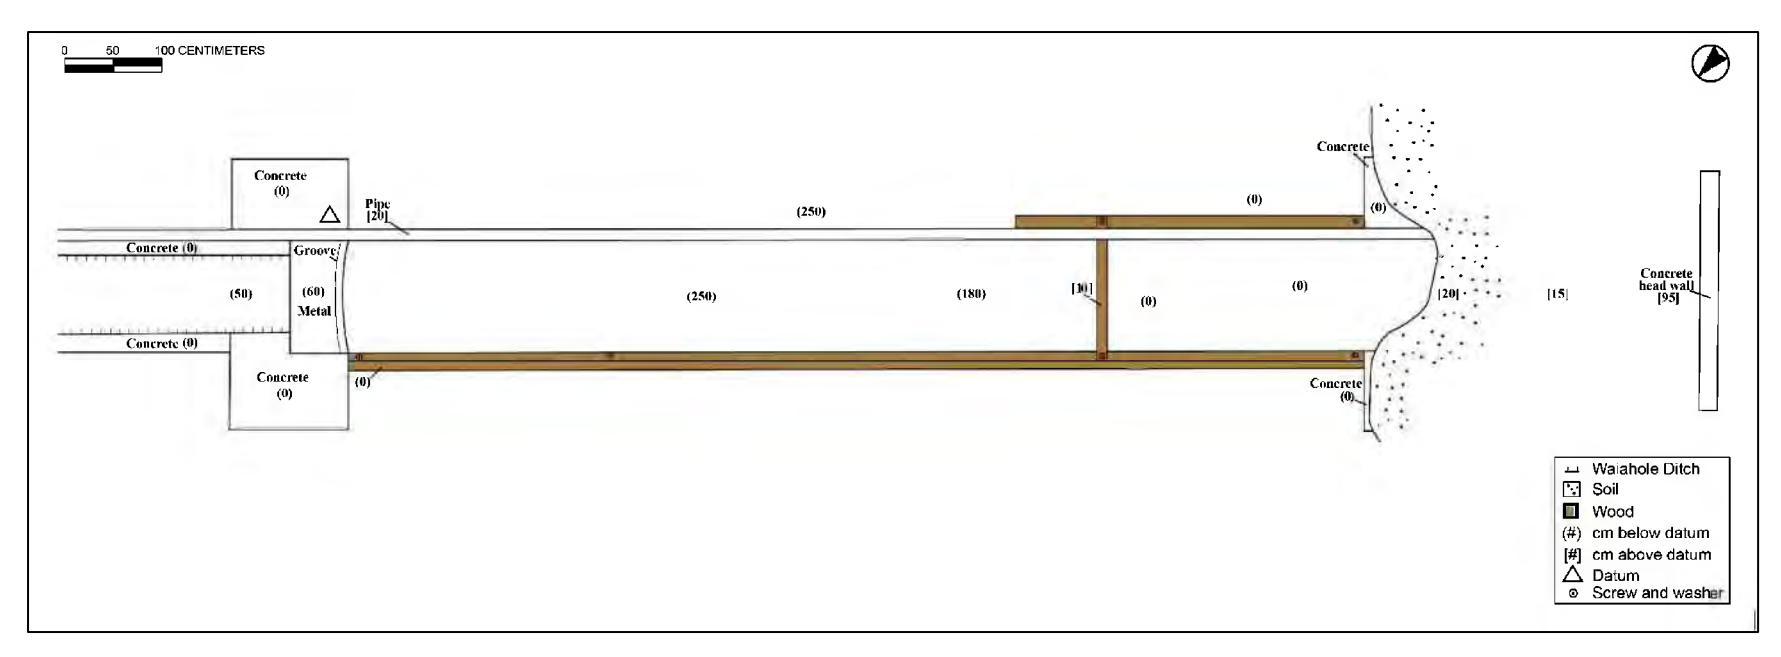
Figure 131. Plan map of SIHP # 50-80-08-2268 Feature I, showing portion of the Waiahole Ditch, collapsed bridge components, and head wall

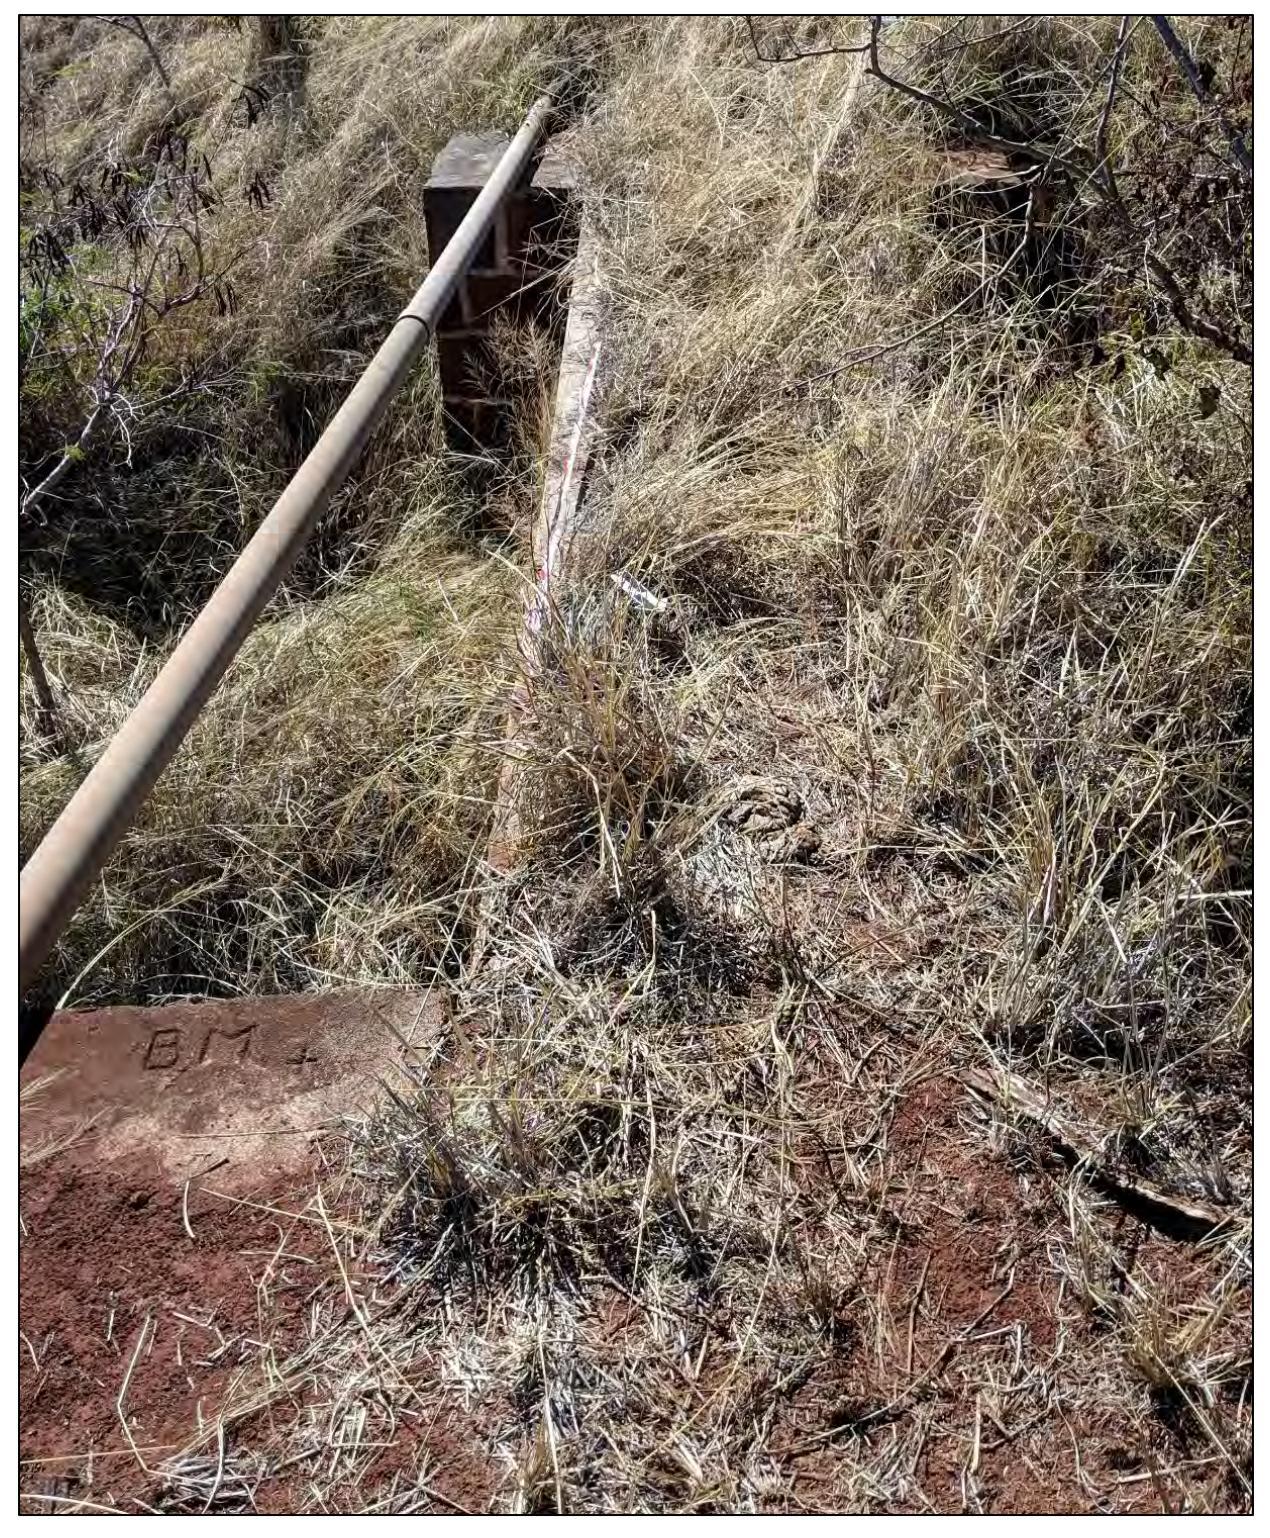
SIHP # 50-80-09-2268 Feature J is similar to Feature I, another area of components to carry the ditch over gulches in the area. The first component consists of four mortared basalt block pillars connected by an elevated concrete bridge (Figure 132 through Figure 134). The concrete has been entirely filled in with soil and is overgrown, and portions of the pillars are also obscured. A 12-cm metal pipe extends the entire length of this feature and beyond, resting on top of the *makai*/south pillars. The letters "B M +" are inscribed in the mortared surface of the northwestern pillar. Approximately 2 m east of this bridge component is a culvert constructed of mortared basalt, which measures 55 cm tall and 105 cm wide (see Figure 133). Only 80 cm of length is exposed, the remainder covered with earth; however, the tunnel appears to extend toward the ditch wall. Overall, the bridge components of Features J and K span an area approximately 53 m long.

Figure 132. Overview of bridge component of SIHP # 50-80-09-2268, Feature J, view to southwest

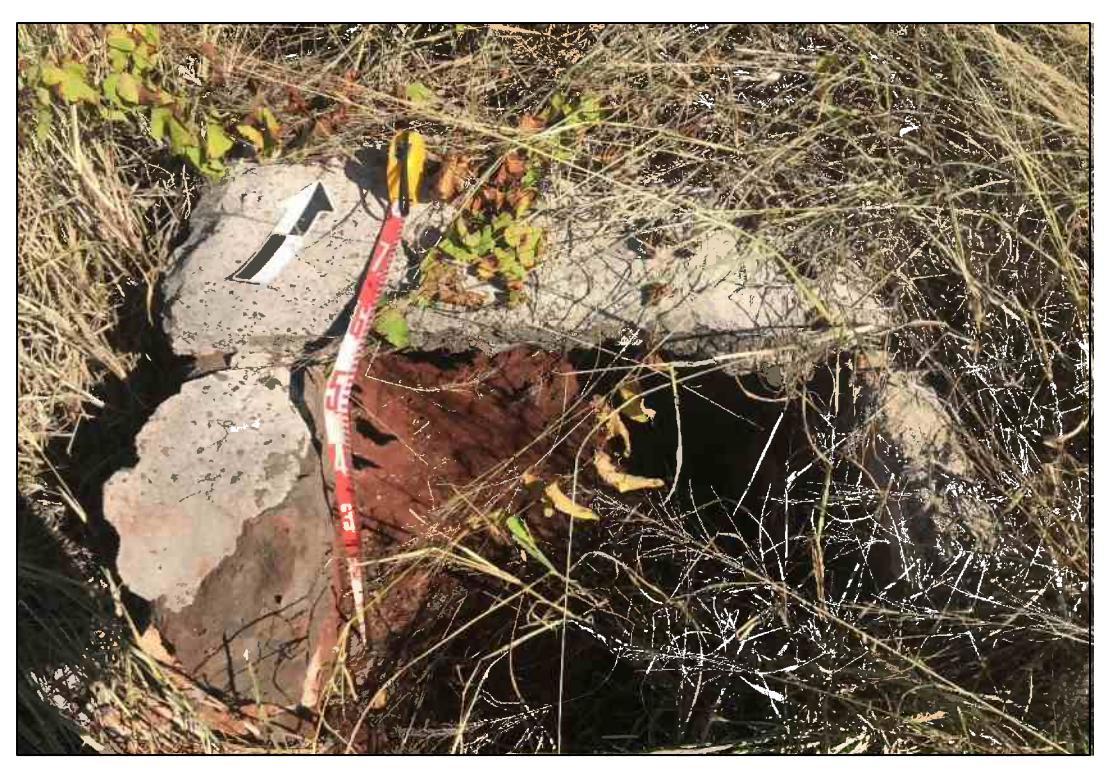
Figure 133. Culvert component of SIHP # 50-80-09-2268 Feature J documented east of bridge component, view to north

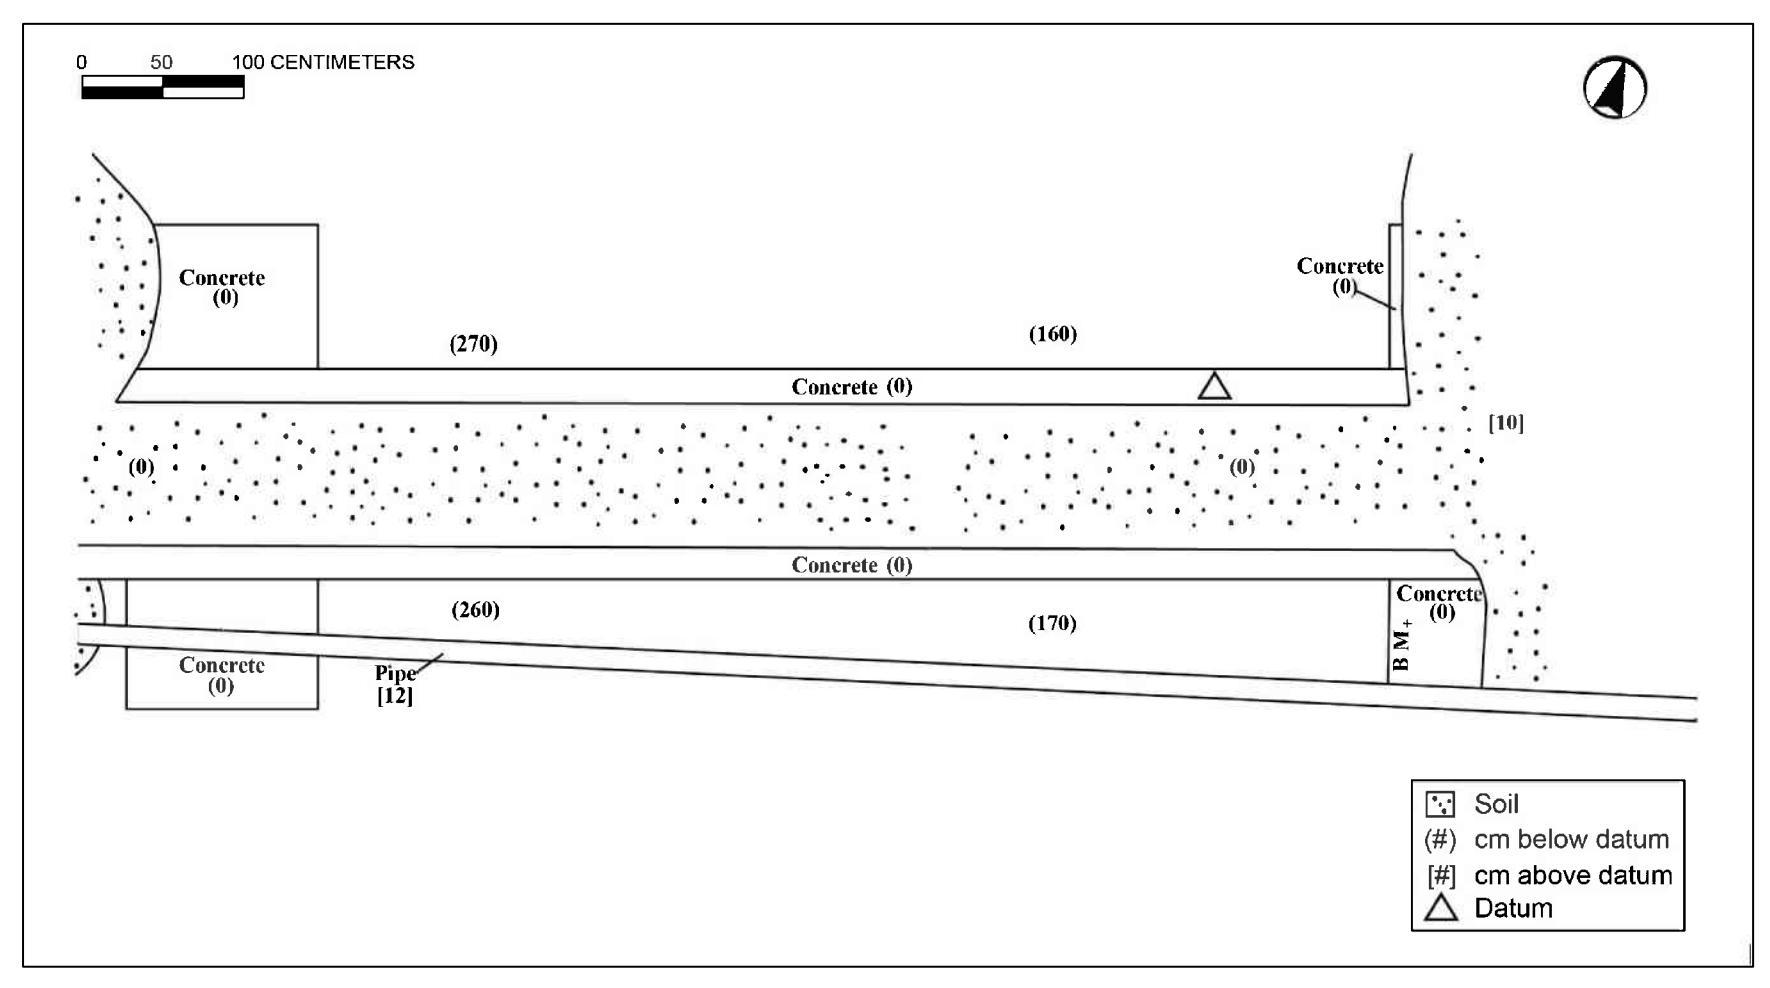
Figure 134. Plan map of SIHP # 50-80-09-2268 Feature J, bridge component

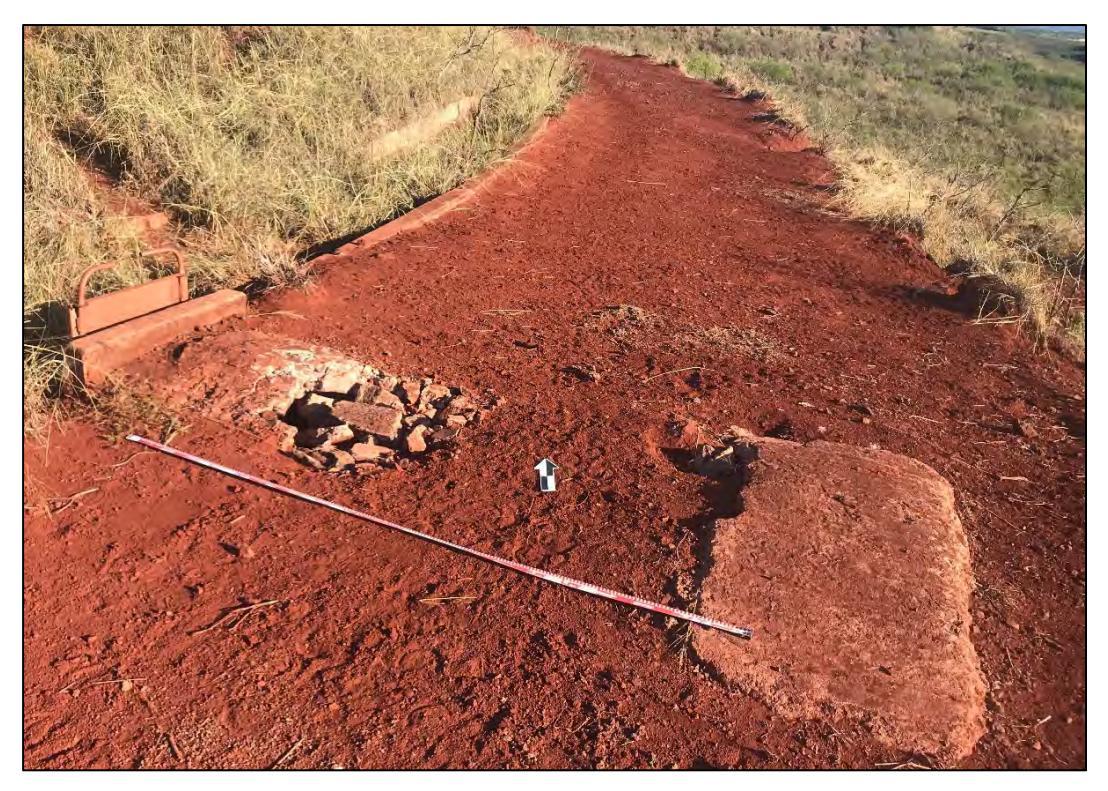
SIHP # 50-80-09-2268 Feature K of the ditch system consists of a culvert and tunnel feature with intact metal sluice gate, along the northern boundary of the project area (Figure 135 through Figure 136). Feature K extends southeast off the ditch, extending under the access road, though the feature could not be identified on the other side of the road. Two concrete patches were noted in the road, which appear to have been used to cover collapsed portions of the tunnel. It is possible the entire tunnel has collapsed. The observable portion of the feature—from the head gate to the end of the second concrete patch—spans 3 m in length and is a maximum of 0.7 m wide. The first, fragmented concrete slab measures 95 cm long and 75 cm wide. The second concrete slab, which is in the middle of the road, measures 1.6 m long by 0.7 m wide. The head wall of Feature I measures 0.9 m long. Overall the feature is in fair condition, as portions of the concrete are fragmented and collapsing.

Figure 135. SIHP # 50-80-09-2268 Feature K, culvert and tunnel feature, view to north

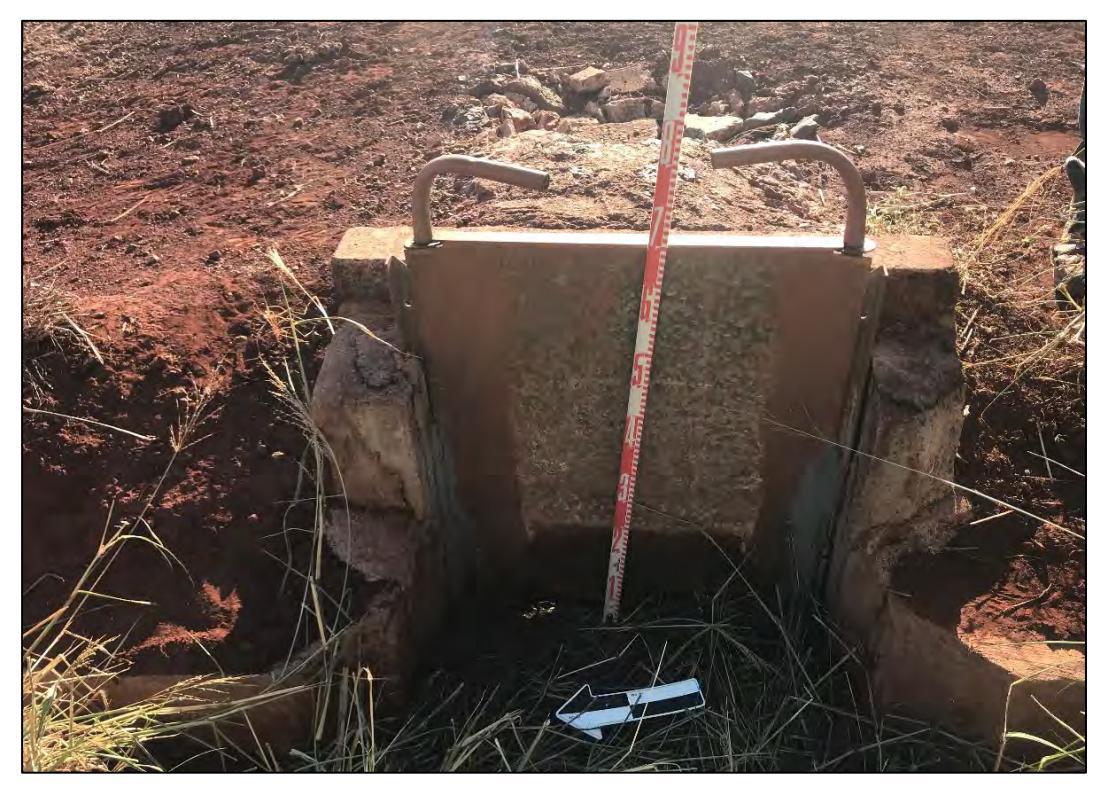
Figure 136. SIHP # 50-80-09-2268 Feature K, showing culvert with intact sluice gate, view to east

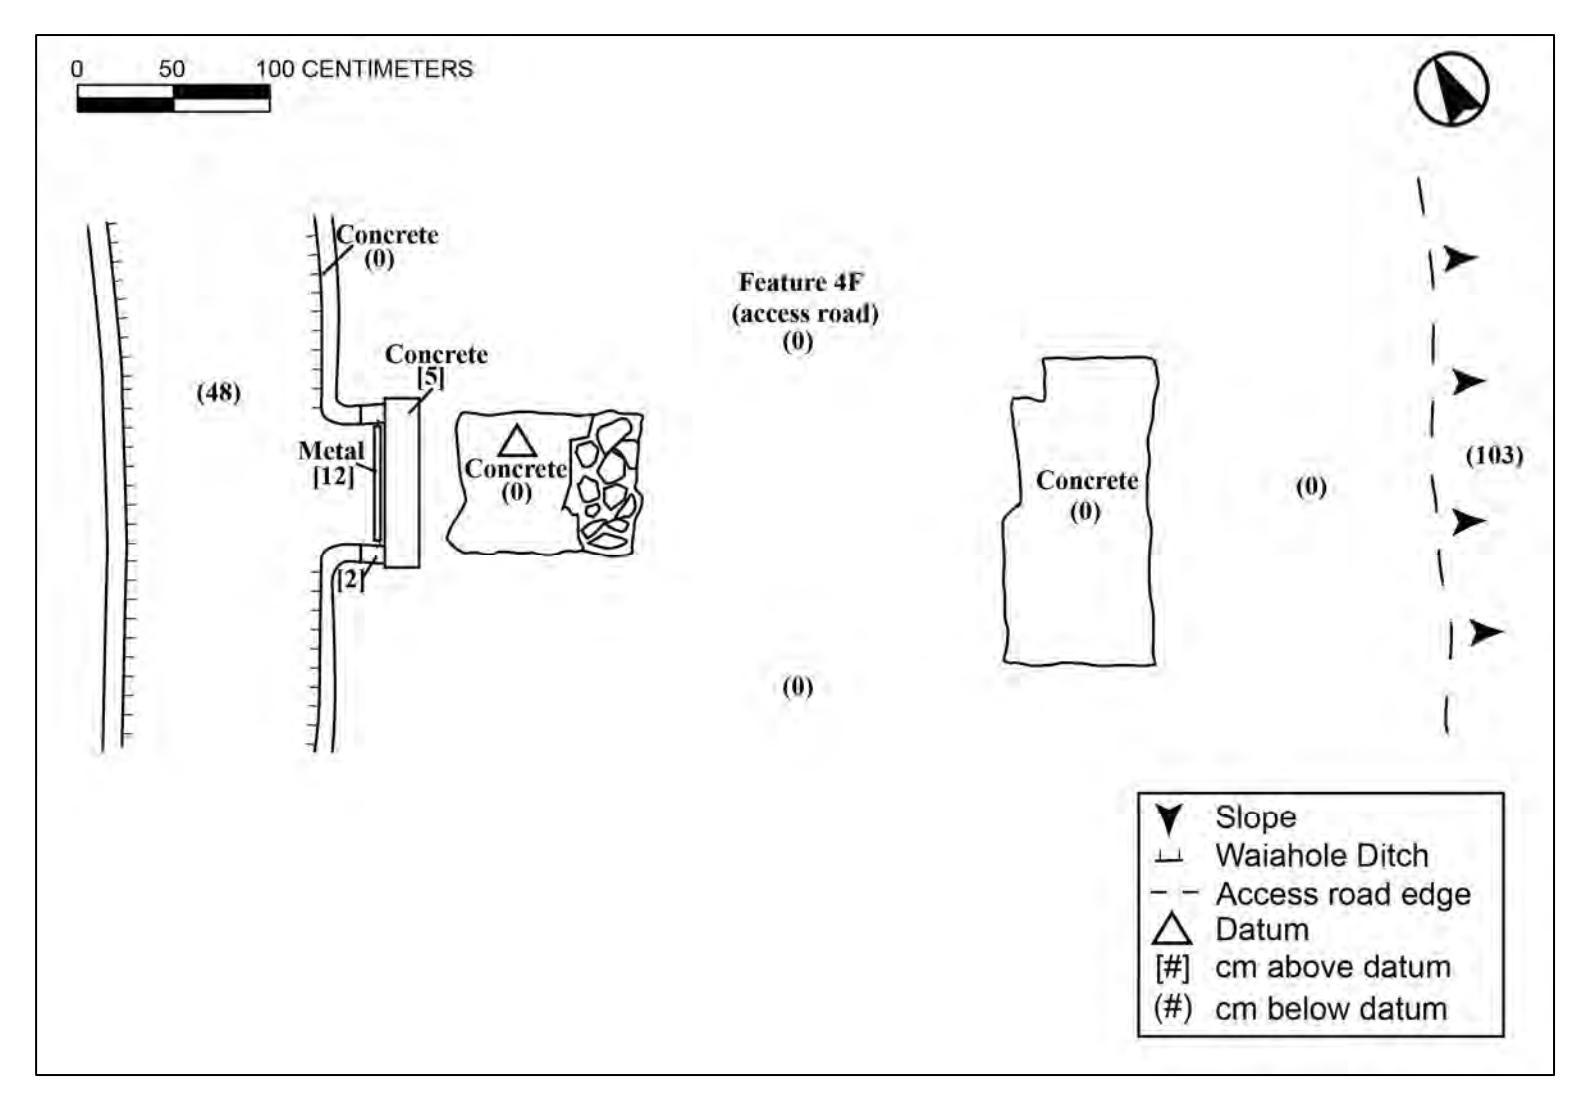
Figure 137. Plan map of SIHP # 50-80-09-2268 Feature K
