FINAL

ARCHAEOLOGICAL INVENTORY SURVEY OF 1,395 ACRES OF KAMEHAMEHA SCHOOLS' LAND IN WAIAWA AND WAIPI'O AHUPUA'A, 'EWA DISTRICT, O'AHU ISLAND, HAWAI'I

TMK (1) 9-4-006:034 por., 035 por., 036, 037 por.; 9-6-004:024 por., 025, 026; 9-6-005:001 por.

> Prepared by: Christopher M. Monahan, Ph.D. TCP Hawai'i, LLC 333 Aoloa Street, #303 Kailua, HI 96734

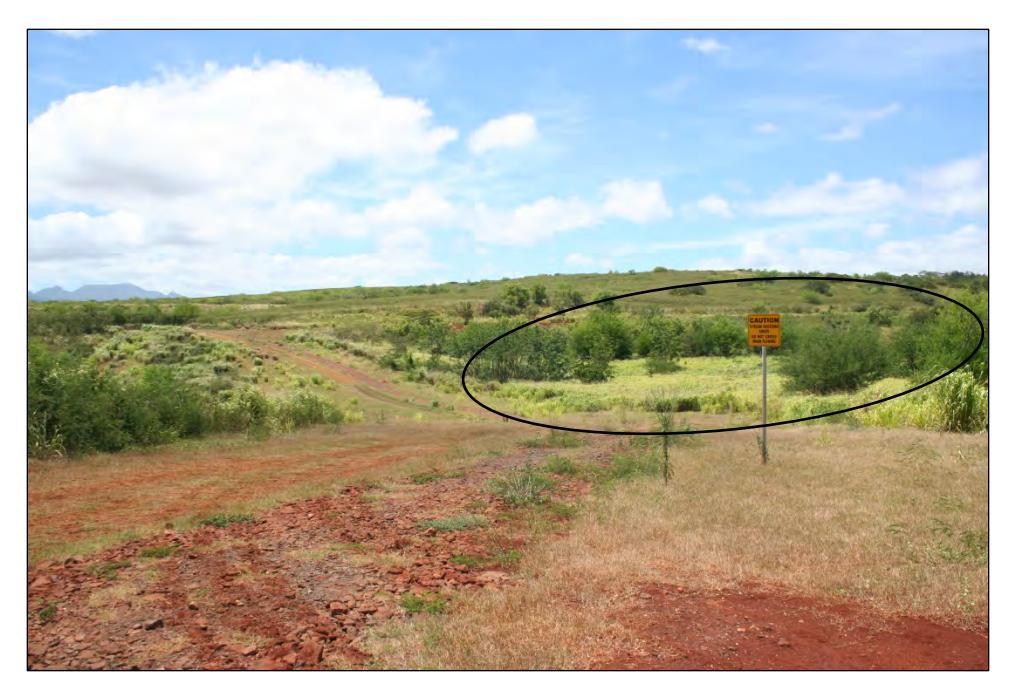
Figure 4. Area of Reservoir 3, which has recently been modified by a flood-control project, view westnorthwest; original reservoir area was to the right (circled, behind the sign) in this view

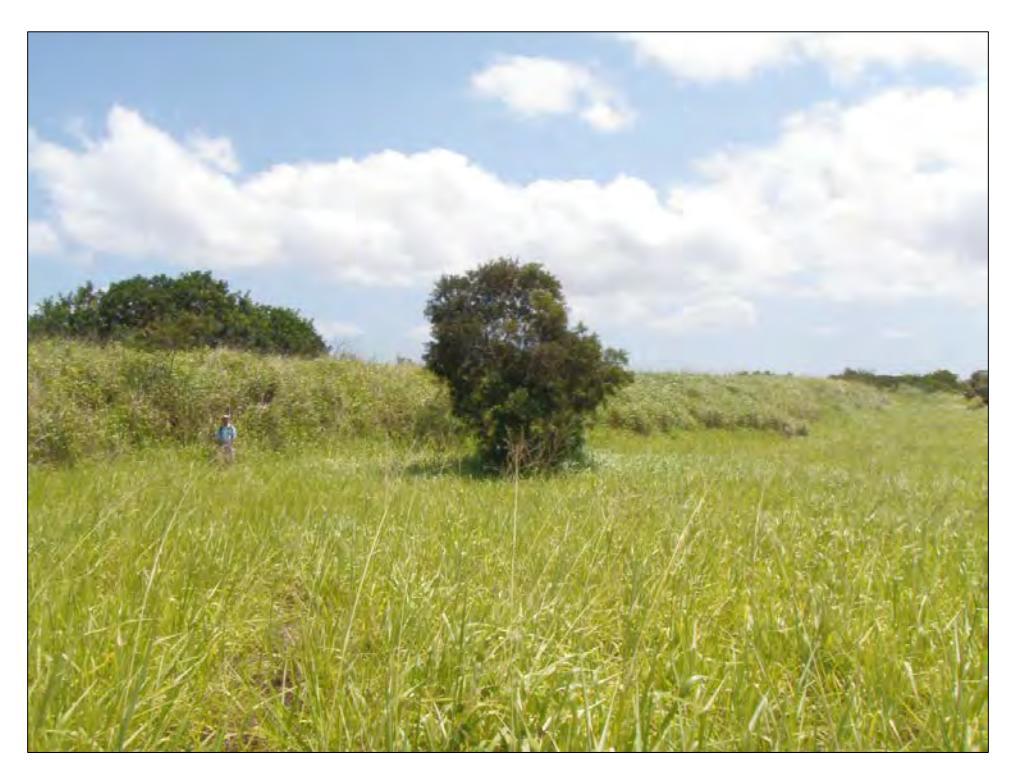
Figure 5. Portion of the north side of the large earthen berm (behind the person for scale) in the northwest project area, view south

A heavily-built earthen berm, much wider and higher than those adjacent to the modern roads, is located in the northwest portion of the project area (Figure 5). This approximately 450-m long berm, clearly visible on aerial imagery, is located immediately north of Gulch A in an area that once housed plantation workers (known as Camp 41). Other than some modern fence lines in the northwest portion of the project area, there are no standing structures besides the historic properties described herein.

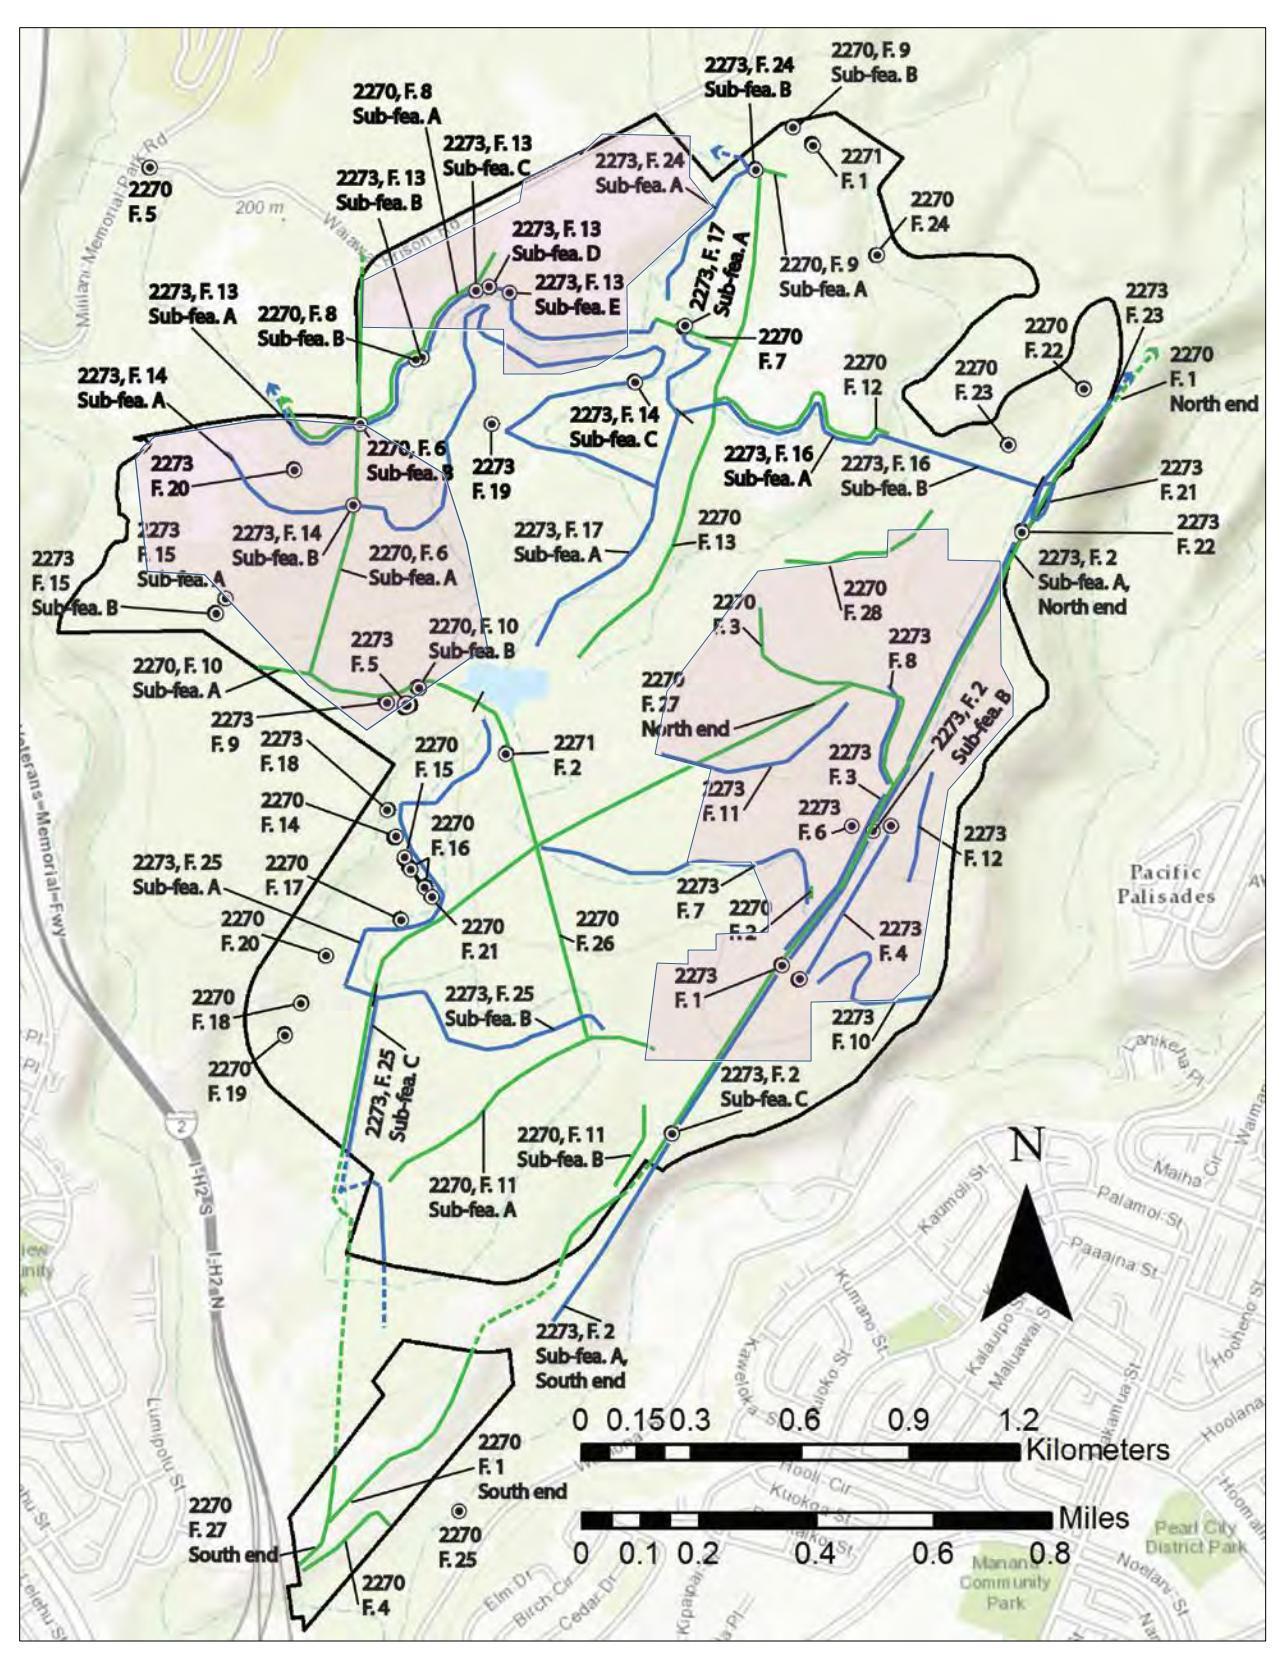
Figure 8. Historic properties and features identified by TCP Hawai'i on a topographic map (base map from ESRI in ArcMap); LUC project area in black; SunEdison project area in light pink; roads in green; linear irrigation features in blue; dashed lines indicate feature continues out of project area

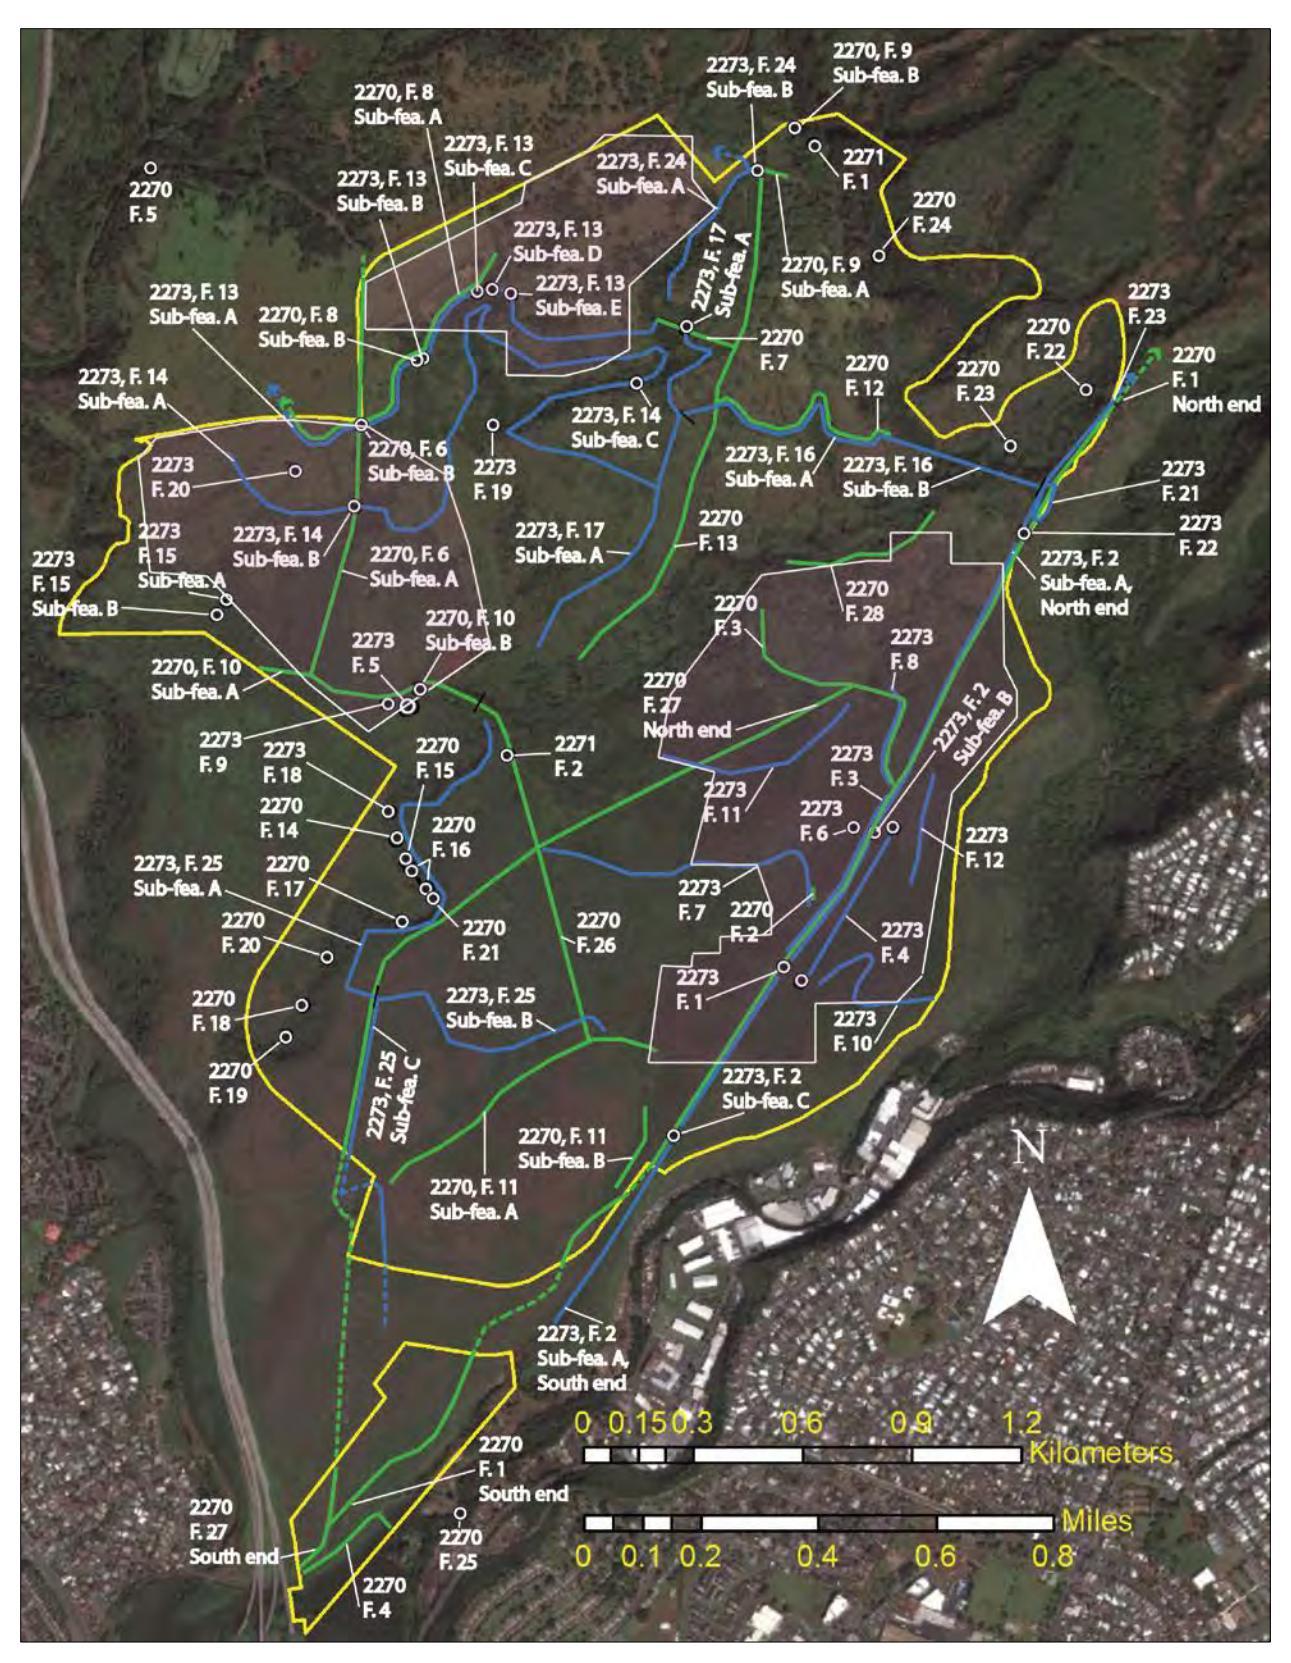
Figure 9. Historic properties and features identified by TCP Hawai'i on aerial image (base map from ESRI in ArcMap); LUC project area in yellow; SunEdison project area in light pink; roads in green; linear irrigation features in blue; dashed lines indicate feature continues out of project area

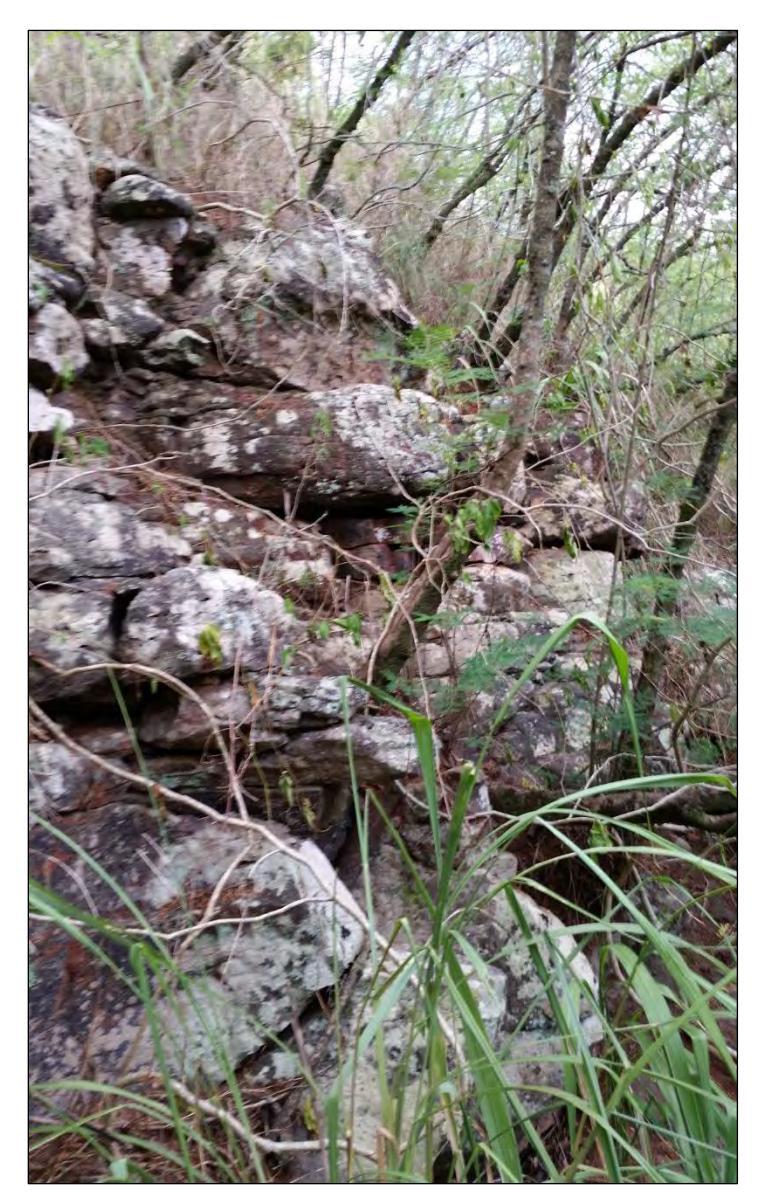
Figure 10. Non-historic property (potential traditional Hawaiian lithic quarry) identified by Thurman et al. (2012) as temporary site number CSH-3, view south; the section of naturally-decomposing bedrock outcrop in this image is approximately 2.0 m high

CSH 3 is on a [2-m long portion of] rock outcrop that begins approximately 20 m above the base of the gulch. The rock outcrop rises approximately 3 m in height. Along this rock outcrop, tucked under a slight overhang, are three areas, 15×10 cm in size, of missing basalt. Chip marks or scarring of the rock surface is visible at each location of missing material,

Chris Monahan, who had never personally inspected this possible site prior to the current AIS, re-located CSH 3, which is on a very steep and dangerous slope that can barely be accessed without sliding down into the gulch (see Figure 10, which was taken with one hand holding onto an upslope koa haole). Based on this inspection, we do not believe this is a precontact lithic quarry, or a historic property of any kind. The weathered, decomposing bedrock outcrop is naturally fractured and friable, and no bona fide flake scars or hard-hammer percussion marks can be observed; chunks of basalt have fallen into the gulch below. All other factors being equal, including its extremely difficult-to-access location and the presence of much better outcrops at the south end of Gulch, TCP Hawai'i evaluates CSH 3 as <u>not</u> a historic property.

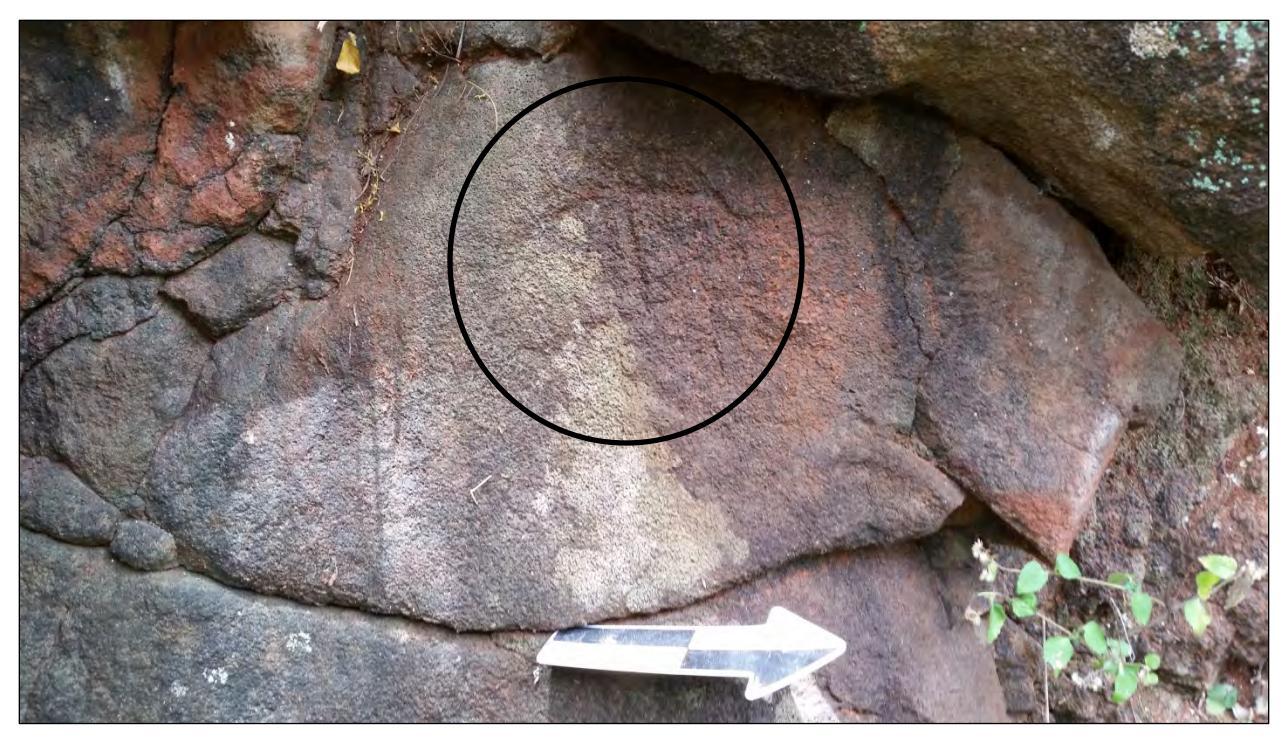
Figure 11. Petroglyph (circled) designated Feature B, Temporary Site CSH-1, view west; north arrow is 20 cm long; photograph taken by TCP Hawai'i on 11 July 2014

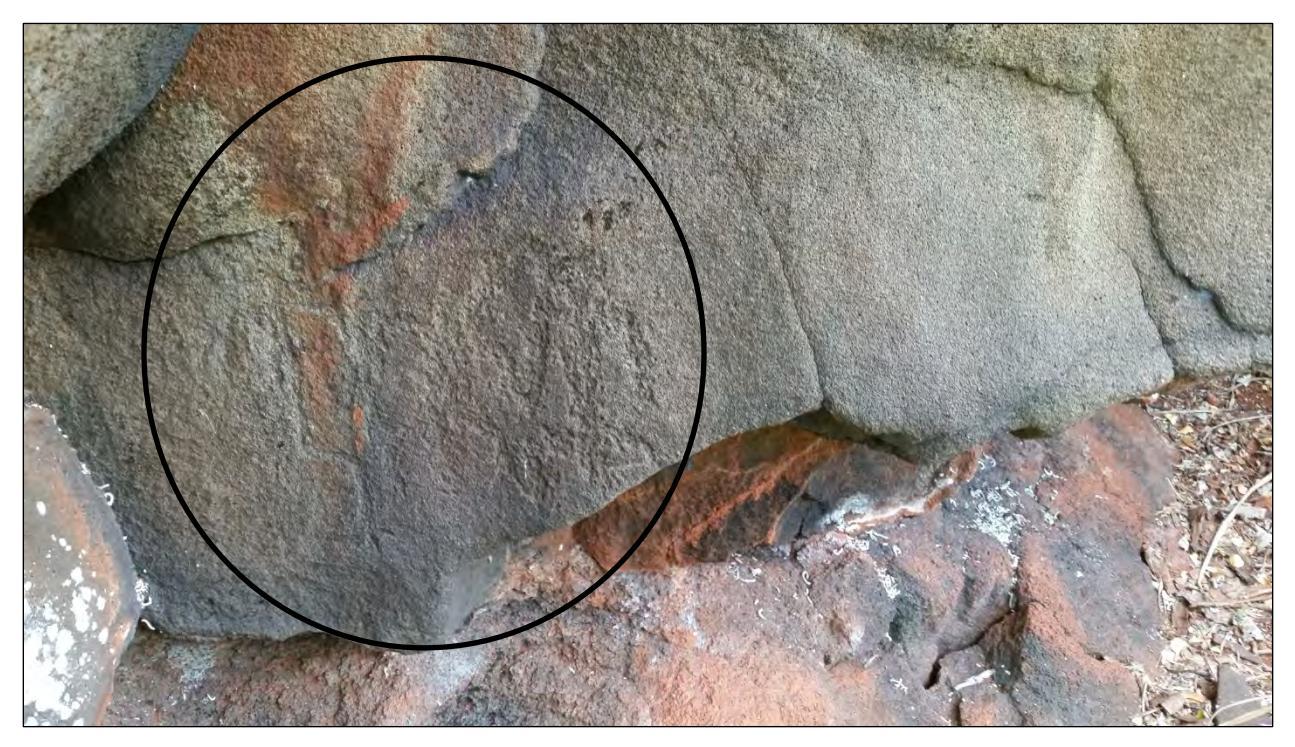
Figure 12. Pair of petroglyphs (circled) designated Feature A, Temporary Site CSH-2, view west; same scale as above; photograph taken by TCP Hawai'i on 11 July 2014

We were more concerned about verifying the location of two sites identified by Thurman et al. (2012) at the south end of Gulch C. CSH 2 is a possible small rockshelter at the north end of an approximately 100m long vertical outcrop on the west side of Gulch C. Thurman et al. (2012) described CSH 2 as a possible precontact habitation but recommended subsurface testing (excavation) "in order to determine whether cultural materials are present. Until testing takes place, it is not currently possible to assess site significance" (Thurman et al. 2012:91). This uncertainty is due to the fact that there are no humanlymodified structures such as rock alignments or stacking at the ground surface of CSH 2; thus, it may simply represent a natural, rather than an archaeological, feature. There is no doubt about the significance of the second, nearby site, CSH 1, a set of three petroglyphs along the same vertical outcrop (Figure 11 and Figure 12). We re-located both CSH 1 and CSH 2, obtained new GPS data, and verified their geospatial location using ESRI software: they are at least 105 m and 80 m (respectively) west of the current "LUC project area" boundary, and much more distant (at least 1.0 km) from the "SunEdison project area."

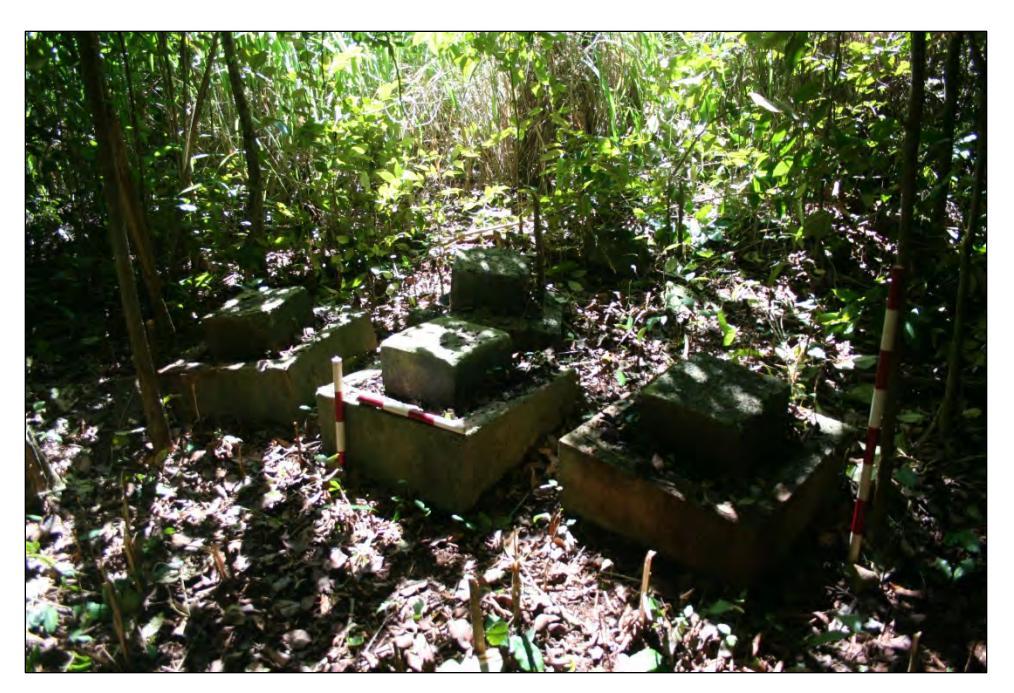
Figure 13. Headstone bases (actual headstones were removed in 1994-5) from Site 2271, Feature 3, that were moved from the slopes of Gulch A, north of the project area boundary, to current location near Site 2271, Feature 1; scale bars in 10-cm increments

Finally, we analyzed previous archival reports and re-located what is left of Site 2271, Feature 3, a small Japanese cemetery that was the subject of data recovery by Sinoto and Pantaleo (1994, 1995). The original location of Site 2271, Feature 3, is approximately 70 m north of the northern limits of the current "LUC project area" (and at least 150 m north-northeast of the "SunEdison project area"). All human skeletal remains and headstones representing burials of several individuals were removed between the 1970s, when the plantation camps were finally abandoned, and 1995, when the data recovery effort, which included extensive consultation with knowledgeable individuals including descendants of those interred at the cemetery, was completed. More recently, Kamehameha Schools also contracted Cultural Surveys Hawai'i to conduct an ethnohistorical study of Kamehameha Schools' Lands in Waiawa, Waiau, and Kalauao (Genz et al. 2010), which included additional consultation regarding this cemetery. Based on all of this information, we did not expect to find any physical evidence of the cemetery. We did, however, discover a set of four headstone bases (Figure 13)—what would have been the foundation stones for the now-removed headstones—within the current project area, just southeast of the pineapple cannery complex (Site 2271, Feature 1). These headstone bases were moved from their original location on the slopes of Gulch A to their current location during the data recovery work 20 years ago.

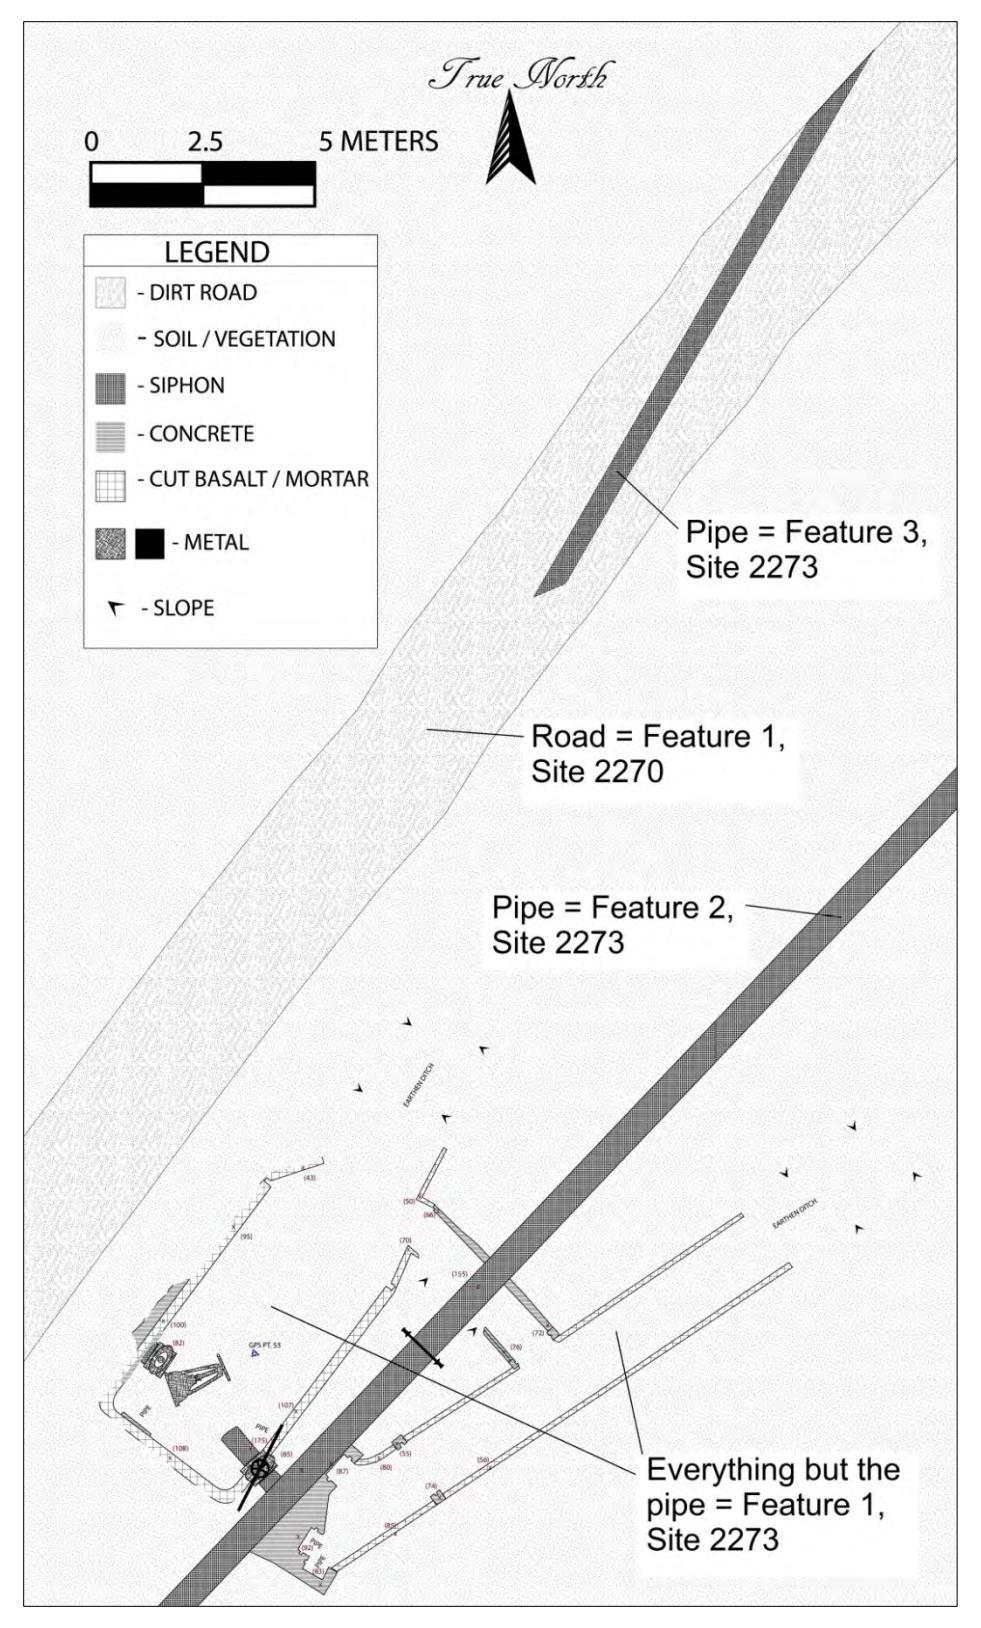
Figure 14. Plan view of Feature 1, Site 2273 (water-distribution basin) in context with road (Feature 1, Site 2270) and partially-buried siphon (Feature 3, Site 2273); siphon connecting with the basin is Feature 2, Site 2273

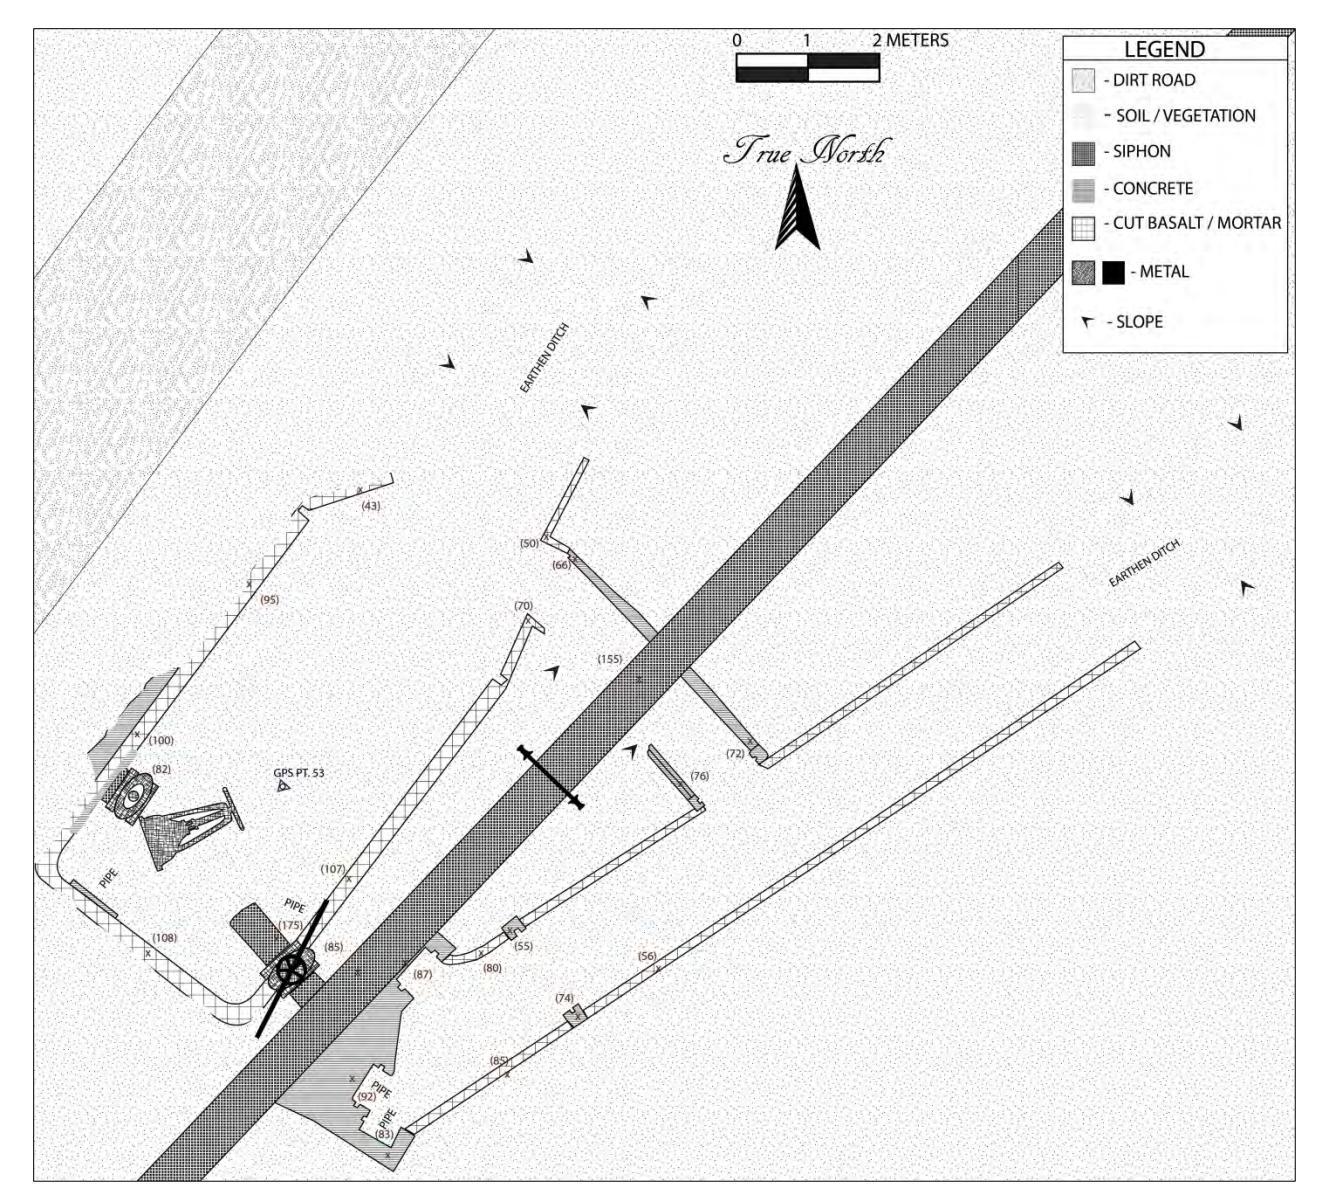
Figure 15. Detail of Feature 1, Site 2273 (water-distribution basin), showing siphon (Feature 2, Site 2273) connecting at hand-operated valve; road (Feature 1, Site 2270) is depicted in upper left of the map
