Exhibit 43H

Figure 3. Response in Shaft 3 During the October 21 to 23, 2015 Pump Test of Lanai Well 2

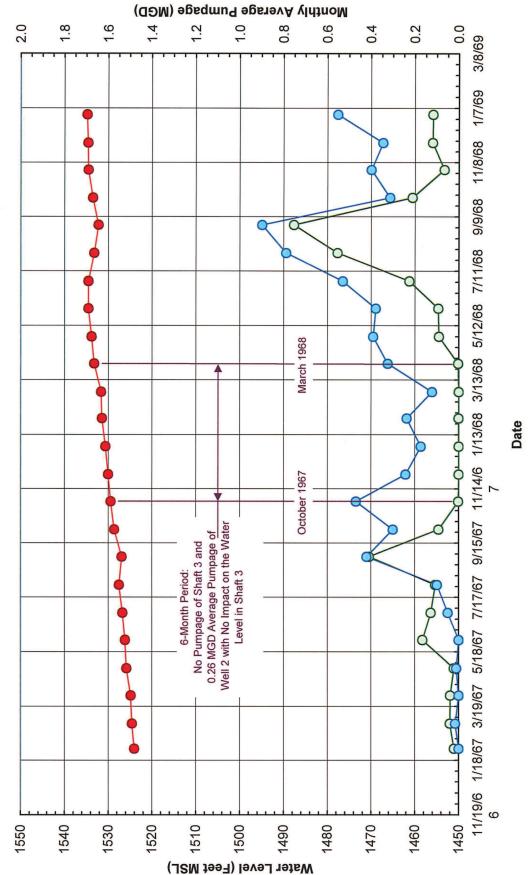
--- Shaft 3 Water Level -O-Shaft 3 Pumpage -O-Well 2 Pumpage
